# **Discovery STS-103**

## **Space Shuttle Program**

### **SSME Flight Readiness Review**

*19 November 1999*

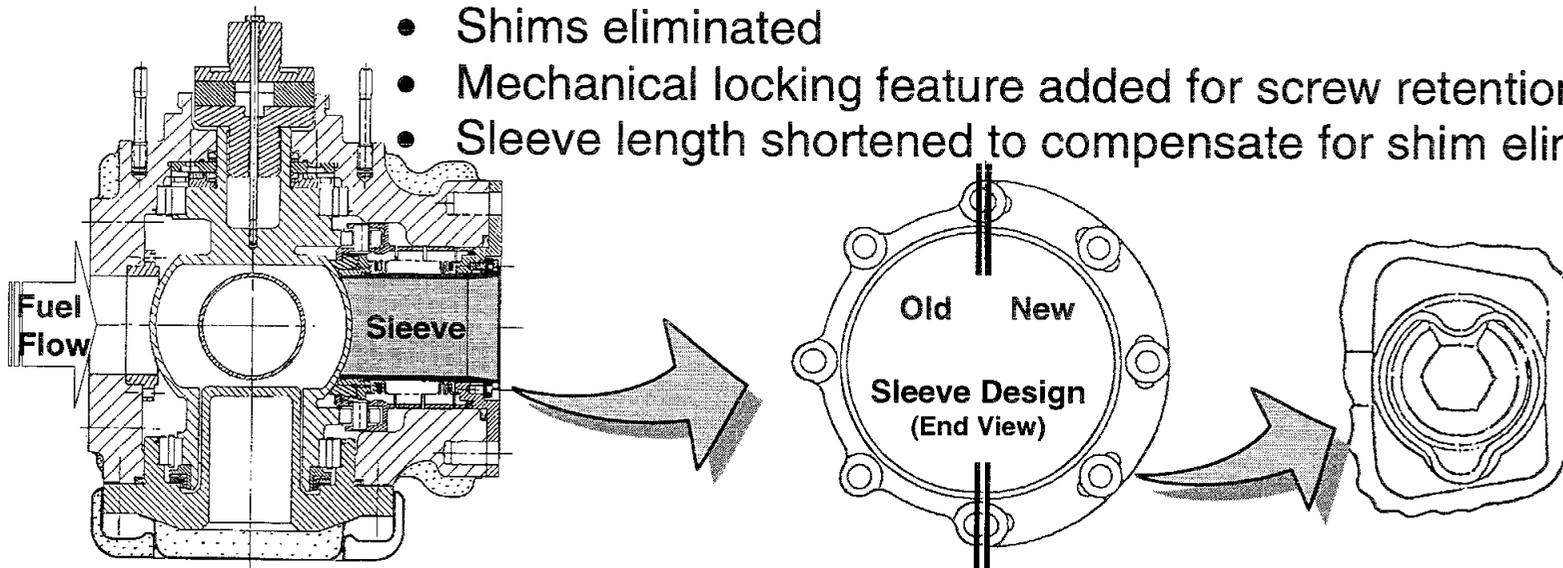
- HPFTP/AT vibrations loosened outlet sleeve screws. Unclamped shims may fret, break, and shed debris into fuel system

- Shims eliminated
- Mechanical locking feature added for screw retention
- Sleeve length shortened to compensate for shim elimination

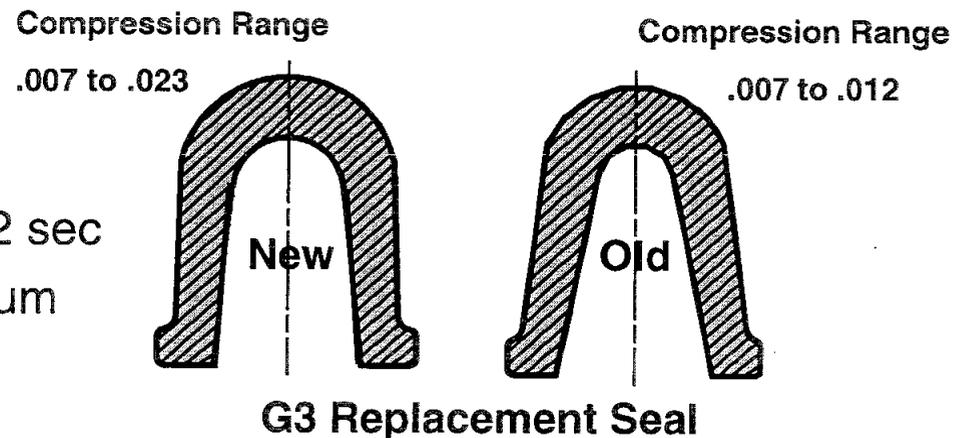
- Material transferred from HPOTP/AT heel to powerhead flange and seal groove lapping causes seal compression outside .007 to .012 experience base

- New, “one size fits all” seal for use with both HPOTP/AT and Phase II HPOTP
  - Allows expanded compression range to cover increased seal travel on HPOTP/AT

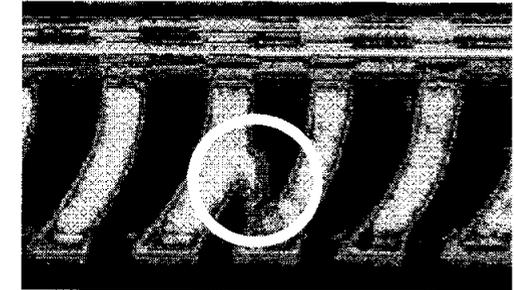
- Shroud to vane braze joint separations found on several rotors
  - Condition attributed to braze thermal cycle changes, isolated to one purchase order
  - Standard visual and penetrant inspections failed to identify defective parts

Example of Ultrasonic Scan Showing Debond

- Improvements to dimensional tolerances and processing requirements
- Addition of ultrasonic inspection
  - Verifies bond area

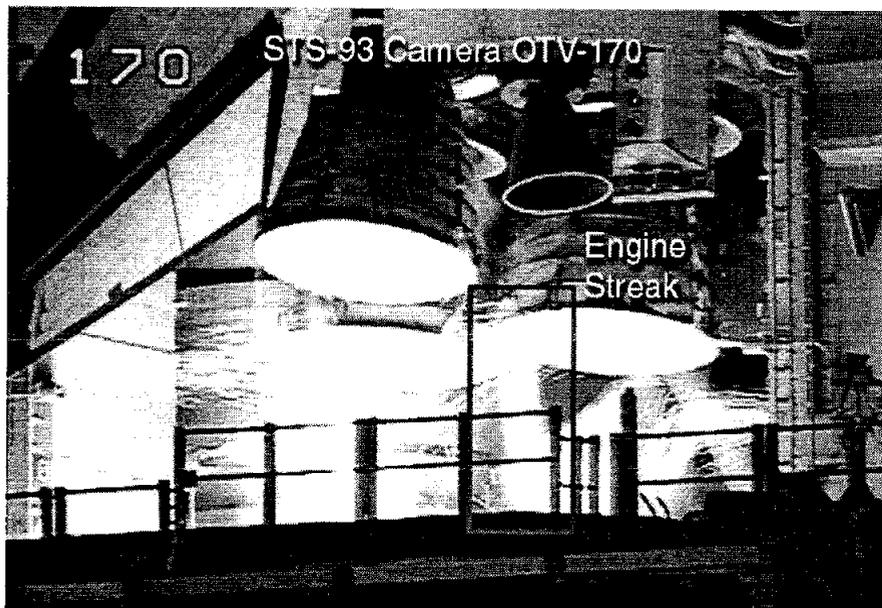
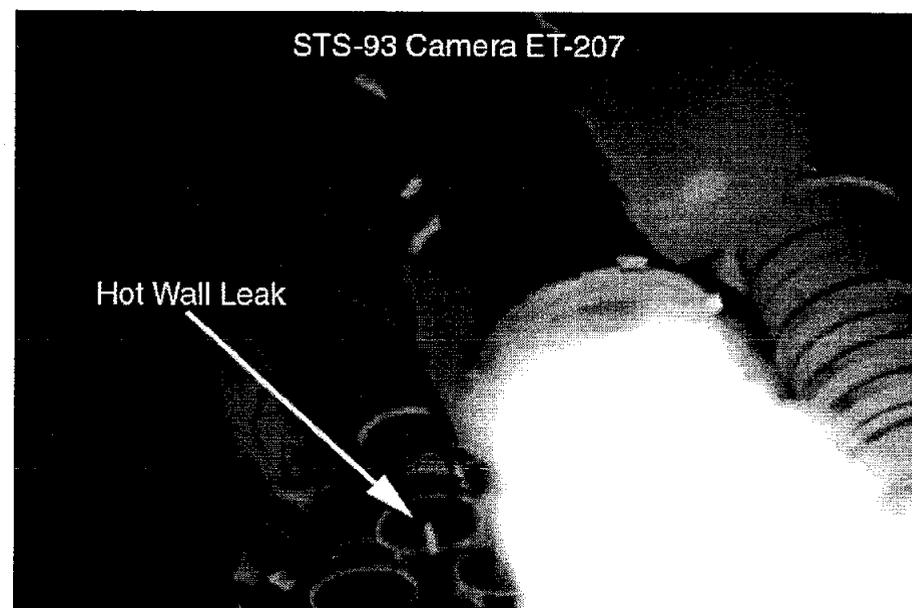
## *In Flight Photography*

- **Issue**
  - Main injector LOX post deactivation pin ejected and ruptured 3 nozzle coolant tubes at start + 5 seconds during STS-93
    - LOX low level cutoff 0.15 seconds before planned MECO
- **Background**
  - Cutoff resulted in orbiter velocity underspeed of 16 ft/sec (of ~26,000 ft/sec)
    - Well within planned mission margins - proper orbit achieved
  - Engine system responded as designed
    - Propellant mixture ratio and thrust controlled properly
    - All redline and structural margins maintained throughout flight
  - Only the second LOX low level cutoff in shuttle history (STS-51F, 7/85)
    - HPFT discharge temperature sensor failures caused premature engine shutdown
    - Other two engines ran longer to achieve orbit

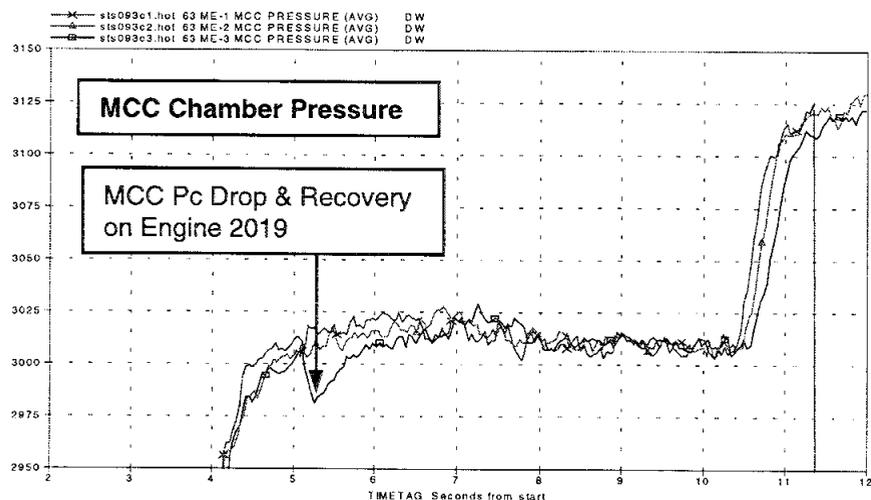
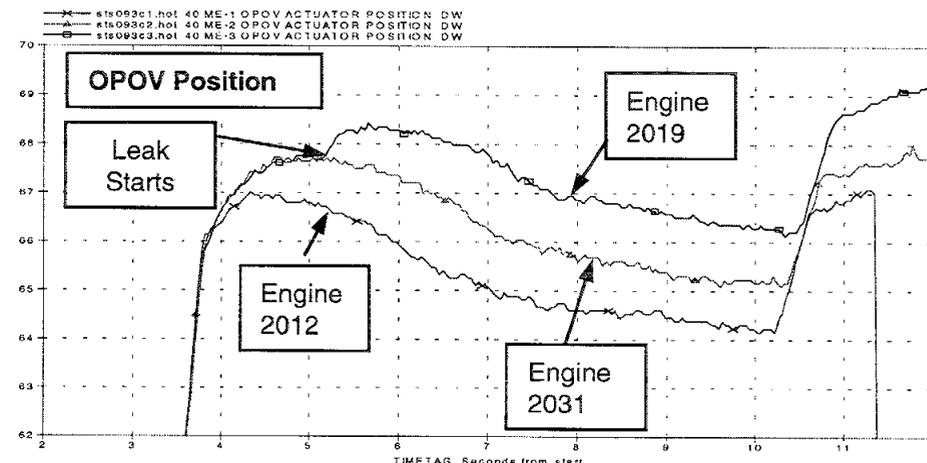
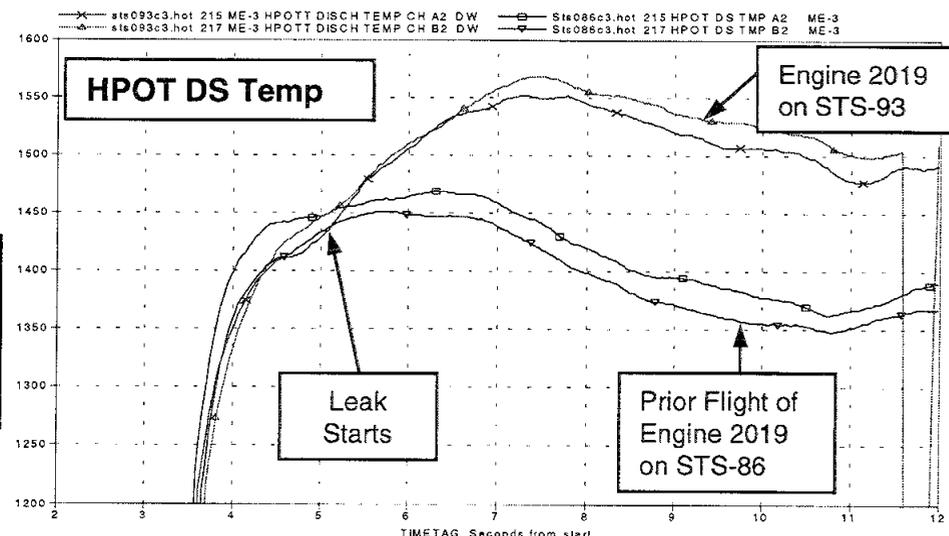
## Engine Performance Data

**Engine system response as designed.  
 Proper control of mixture ratio and thrust.  
 All redline and structural margins maintained.**

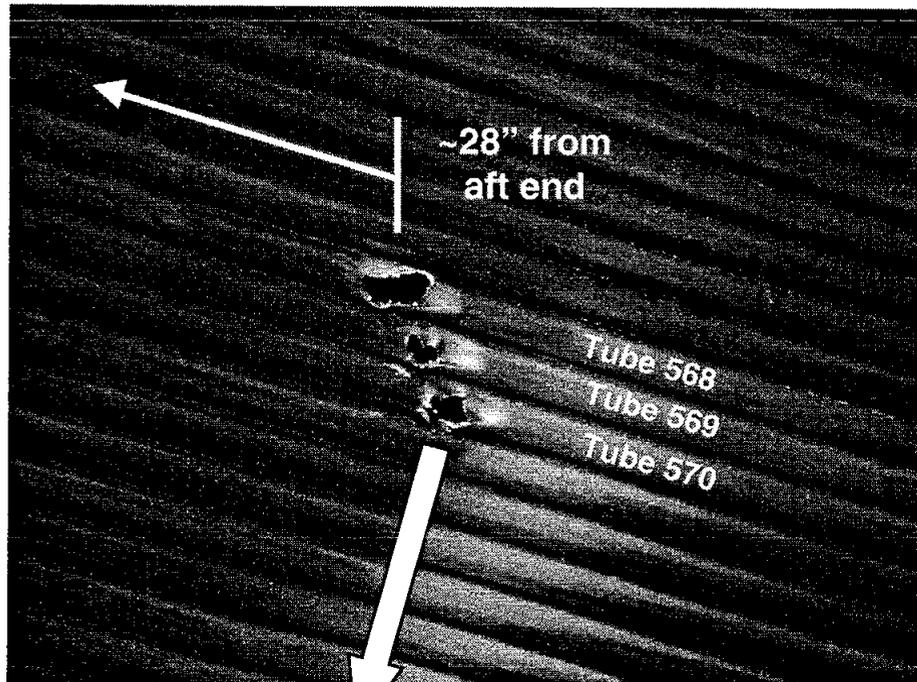
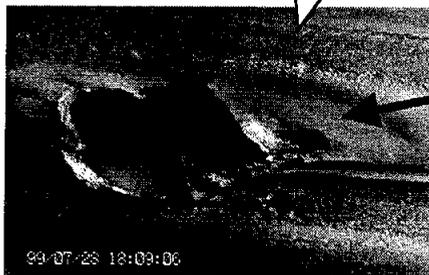
Tube 570 ~5.3x

Dents noted at all 3 tube ruptures. Evidence of gold present.

- Tube leaks confirmed upon landing
  - 3 consecutive tube ruptures
  - $3.5 \pm 0.5$  lbm/sec calculated leak
    - Correlates with performance data and calculated leak area
  - Results in an additional LOX usage of ~5300 lbm
    - Consistent with RSS (Downey) estimates
- Nozzle leak was large enough to cause LOX low level cutoff

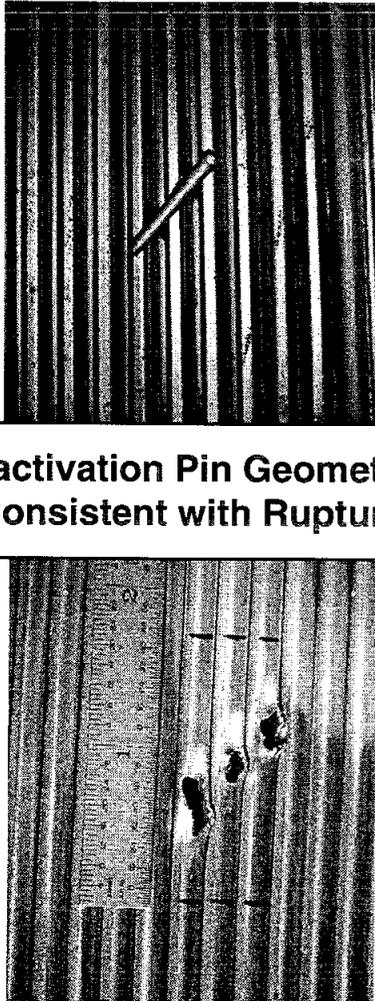
**Deactivation Pin Geometry  
is Consistent with Ruptures**

- **Pin use common on earlier SSME configurations**
  - 212 deactivated posts
  - 18 prior occurrences of loss with no hardware damage
- **Design and process improvements have eliminated need to deactivate posts**
  - All future flights (Block IIA) use new design
  - There are no pinned posts remaining in flight fleet
    - E2048 has been returned to Canoga for replacement of Powerhead

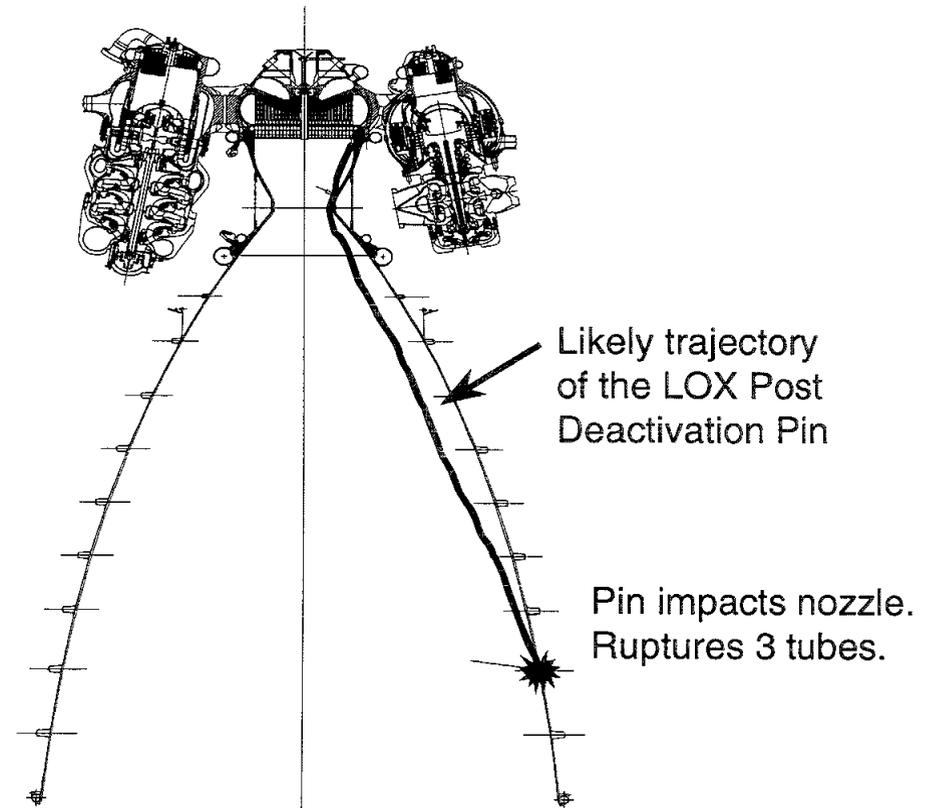
- **Failure Scenario**

- Pin expelled during engine start as pressure builds in LOX dome (~5 sec)
- Pin strikes MCC hot wall and entrains in hot gas flow stream at throat
- Pin traverses across flow streams and strikes the nozzle tubes ~28 inches forward of aft manifold
- Puncturing of the wall results in fuel leakage, increased LOX usage, and early depletion of the LOX supply

- **Fault tree analysis completed**

- No other credible scenarios

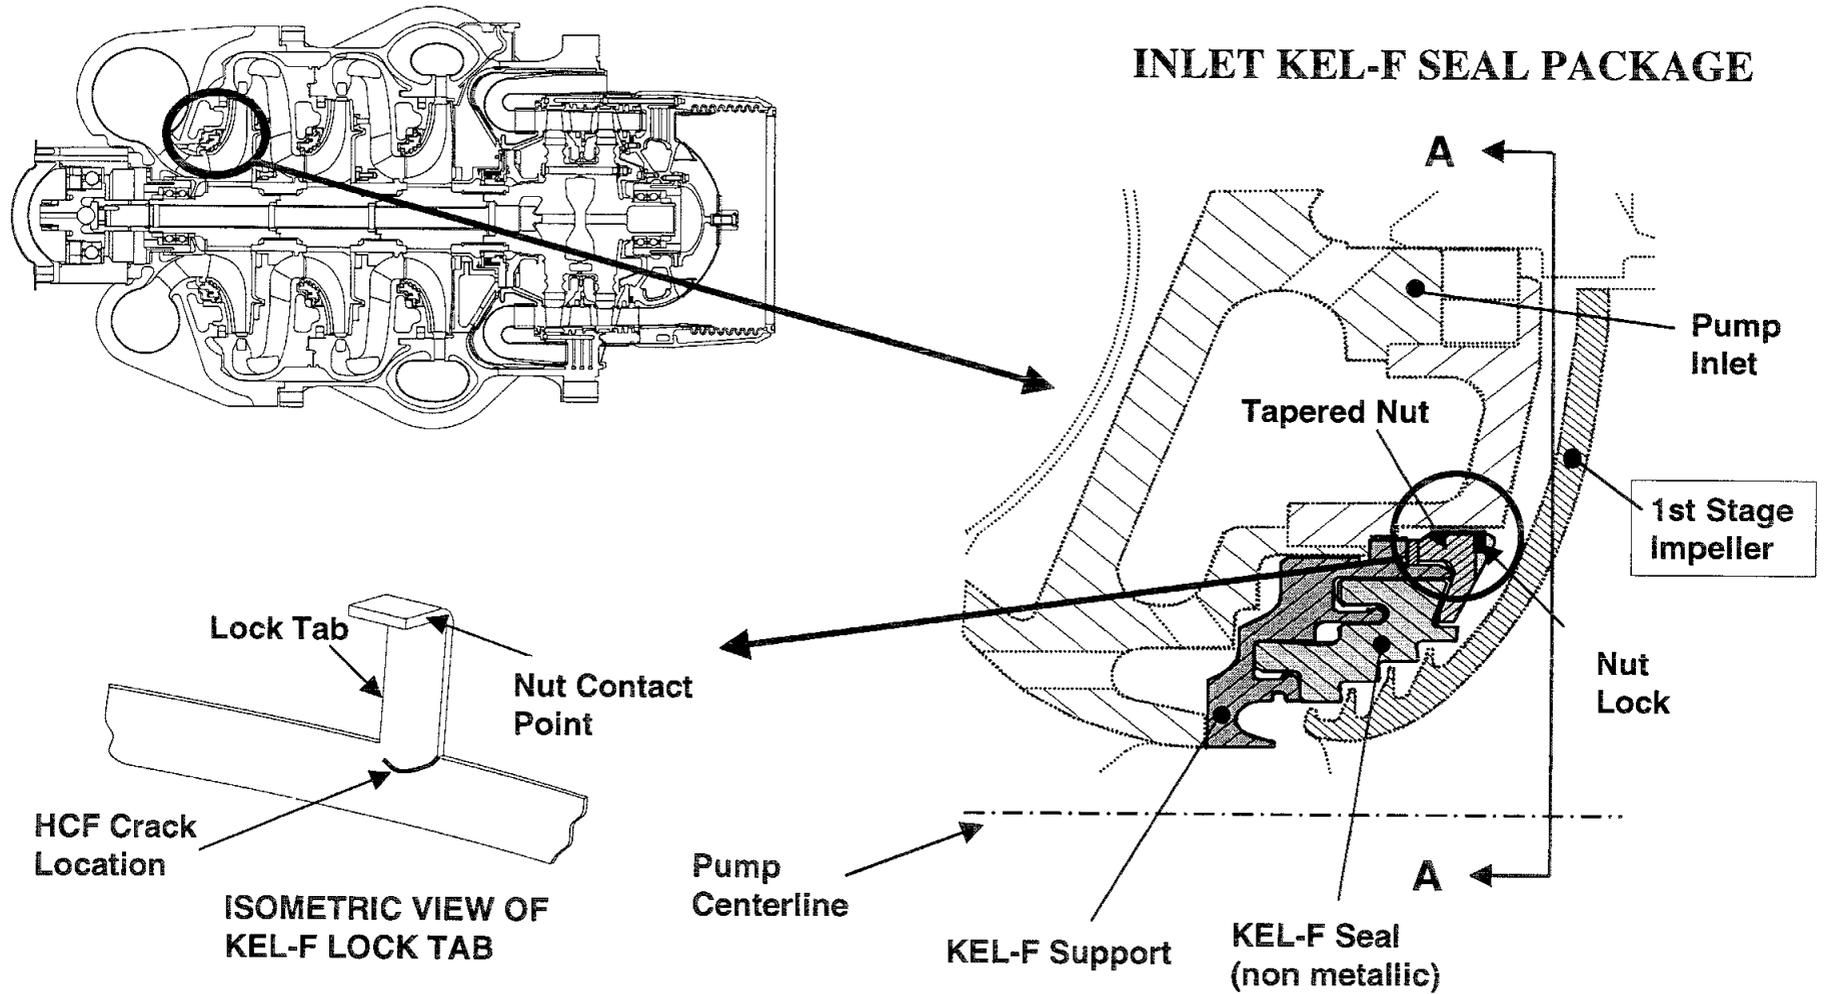
## KEL-F Seal Package

- Pump inlet KEL-F seal subassembly lock tab cracked - concern for foreign object damage/debris (FOD)

- Lock tab broke by overload while being bent back during disassembly
  - Cracked 90% through by high cycle fatigue after nut rotation and “pinching” of lock tab
- Lock tab damage and/or loss caused by nut rotation and contact with seal package lock
- Nut designed to tighten by fluid torque

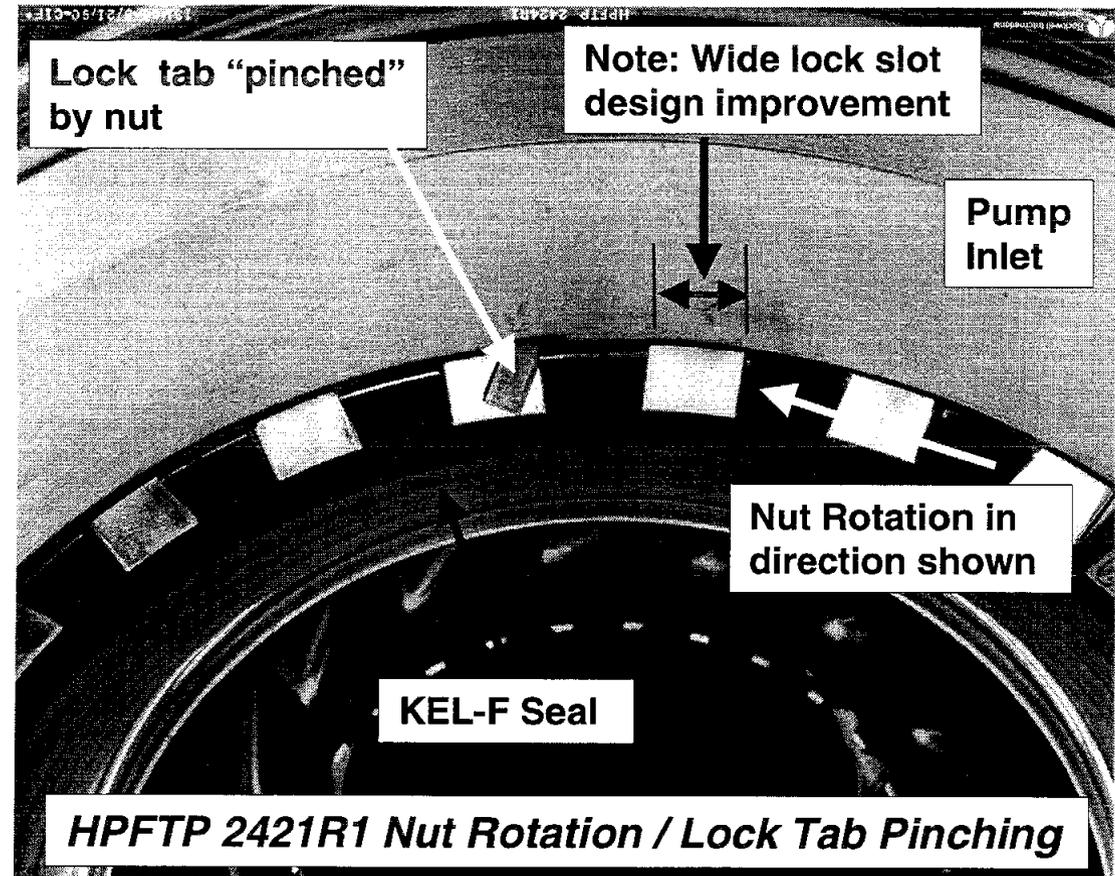
### View A-A

- **Metals utilized in inlet sub assembly contribute to nut rotation**
  - Incoloy 903 / titanium thermal “mismatch”
- **1990 design improvements implemented reduced occurrences of lock damage and loss**
  - Increased torque
  - Increased nut slot width

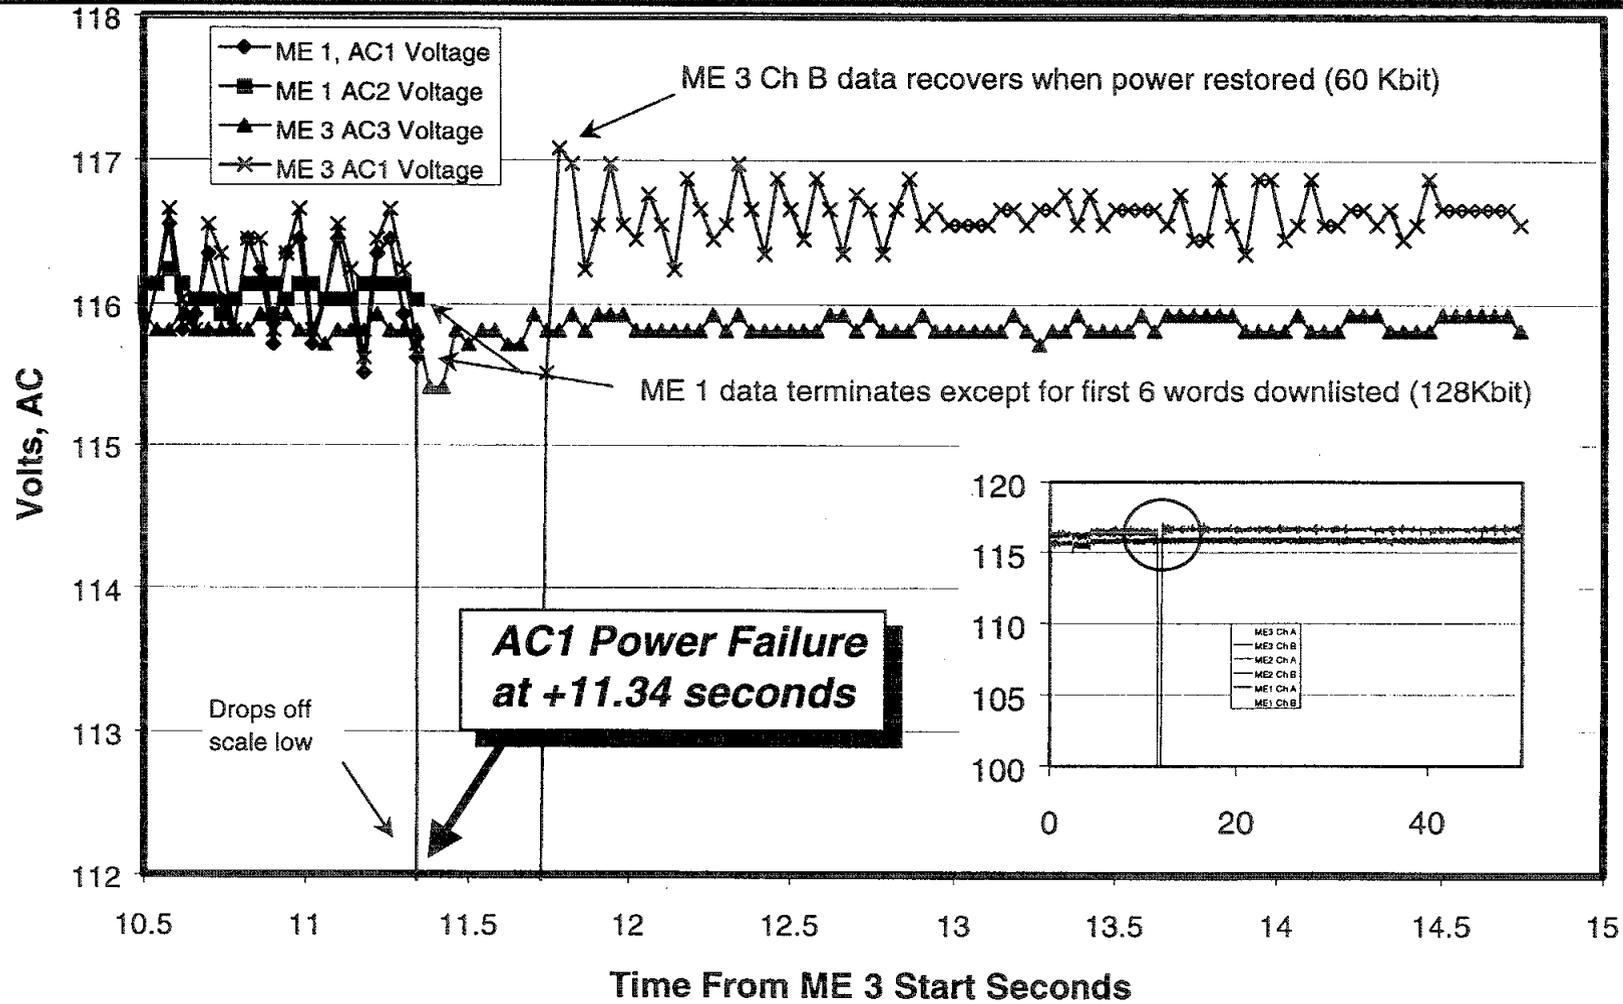
## ME-1 & ME-3 AC Voltage

- At engine start +11.34 seconds, orbiter power to the engine controller failed (orbiter midbody wiring short)
- Each engine supplied by redundant power supplies
- Engines responded as designed
  - ME-1 and ME-3 continued operation on single channel
    - ME-1 backup channel resumed control but with limited orbiter data transmission and recording
    - ME-3 backup channel disqualified for engine control

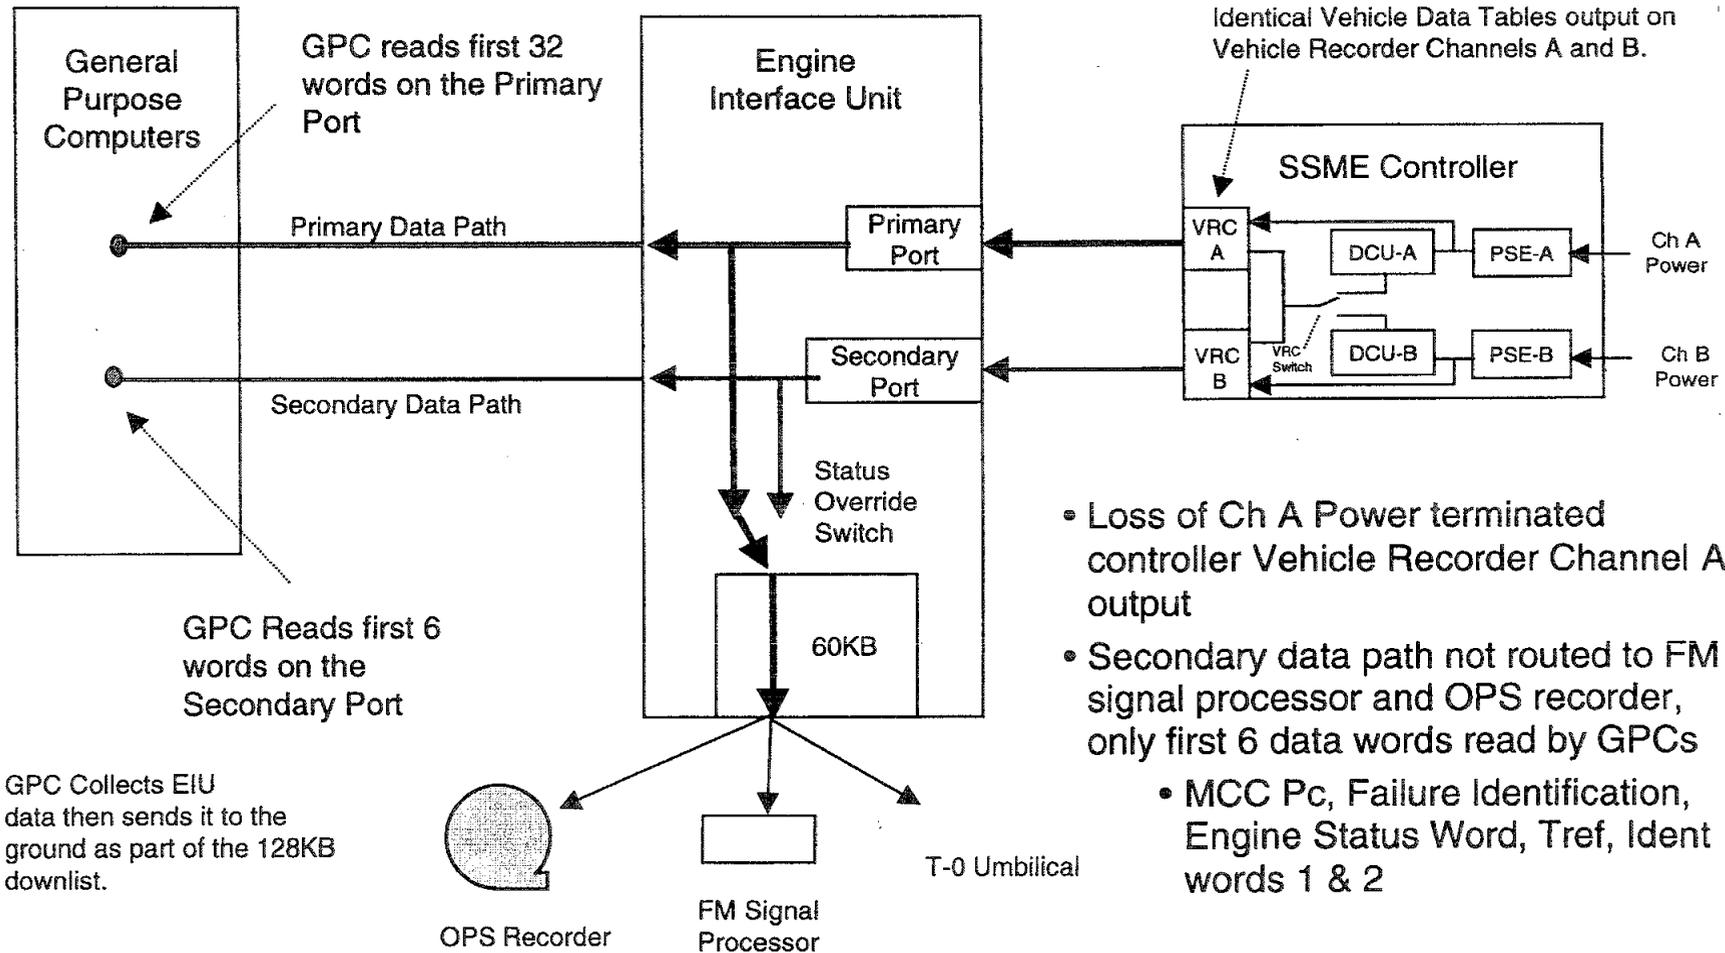
## ME-1 Data Loss

- Loss of Ch A Power terminated controller Vehicle Recorder Channel A output
- Secondary data path not routed to FM signal processor and OPS recorder, only first 6 data words read by GPCs
- MCC Pc, Failure Identification, Engine Status Word, Tref, Ident words 1 & 2

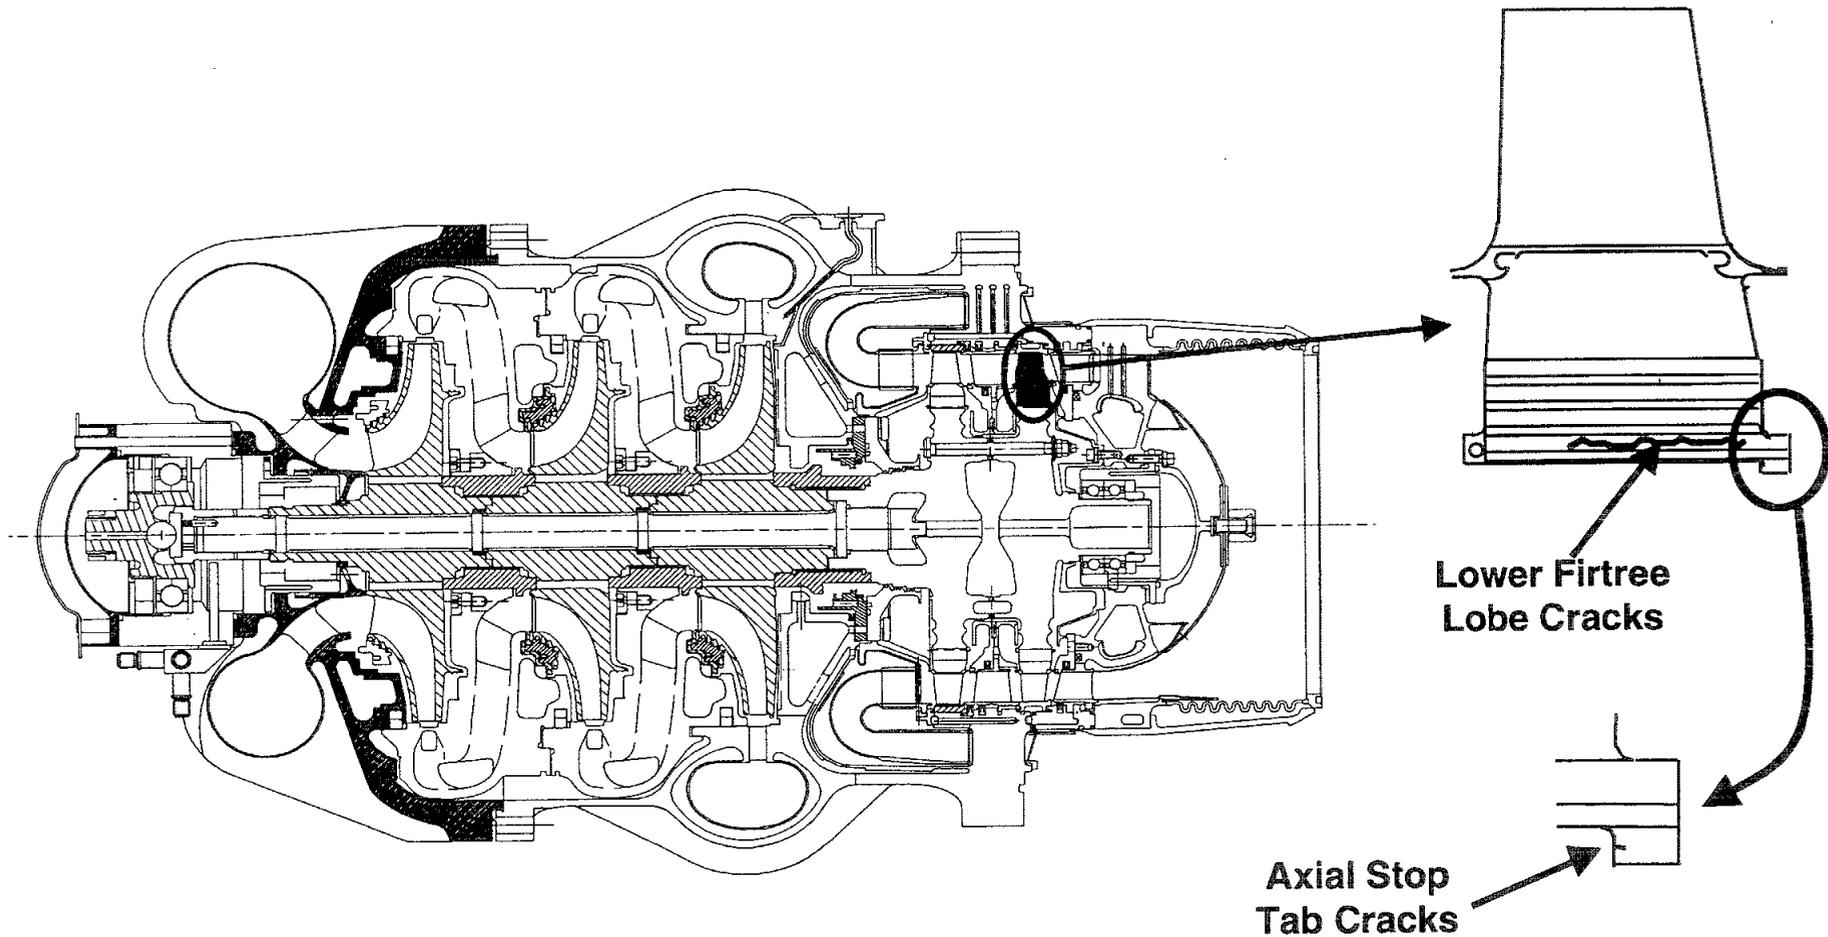
## *Lower Firtree Lobe and Stop Tab Cracks*

- **Issue**
  - Reoccurrence of cracks in 1st stage blade lower firtree lobe and in axial stop tab
- **Background**
  - HPFTP 2128R2 recently returned from field for disassembly and recycle (7 starts and 3396 seconds on build)
    - Pump initially assembled in 1994
  - Cracks found during normal disassembly visual inspections (confirmed with dye penetrant inspection)
    - 10 blades with lower firtree lobe cracks
    - 11 blades with axial stop tab cracks
      - 3 blades with both types of cracks
  - Investigation Team formed - actions in work
    - No change to existing flight rationale anticipated

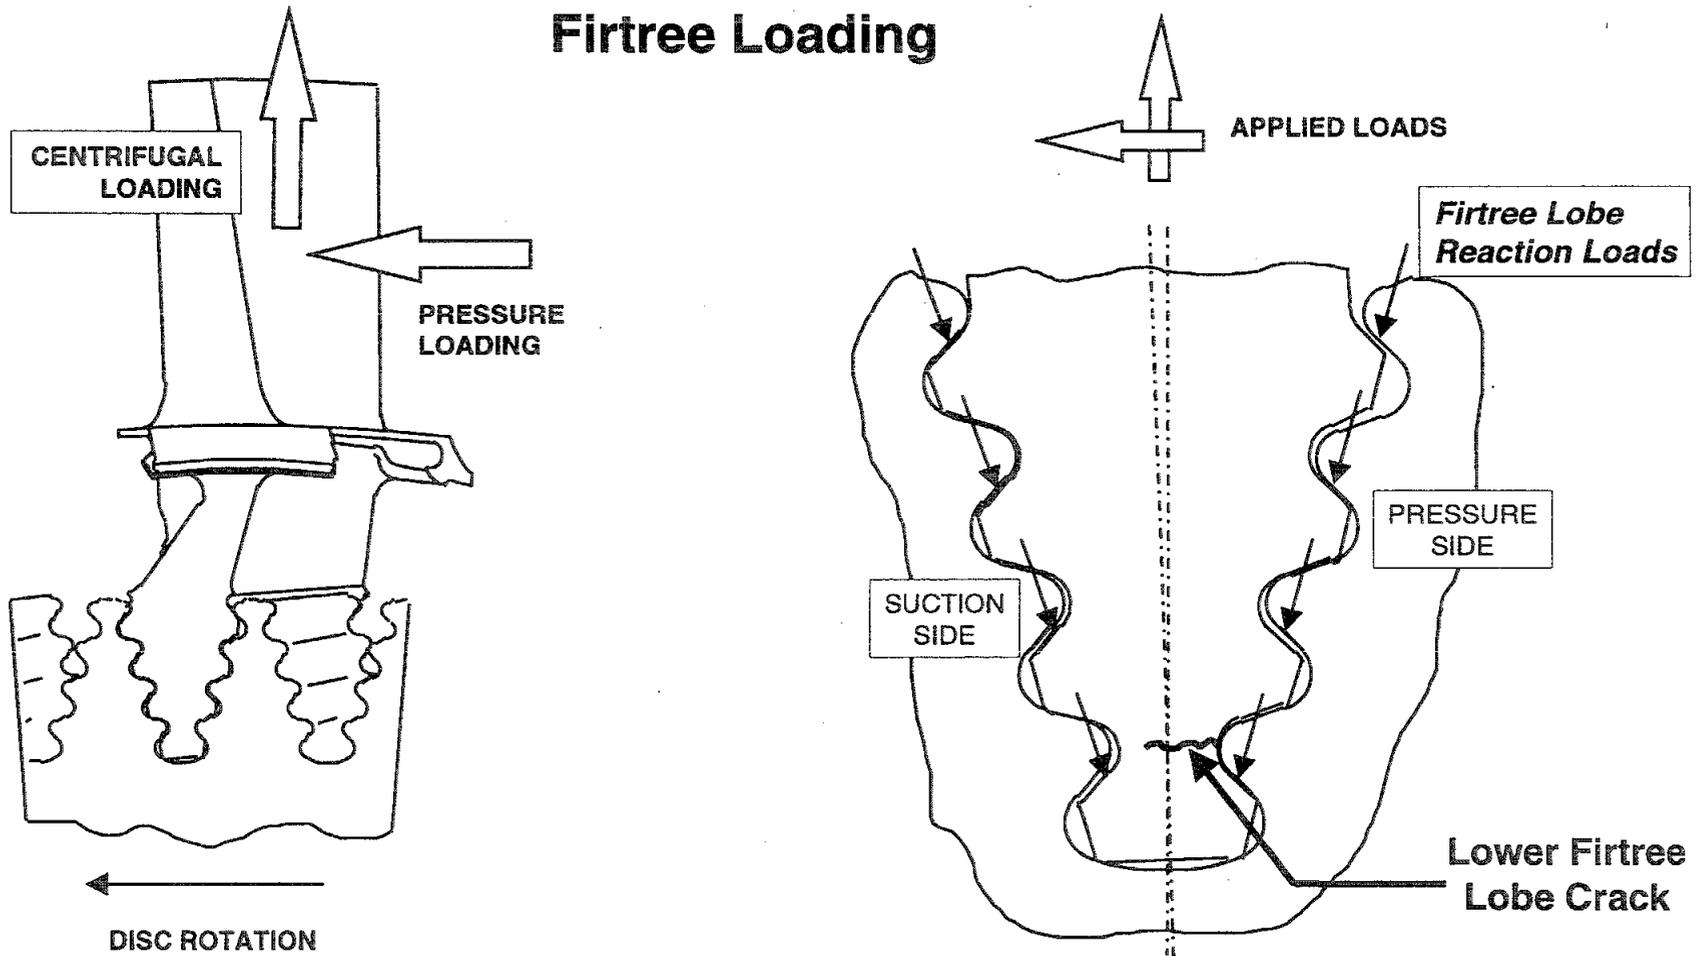
## Lower Firtree Lobe Cracks

- **Prior to HPFTP 2128R2**
  - Previously identified condition
    - 34 blades prior to “Return to Flight” (0.83% occurrence rate)
      - 11 of 65 blades sets (max of 15 blades cracked in one set)
      - 4 blades with cracks in 2nd lobe
    - 4 “Return to Flight” configuration blades (0.09% occurrence rate)
      - 3 of 72 blade sets (max of 2 blades cracked in one set)
      - No occurrences of cracks in 2nd lobe
  - Reduced occurrence rate since “Return to Flight”
    - Process modifications incorporated in 1986
      - Improved load sharing between firtree lobes (process change)
      - Improved blade material capability (shot peening)

- **Hydrogen Assisted, Sustained Load Cracking**
  - Crack initiates in 1st or 2nd test
  - Multiple, pressure side, midspan initiation sites (typically at carbides)
  - Growth continues through firtree to suction side
  - No history of complete separation of lower lobe
    - Loads redistribute to upper lobes, self limiting
- **Most Probable Cause**
  - Tight fit of blade into disc firtree slots
  - Lower lobe neck is most sensitive to tolerance and fit variations between lobes
    - Largest increase in strains and largest peak strains
    - Supported by detailed finite element analyses

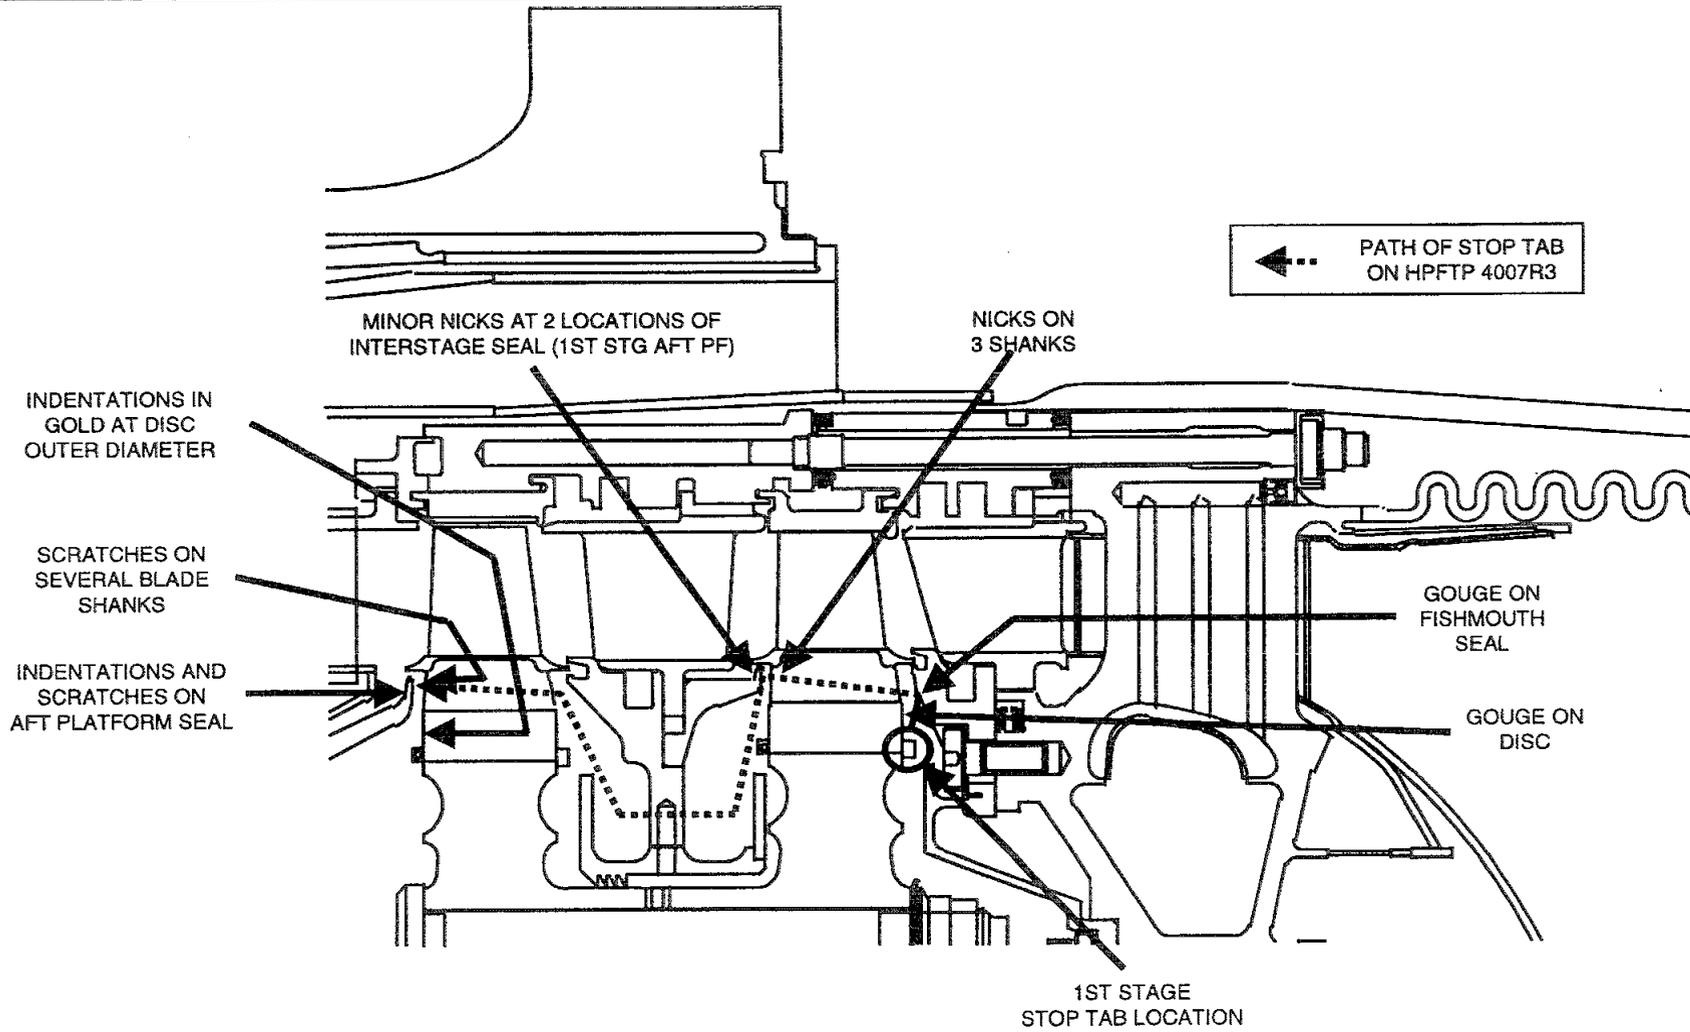
## *Loss of Stop Tab - HPFTP 4007R3 Particle Path*

- **Negligible effect on blade retention and damping**
  - No evidence of movement of blade on either HPFTP 4007R3 or 4110R2
  - Blade movement precluded by high firtree frictional forces
- **No effect on engine start from dislodged fragment**
  - Breakaway torque up to 1000 in-lbs has no effect on start
    - HPFTP 4007R3 required 660 in-lbs to rotate with fragment fully lodged between 2nd stage disc and aft platform seal
- **Fragment of insufficient mass to cause damage**
  - Results in minor scratches and nicks on blade shanks, discs, fishmouth and platform seals
  - Stop tab remains below blade platforms and cannot enter flowstream in one piece
    - Only 36% of tab fragment mass (0.06 grams) could enter hot gas flow stream with worst case tolerances

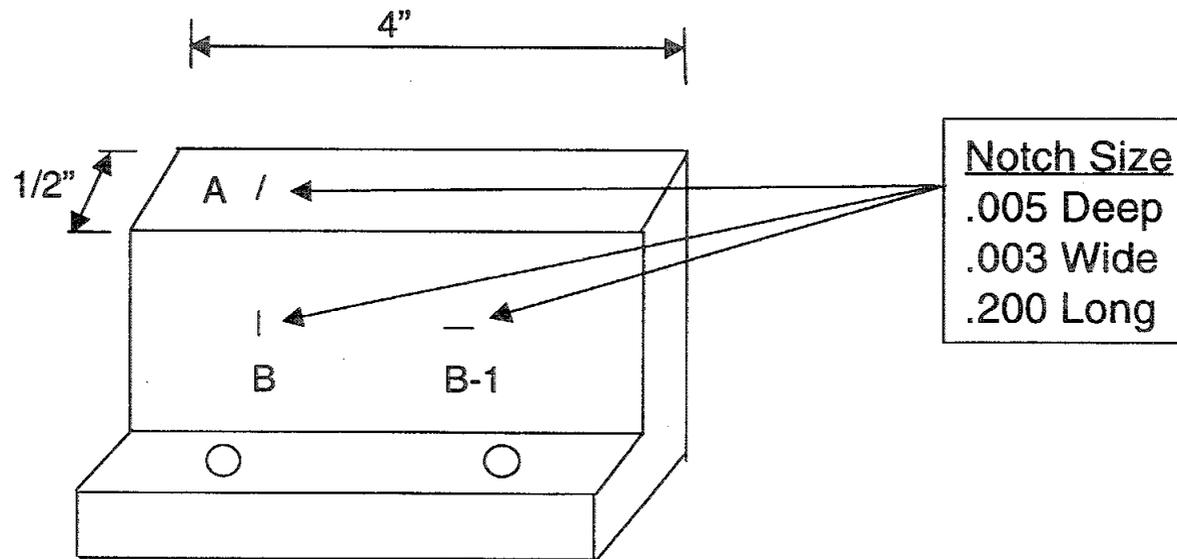
ECI Anorad Calibration Block Illustration

- **Background (Continued)**
  - Calibration of Anorad machine has been performed using one standard for all crack orientations and probe types
    - Discovered in Air Force audit at P&W Middletown, CT
  - Result is inspection errors for certain setups for parts - splines, slots, small fillets, ID bores, etc
  - P&W machining process controls have history of producing defect-free parts
    - No evidence of machining induced flaws in the AT program history

- Notch orientations B and B-1 have incorrect calibration
- Calibration for notch orientation A is correct

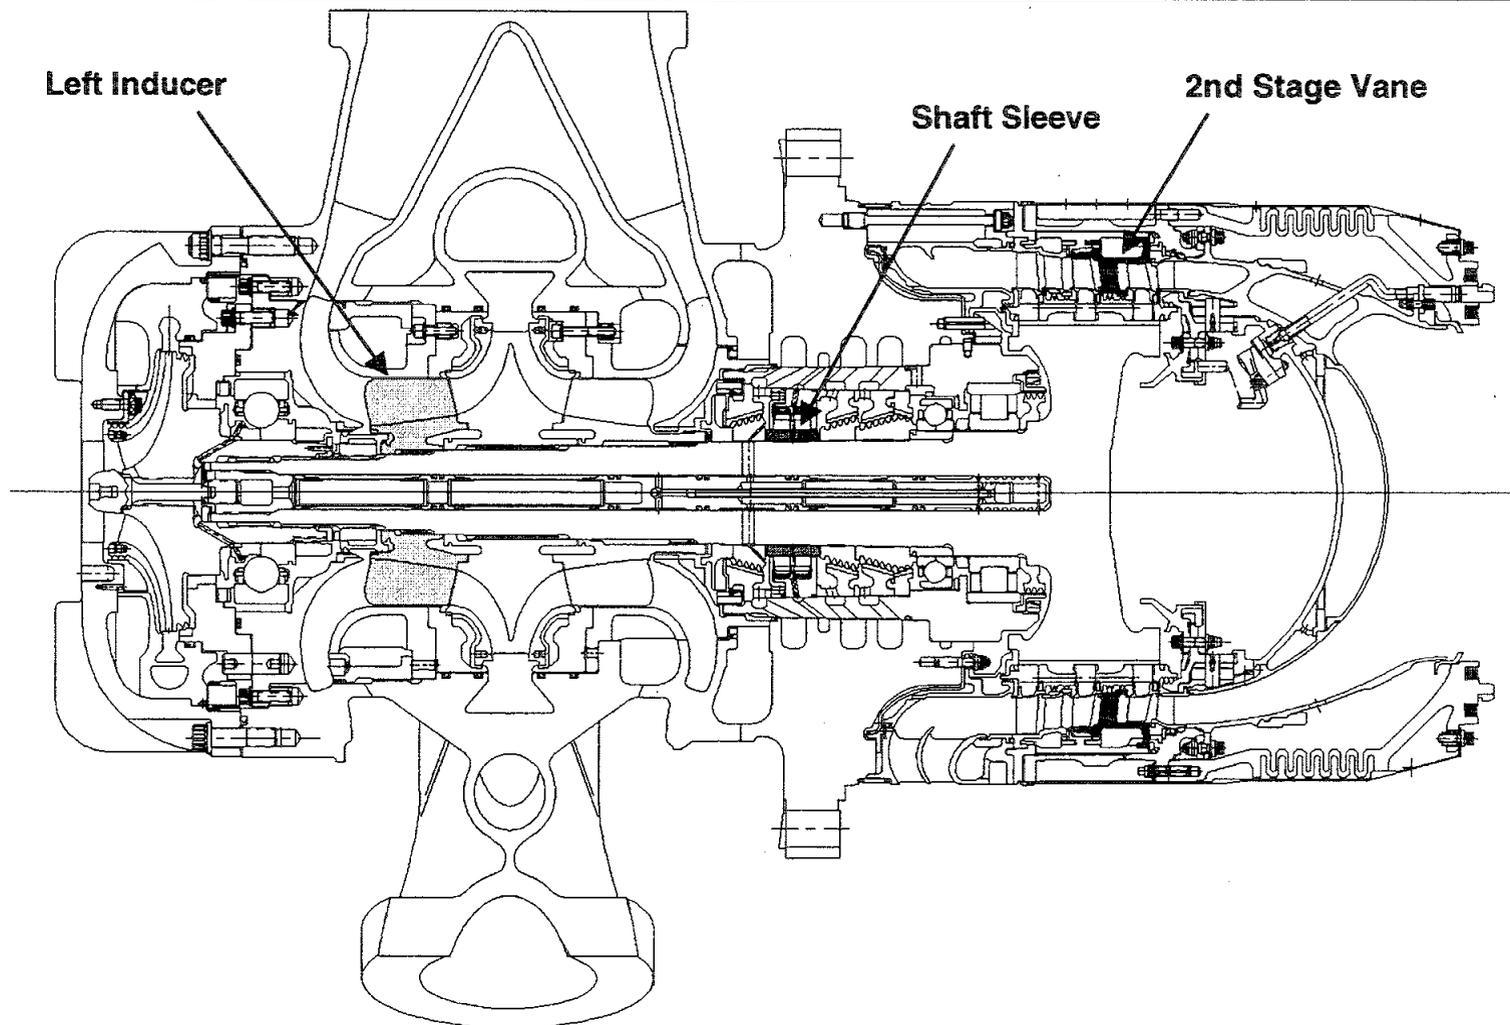
## *STS-103 Parts Exceeding ECI Reject Amplitude*

- **Diagnostic testing performed to quantify inspection error**
  - Inspection error found to be 47%
- **Assessment of flight hardware for STS-103 is complete**
  - Screen of 25% of target signal amplitude used
  - ECI trace review for 21 components per pump which use Anorad machine in B and B-1 orientations
    - 44 parts on STS-103 exceed 25% screen
    - 5 parts on STS-103 had corrected indications in excess of reject signal amplitude
  - Fracture life analysis performed on components which exceeded the reject level
    - Included correction for signal error
    - Assessed as known defects
    - All parts on STS-103 meet CEI life requirements
