TWR-75738
ECS SS10969

Reusable Solid Rocket Motor **STS-104 Flight Readiness Review/CoFR**

Motor Set RSRM-80

28 June 2001

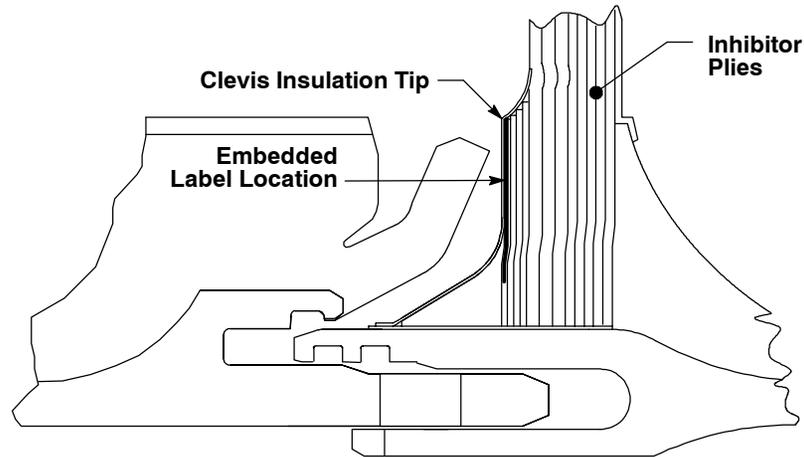
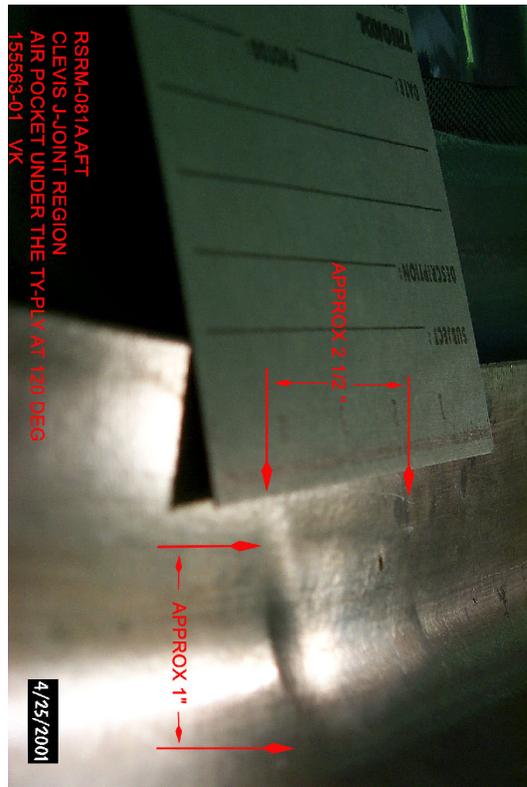
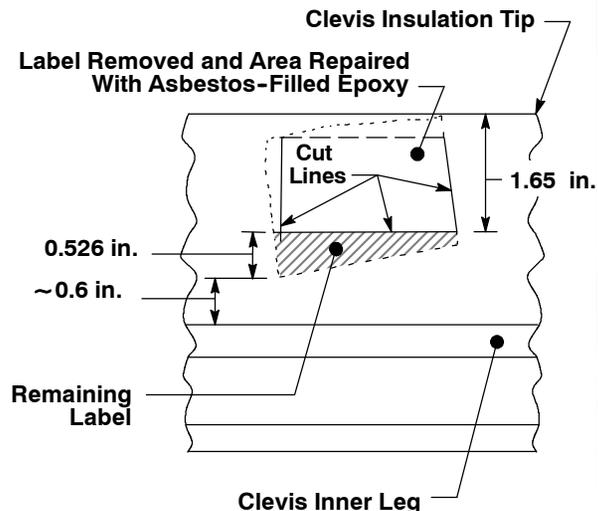
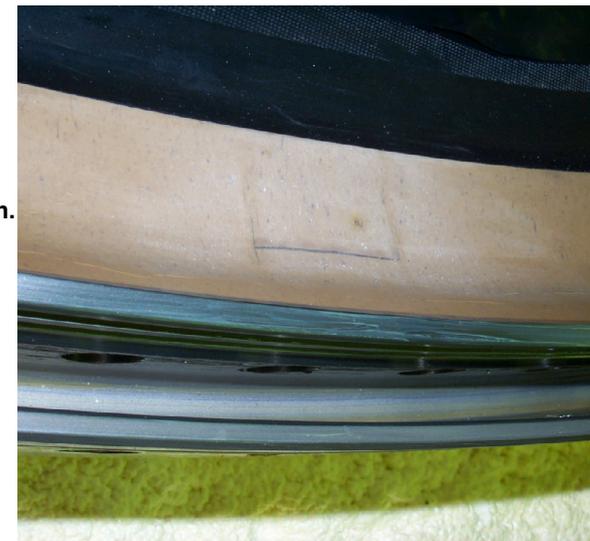
STS-105 (RSRM-81) LH Aft Condition

- A pattern identification label was found embedded in the clevis insulation of the STS-105 LH aft segment during processing at KSC
 - The label-caused void was cut open, most of the label removed, the rubber bonded back in place, and the repair blended to the surrounding contour
 - STS-105 LH aft segment repair has been fully evaluated and meets all requirements

- Consequence of a label incorporated anywhere within the insulation on any segment relative to thermal, structural, or sealing requirements
 - Label could create a small unbond or void (1.75 in. x 2.5 in.)

- Cause of the out-of-place label is understood
 - Missing or misaligned polyethylene film cover resulted in label adhering to the back of a green rubber ply in the pre-cut ply kit
 - Cause determined to be a rare and isolated event
- A joint Thiokol and MSFC team conducted a comprehensive evaluation of the insulation layup process and design to understand the probability and criticality of labels in the insulation

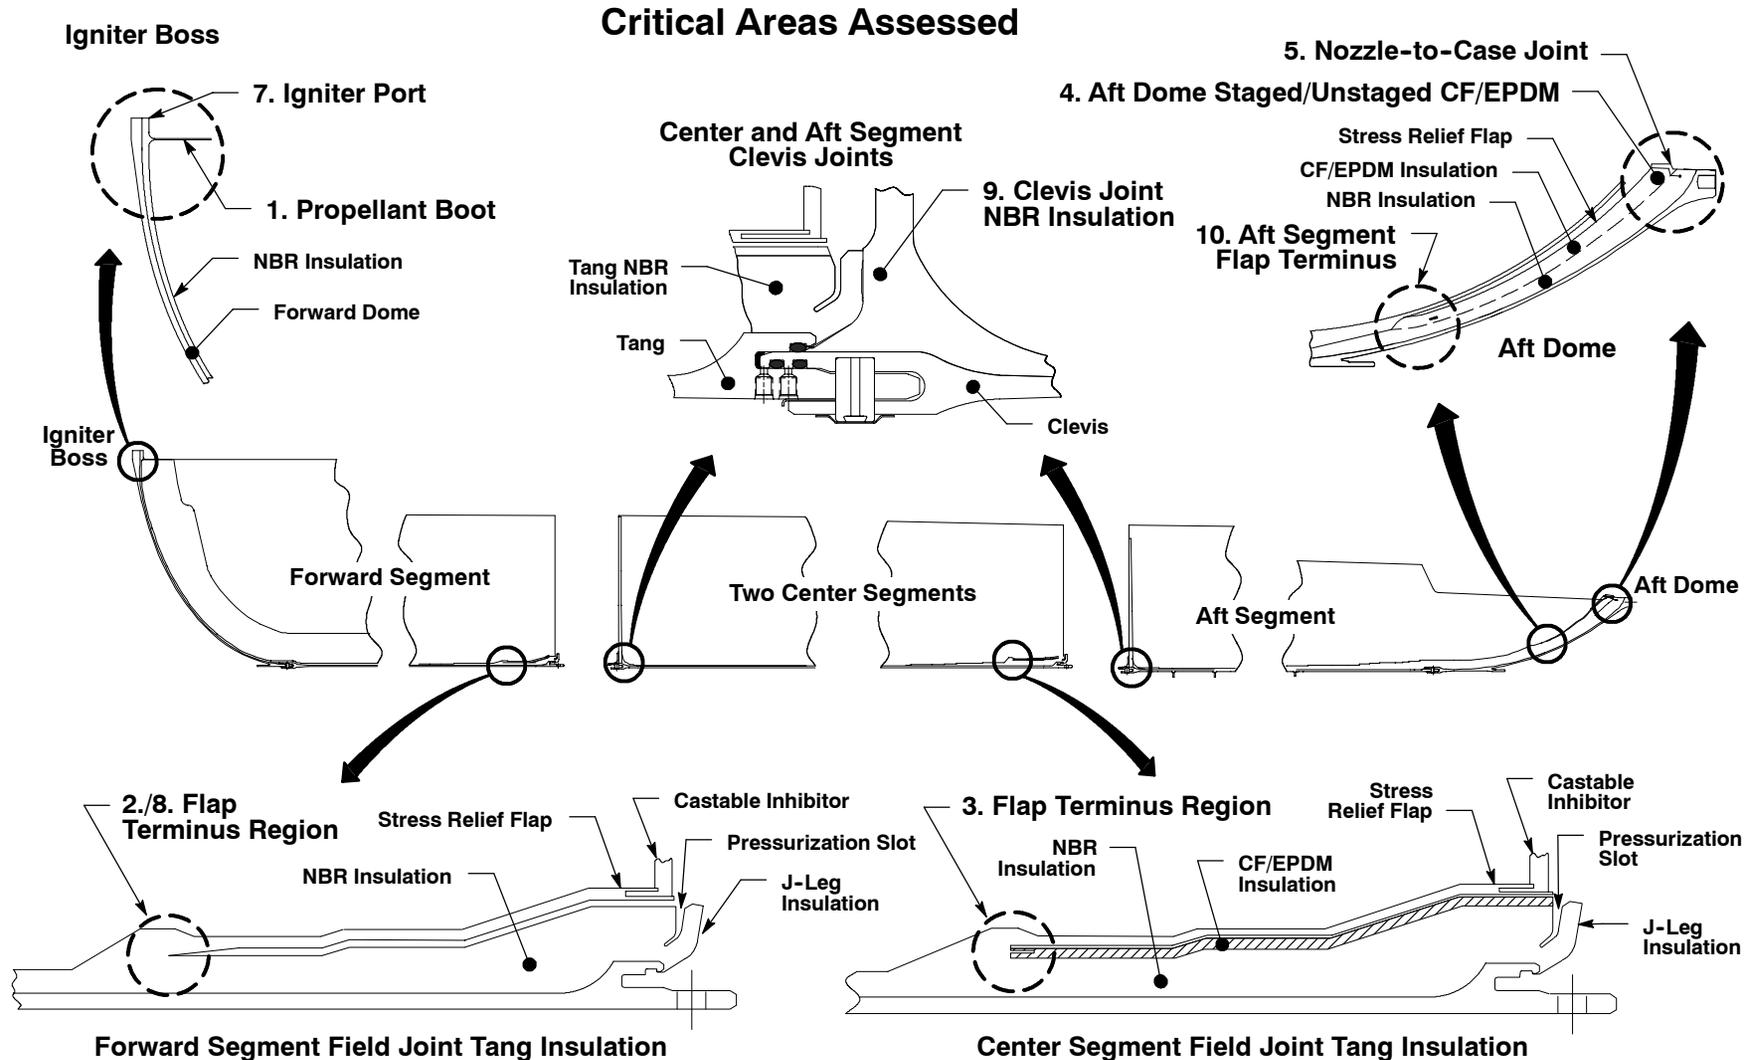
- The following structurally critical areas (see figure) were found to have no credible mechanism for getting a label in that location (no labels used in the process, for example)

1. Propellant boot
 2. Forward segment flap terminus
 3. Center segment flap terminus
 4. Aft dome staged/unstaged CF/EPDM
 5. Nozzle-to-case joint
 6. Igniter chamber and adapter

- While unlikely, labels could occur sometime in the life of the program in the following critical areas, but all have adequate structural margins even if a label were present

7. Forward dome igniter port (2.04 factor of safety, 2.0 required)
 8. Forward segment flap terminus (1.5 factor of safety, 1.4 required)
 9. Clevis joint (2.0 factor of safety, 2.0 required)

10. Aft segment flap terminus (2.8 factor of safety, 2.0 required)
- All analyses assumed label was in worst possible location, with worst possible orientation, under worst-case loads and environments

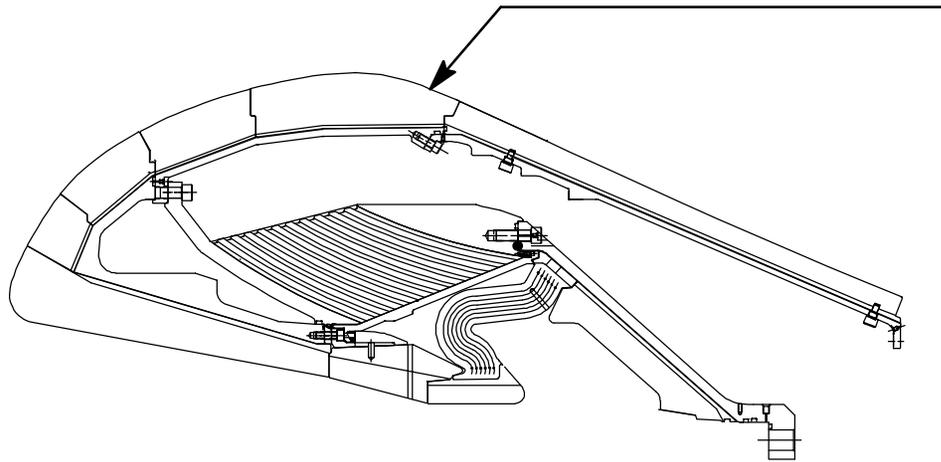
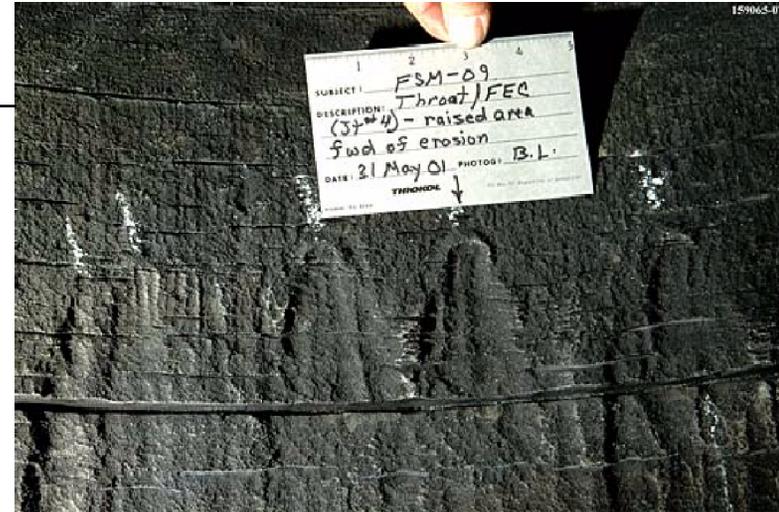
FSM-9 Throat Ring Pocketing

- The aft region of the FSM-9 throat ring experienced pocketing erosion
 - 72 pockets were observed with depths up to 0.38 in.
 - Erosion factor of safety 1.9 (-0.04 margin with 2.0 safety factor)
 - Substantial remaining virgin material (0.88 in.)
 - Remaining burn time = 175 seconds beyond the nominal 123-second motor burn time
 - Similar in appearance to STS-79 RH, STS-80 LH and RH, and STS-85 RH

- Major investigative effort was completed following pocketing in STS-79 and STS-80 in 1996/1997 timeframe
- STS-79 RH, STS-80 LH and RH, and STS-85 RH nozzle throat pocketing attributed to near flame surface ply distortions in combination with a high-propensity-to-pocket material

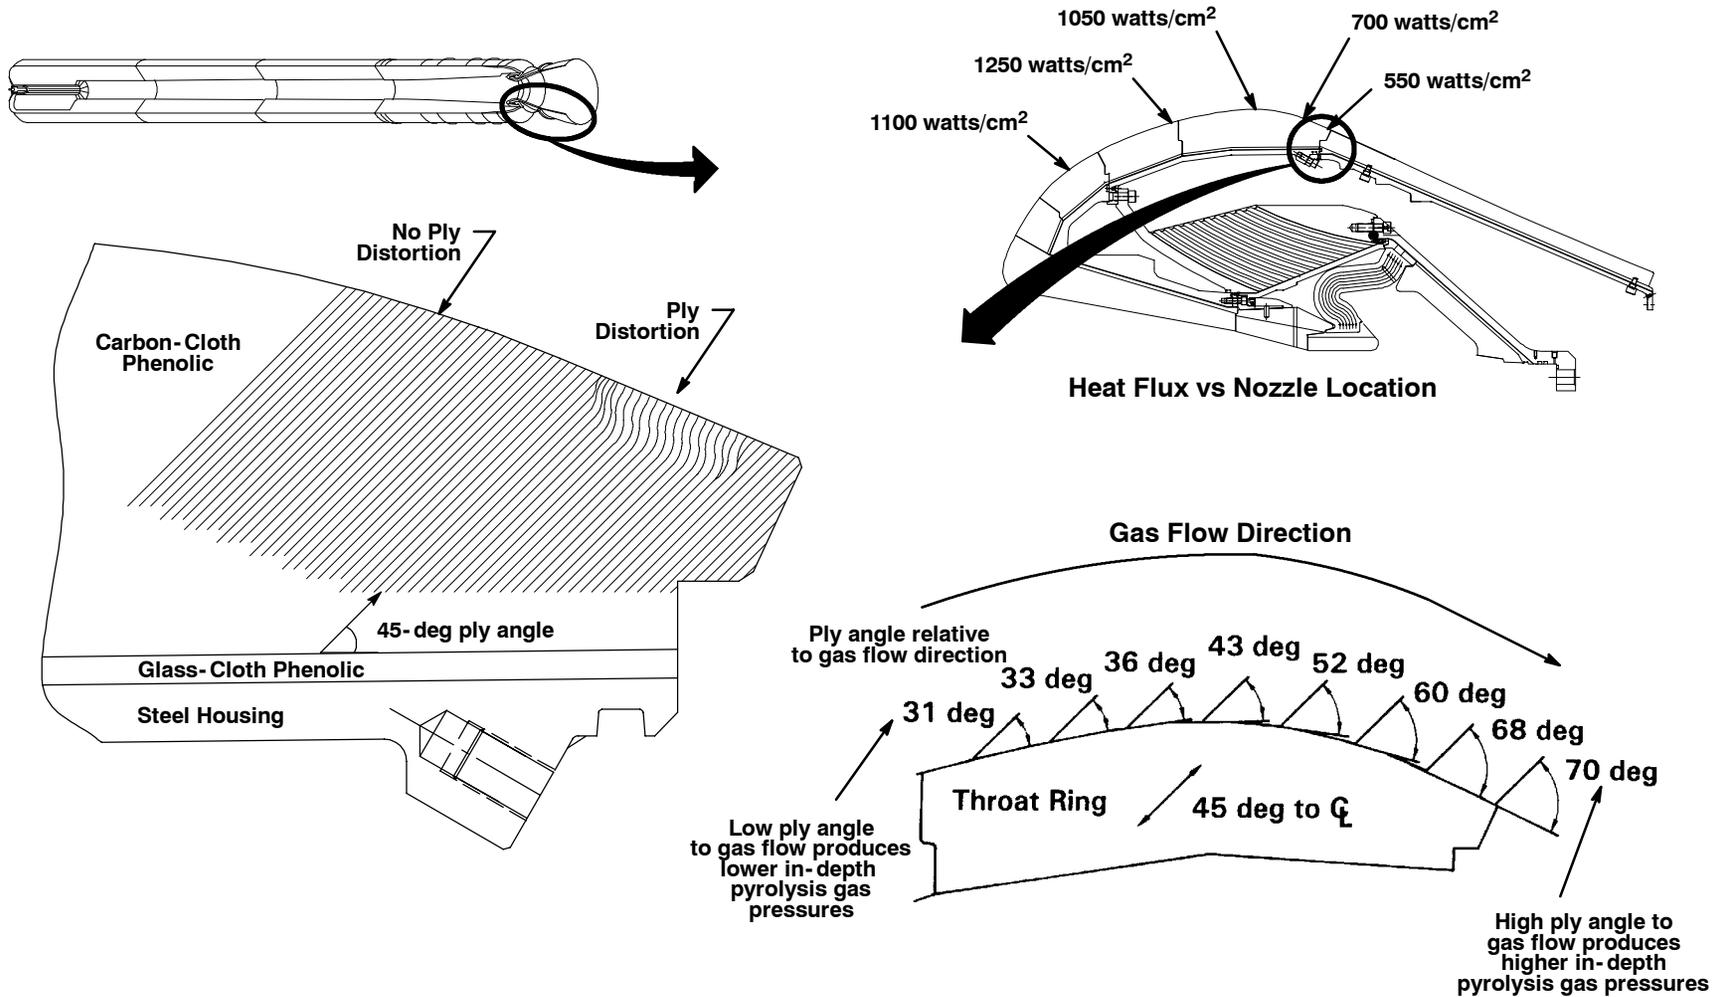
Carbon-Cloth Phenolic Ply Angle Relative to Combustion Gas Flow

- Investigation showed that nozzle pocketing occurs when pyrolysis gas pressures exceed the carbon-fiber strength in the hot char material
 - Key factors include
 - High heating rate
 - High ply angle relative to flame side gas flow
 - Low carbon fiber tensile strength at 2000 to 3000° F
- Investigation results are based on a high fidelity test bed which has been developed to explore nozzle material response to very high heat rates under controlled conditions
- Test bed uses the high-powered laser at the Laser Hardening Materials Evaluation Laboratory (LHMEL) at Wright-Patterson
 - Laser intensity set to match RSRM motor heat flux
 - Highly instrumented samples measure in-depth temperatures, pore pressures, char density, etc.
 - Tests explore material response to ply angle, heat rate, and environmental exposure

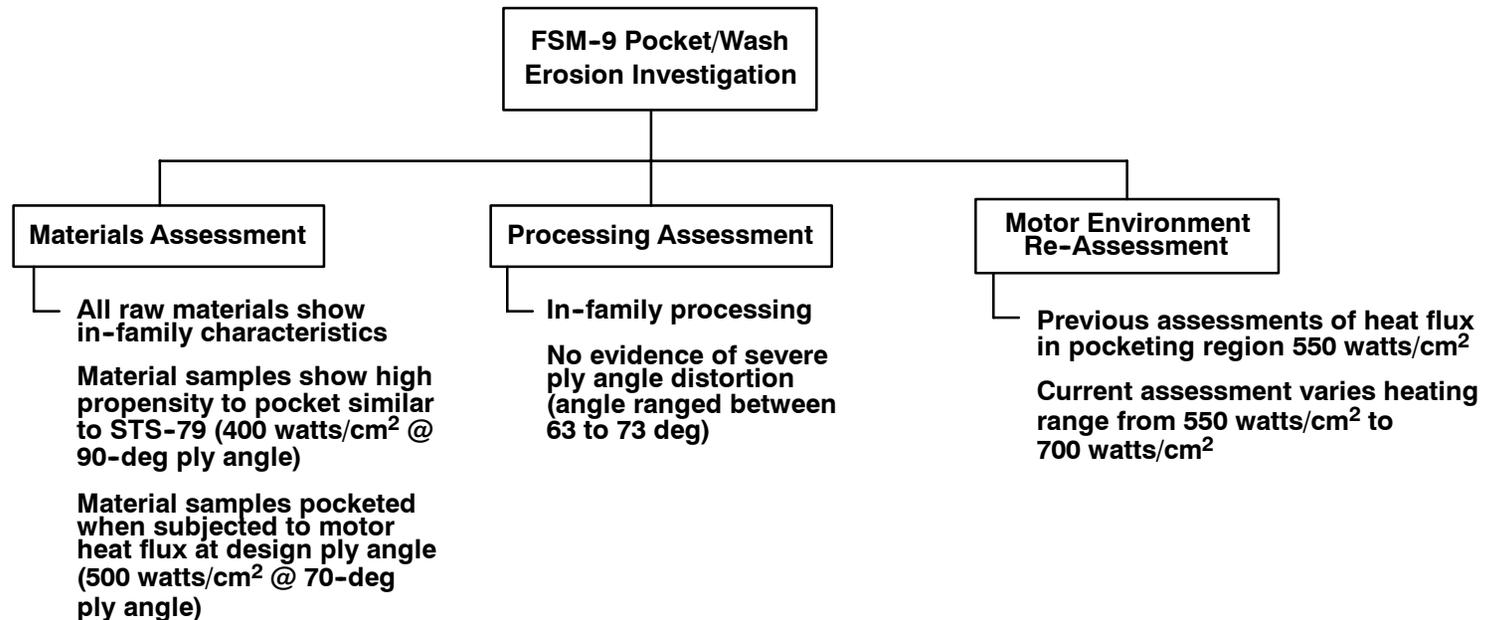
- Joint Thiokol and MSFC anomaly investigation team used a comprehensive fault-tree analysis method to conclude that FSM-9 resulted from a combination of “in-family” events

- FSM-9 cause summary
 - FSM-9 had a high (70-deg) ply angle unique to aft end of throat ring, and a high, in-family propensity-to-pocket material
 - No unique or special causes are necessary to explain FSM-9—validity of basic pocketing hypotheses not challenged
