**STS-105
PROGRAM
FLIGHT READINESS REVIEW**

AUGUST 1, 2001

Orbiter

STS-102 INFLIGHT ANOMALIES

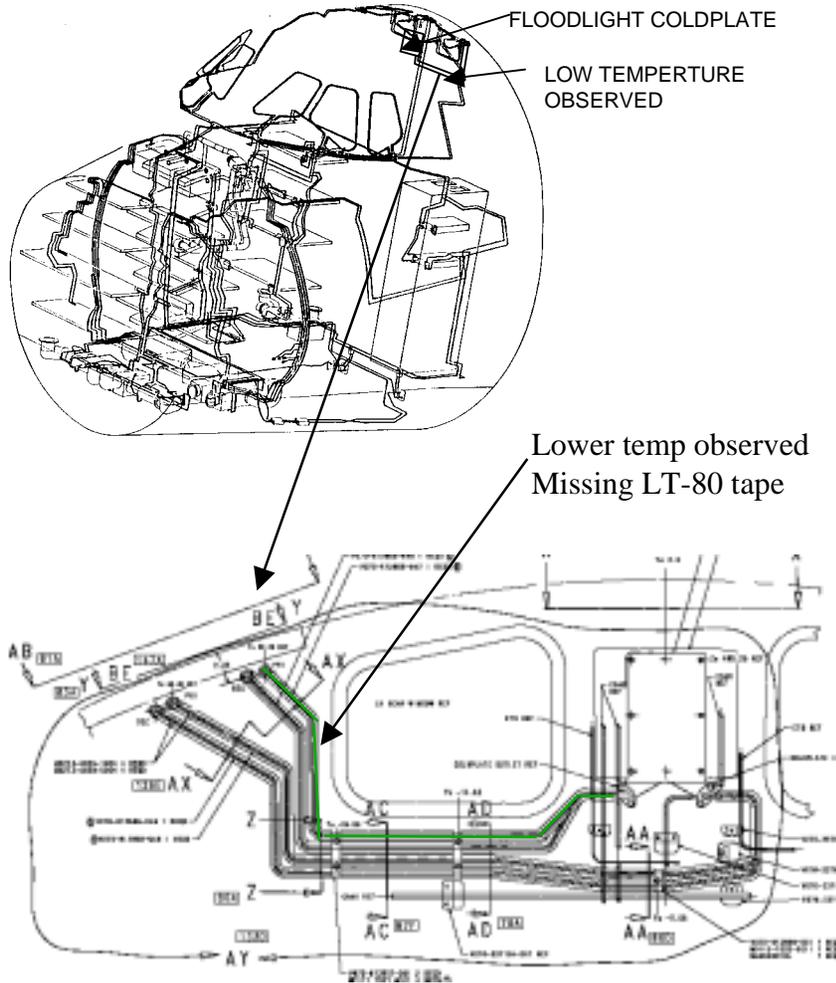
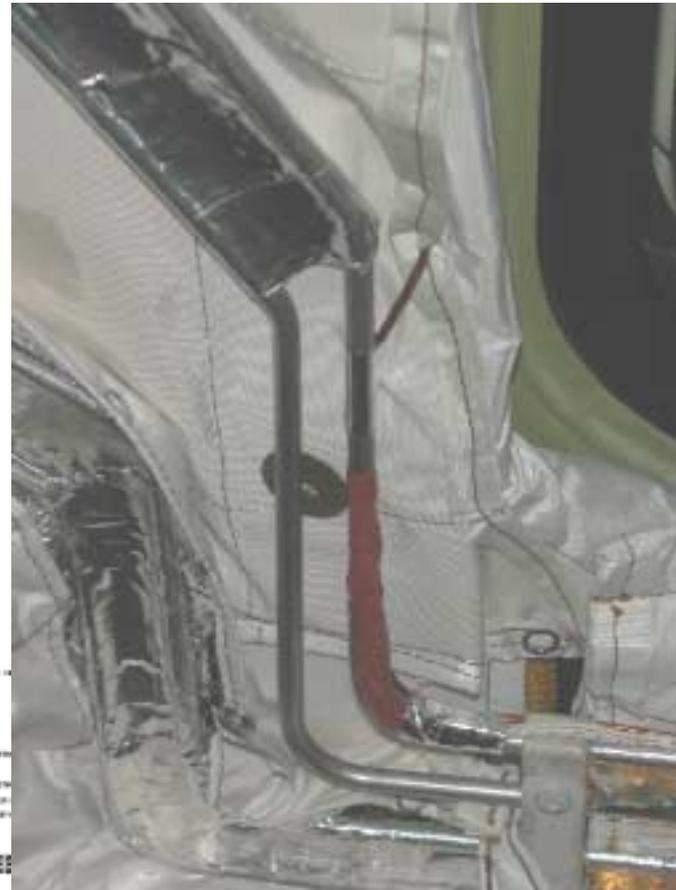
- Forward bulkhead floodlight coldplate Water Coolant Loop 1 (WCL 1) temperature dropped to 36°F

- Water line temperatures below 32°F will result in freezing and possible coldplate or water line damage

- Floodlight coldplate water lines are installed on the aft side of the Xo576 bulkhead and exposed to the payload bay thermal environment
- Lines are wrapped with LT-80 aluminum tape for thermal conductivity and insulated from space with MLI blankets
 - Aluminum tape allows heat conduction from active WCL 2 to passive WCL 1

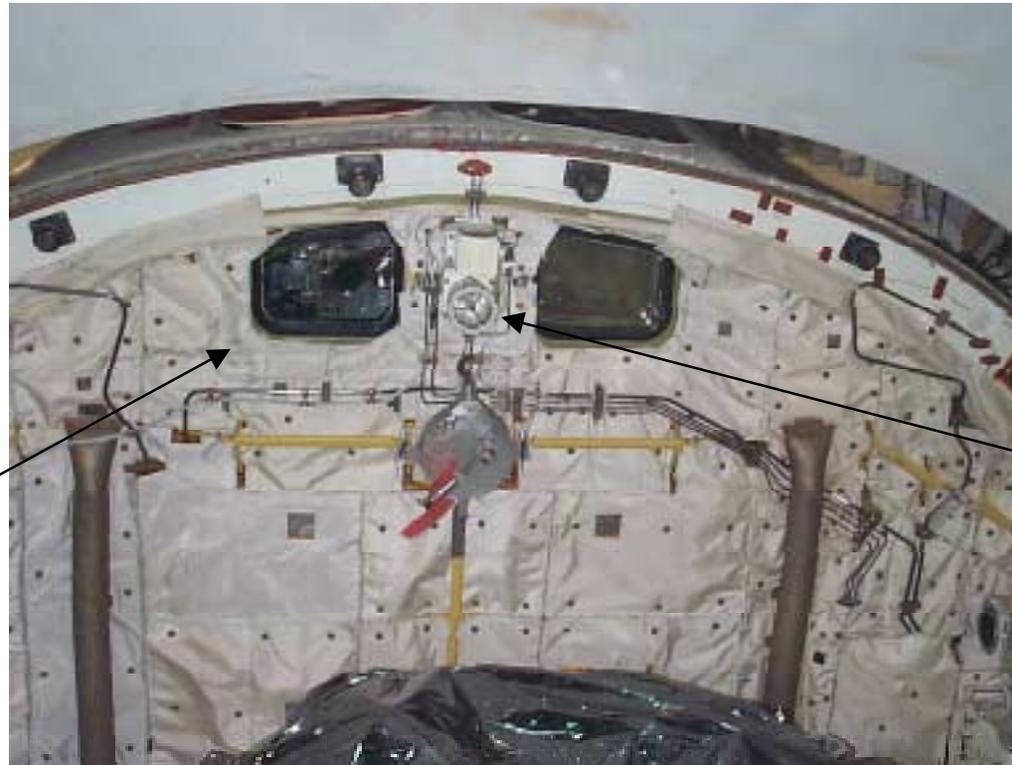
OV-103 Closeout Picture

Line Insulation

Floodlight
Coldplate

- Possible causes:
 - Sensor debonding
 - Insulation not per print
 - Low flow rate in WCL2
- Temp sensor performance is nominal, evidenced by good temp response (~75°F) during loop cycling
- STS-104 temperature signature closely tracked the attitude timeline thermal conditions indicating a problem with the line insulation or a lack of heat transfer between WCL 2 and WCL 1
- Post-flight inspection has located a 10-inch section of WCL 1 and WCL 2 that is not properly wrapped with LT-80 tape
 - Unwrapped section is at the temp sensor

- No risk to STS-105, OV-103
- Review of previous OV-103 flight data shows WCL 1 temperature remained above 50°F for similar vehicle attitude profiles
- Photos from this flow show proper installation of MLI blanket
- No work performed in this area that may have disturbed the line insulation

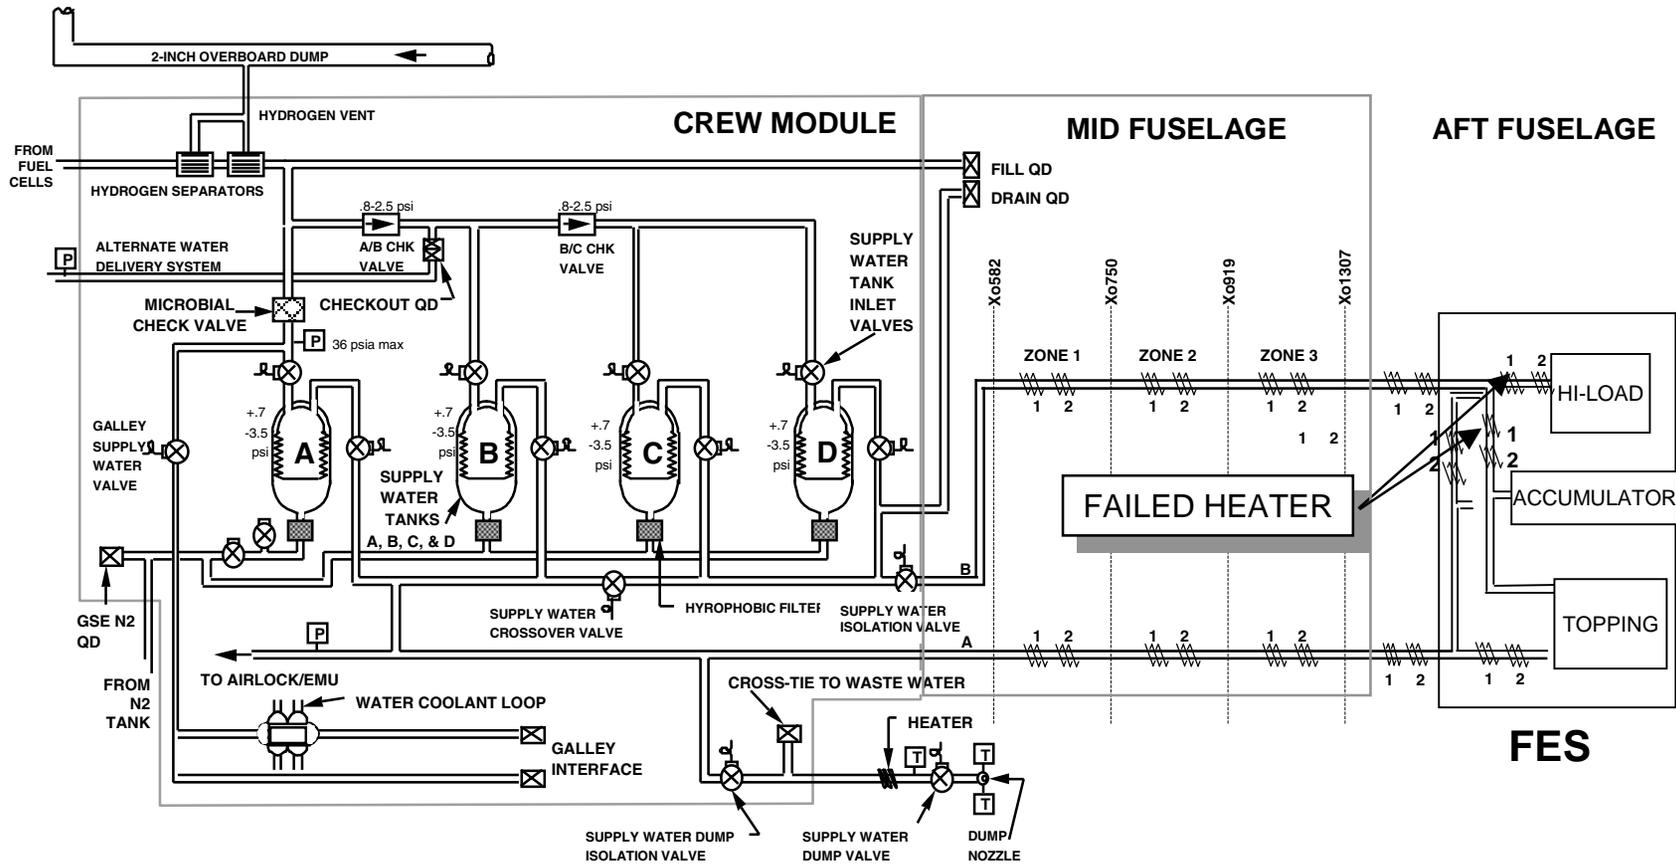
SUPPLY WATER SYSTEM

- FES hi-load and accumulator H₂O feed line A, heater 1 failed off

- Two redundant heater strings provide water line temperature control to prevent freezing
 - Hi-load line temperatures cycle between 150°F and 180°F
 - Accumulator line temperatures typically cycle between 75°F and 95°F
- The heater performed nominally until approximately MET 003:13:00
 - Line temperatures dropped to 90°F and 53°F respectively
 - Data showed heater cycling before failing indicating possible thermostat failure
- Crew switched to redundant heater string which performed nominally for the rest of the mission

- With the loss of both heater strings, a contingency procedure to purge the affected line is available to prevent freezing and allow recovery of the system for entry

- Post-flight troubleshooting will be performed to isolate the cause of the anomaly

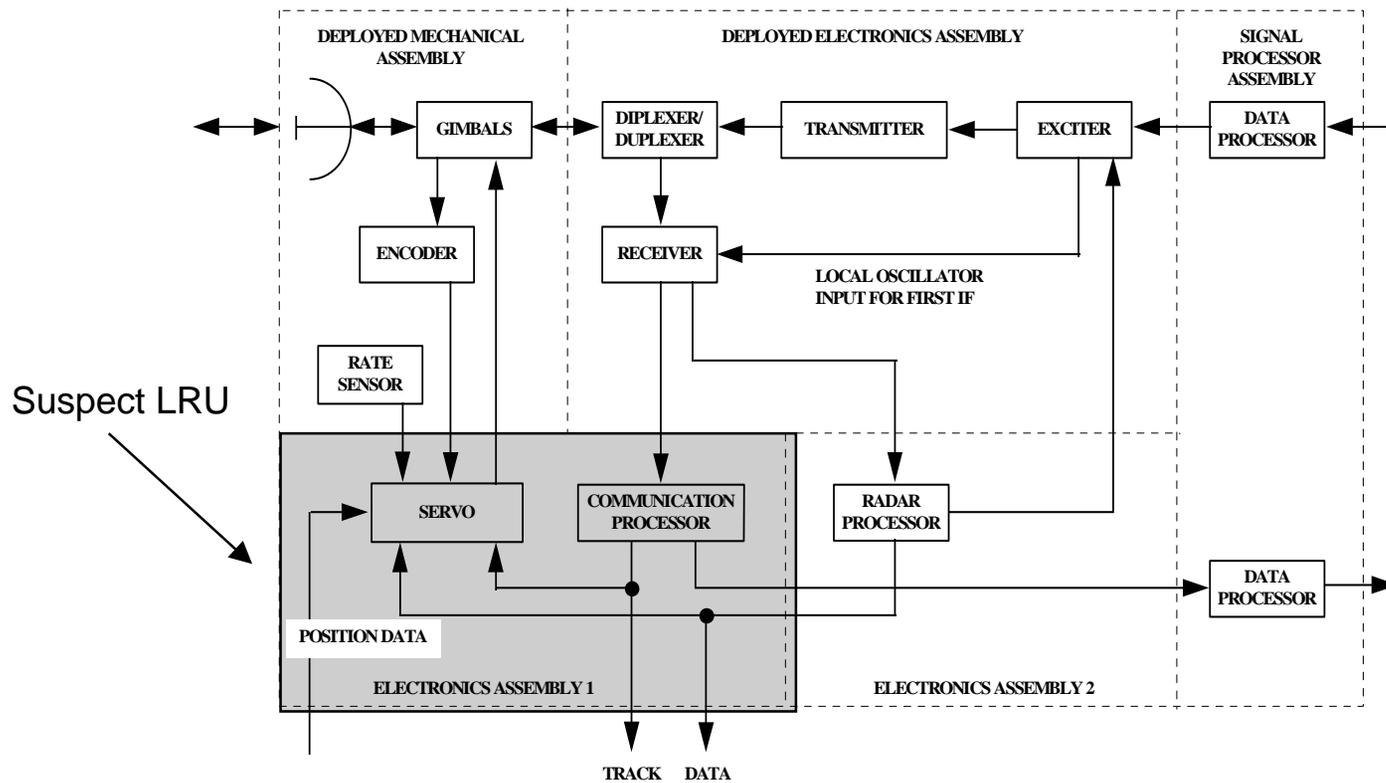
Ku-Band Functional Diagram

- During STS-104 mission, Ku-Band failed to acquire forward link communication

- Review of flight data suggests that problem is most likely associated with the Electronic Assembly-1 (EA-1) LRU located in avionics bay 3A
 - EA-1 is responsible for processing the forward link communication signal
 - Communication AGC and detect & track flags are generated within the EA-1
 - Detect & track flags were absent during the dropout period
- Post-flight troubleshooting planned to isolate problem
- The OV-104 Ku-Band LRU flight experience ranges from 10-20 flights with 3 flights as an integrated system
- Comparison of this failure signature to Ku-Band failure history does not show any evidence of a trend or generic problem

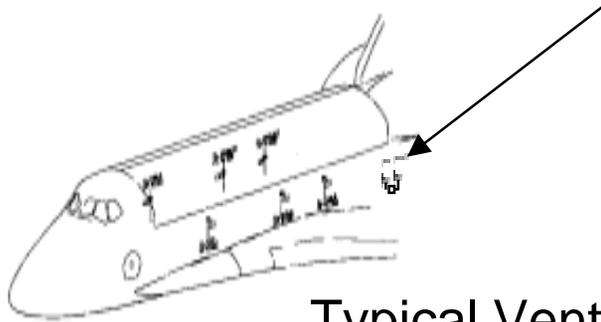
Location of Vent Door # 8 & 9 - AFT Fuselage

- Left hand vent doors 8 & 9 OPEN limit switch #2 temporarily failed off during entry

- After entry interface the vent doors are commanded open
- Left hand vent door 8 & 9 CLOSED indication went off and the motor 1 OPEN went on as expected
- Motor 2 OPEN indication failed off and motor 2 continued to run
 - After driving for 10 seconds (single-motor run time), motor 2 was shut down normally by software
 - Approximately 1 minute and 45 seconds later the motor 2 OPEN indication came on
- RH Vent doors 8 & 9 operated normally

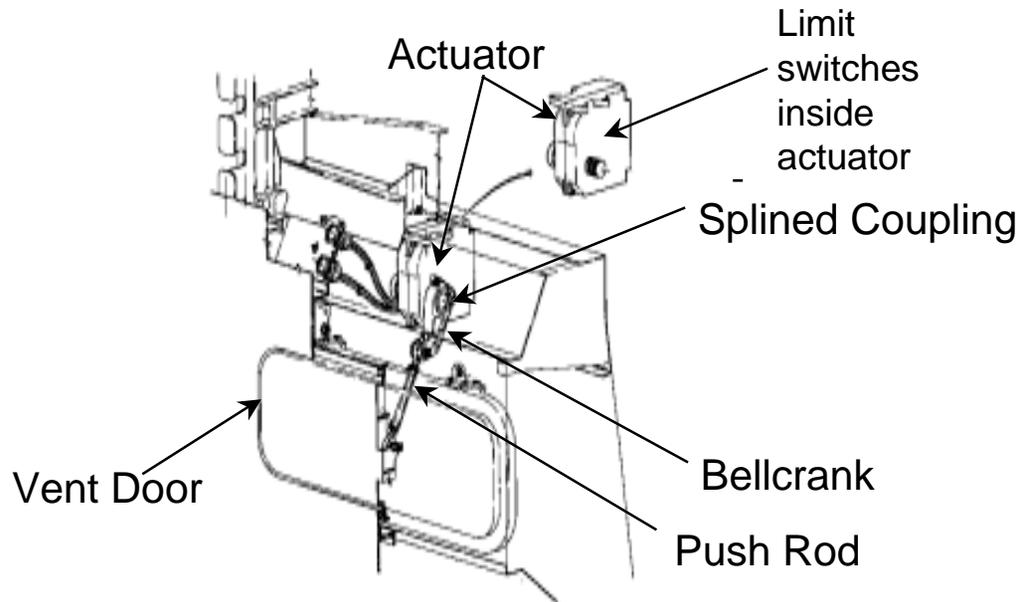
Typical Vent Door Actuator

- Purpose of OPEN limit switch is to turn off motor when door is opened
- Without OPEN indication, actuator continues to run and stalls against mechanical hard stops until terminated by software
 - Actuator certified for prolonged stall operation
 - Loss of OPEN indication for this condition does not inhibit motor operation
- Worst case anomaly could cause launch delay due to LCC requirements if both switches fail
 - One of two switch indications required prior to launch
- This failure mode is criticality 3/3
 - No impact during a mission

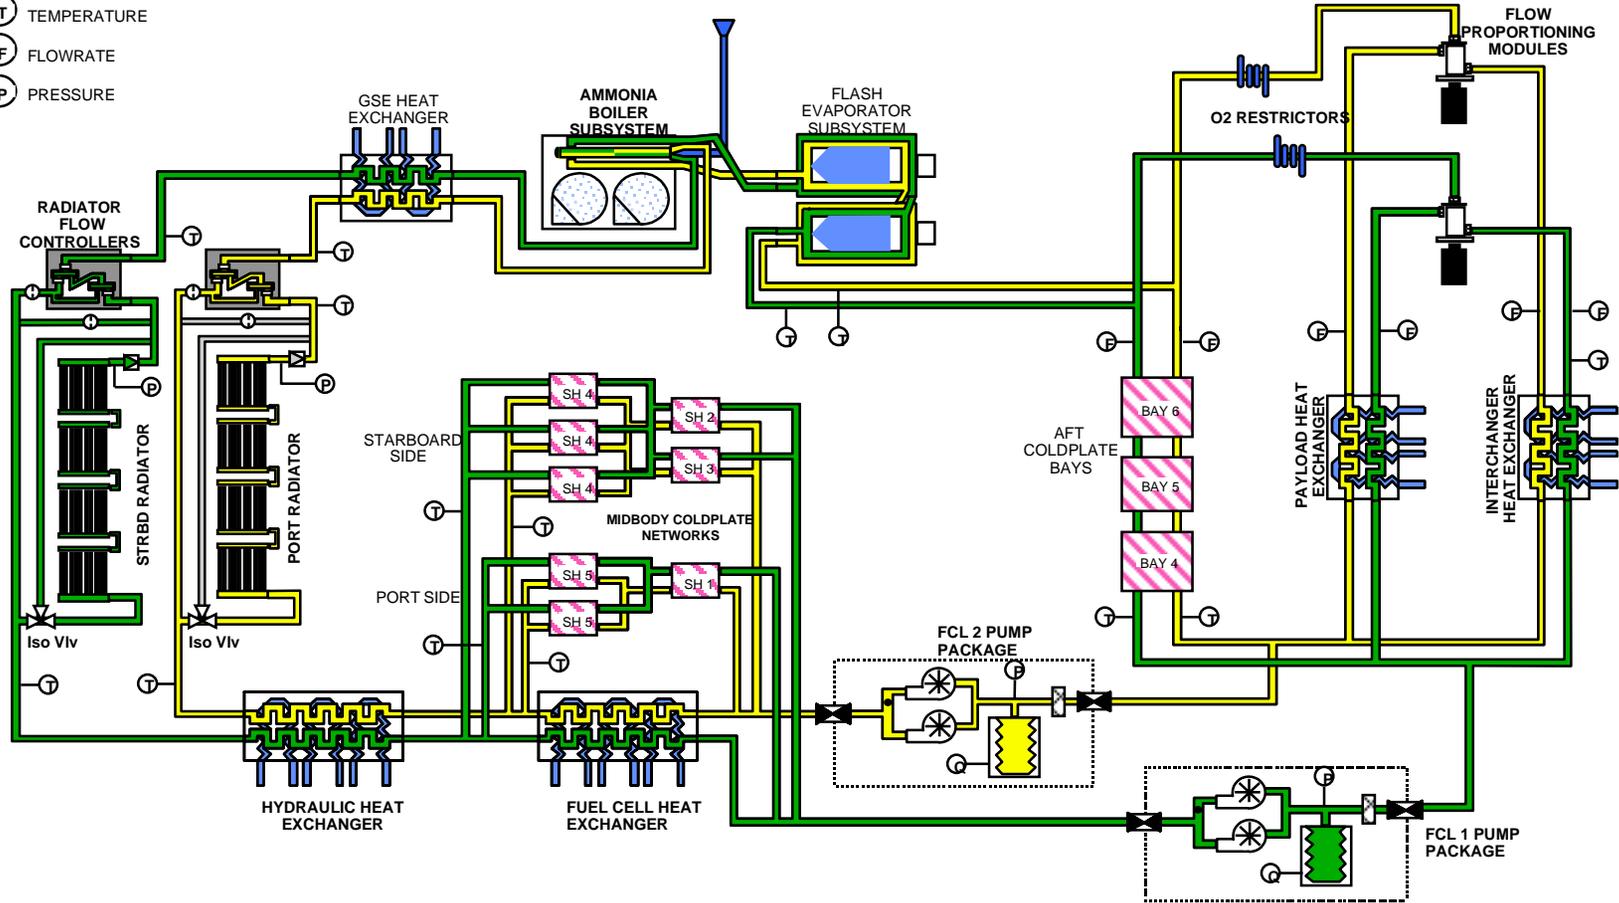
ORBITER ACTIVE THERMAL CONTROL SYSTEM (ATCS)

- During STS-102 Docking period, a FES water dump was performed with RFCAs in “High” setting
- Radiator Freon temp dropped from -18°F to as low as -82°F and flow decreased
- Cause of icing attributed to radiator being too cold, although current flight rule allows -85°F min Freon temp
 - Similar problem was observed during STS-28 and STS-35

- Freon post-flight sample showed water content of 44 ppm and 50 ppm in FCL 1 and 2 vs. 15 ppm max OMRSD allowable limit
- Freon sample confirmed that radiator freezing was due to high moisture content
- Both FCLs have been re-serviced with new Freon
 - FCL 1 with 6 ppm moisture is within 15 ppm max limit
 - FCL 2 with 23 ppm requires a waiver to fly
 - -82F Water-in-Freon solubility temperature
 - Minimum predicted for STS-105 is -20F per pre-flight analysis based on nominal planned attitude
 - -65F panel temperature expected during radiator cold soak per previous flight data
- Investigation to determine the cause of moisture content increase is ongoing

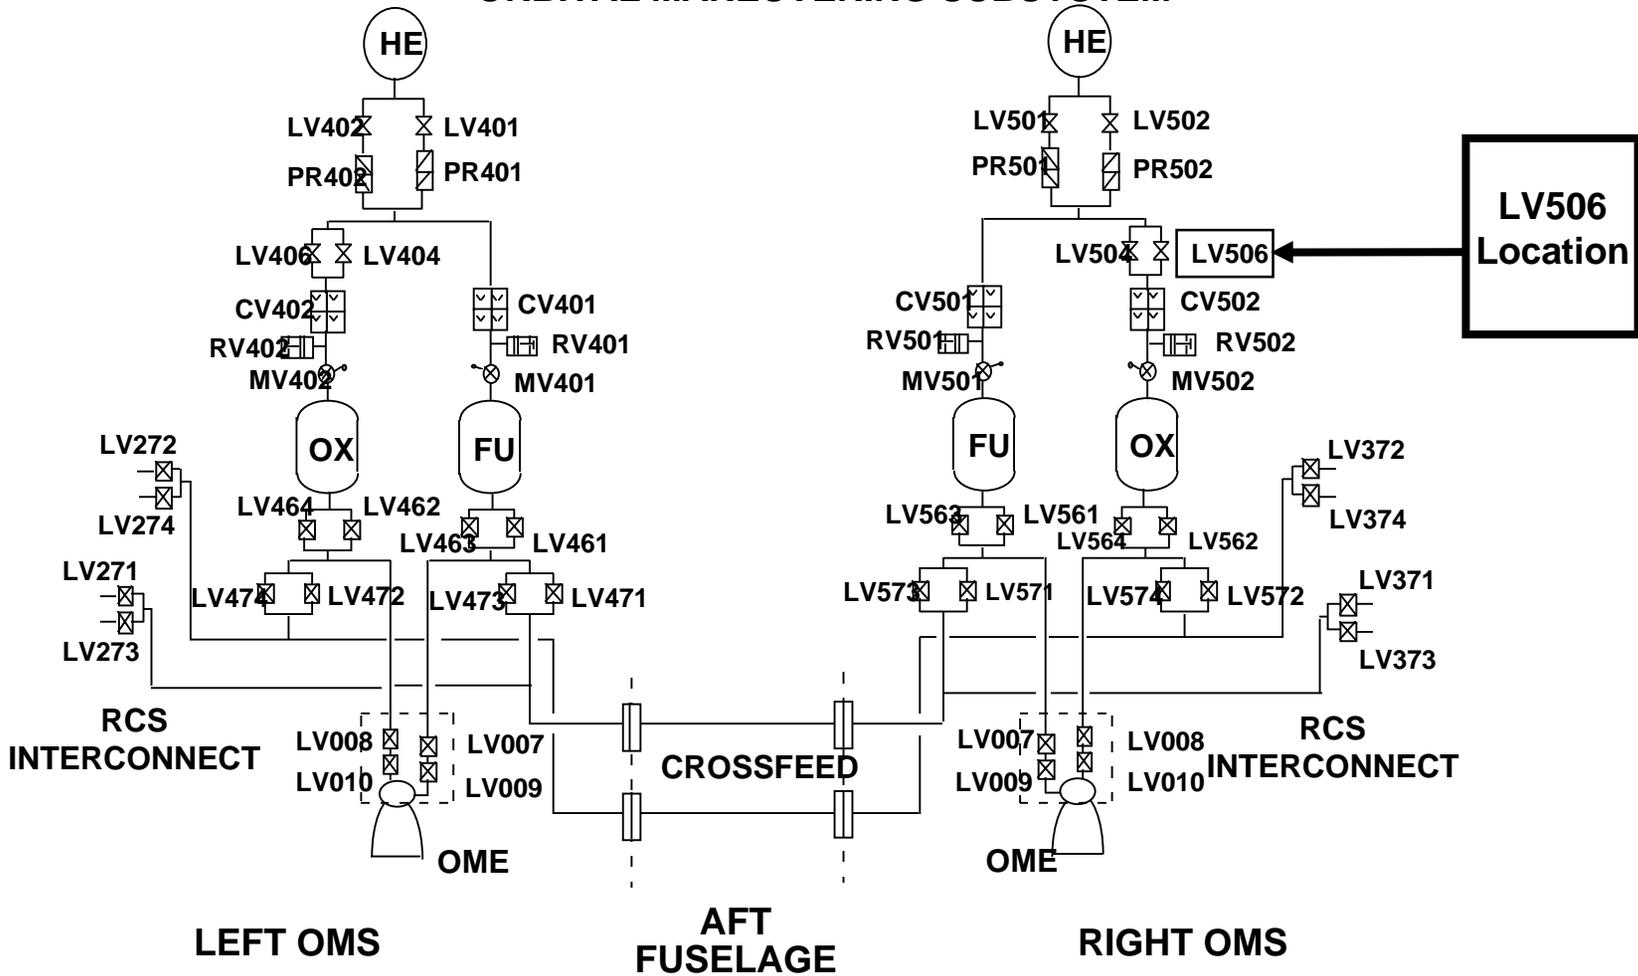
ORBITAL MANEUVERING SUBSYSTEM

- During last two (of 8) right OMS (RP03) engine burns, vapor isolation valve #2 (LV506, S/N 25) failed to indicate open

- Vapor iso valves 1 and 2 were commanded open via cockpit switch prior to each OMS engine burn
 - Valve 1 indicated open and valve 2 did not indicate open
- Valve function cannot be determined in-flight without VPI
 - A single cockpit switch throw controls both valves
 - Two switches available for this function
 - No system operation impact because valves 1 and 2 are in parallel, with valve 1 providing a redundant flow path
 - Tank pressures verified at least one flow path was open

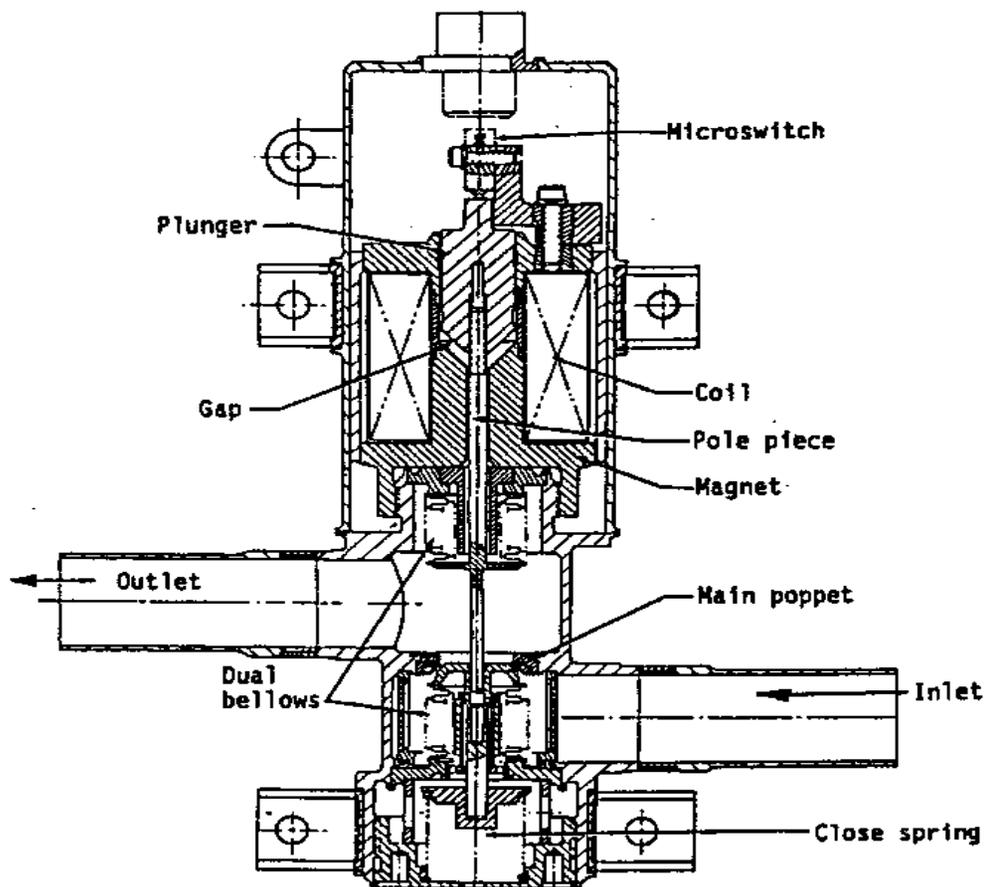
CROSS-SECTION OF THE OMS ISOLATION VALVE

- Possible causes of failure evaluated
 - Contamination/corrosion in the valve switch
 - Wiring problem
 - MDM failure (FA4)
 - Vapor iso valve 2 VPI signal goes through MDM FA4, card D
- Troubleshooting conducted revealed no cause for the failure
 - A BITE test 4 was performed - no anomalies with MDM FA4 were found
 - Orbiter wiring connectors were checked and no discrepancies were evident
 - Valve cycling performed with break out boxes installed revealed power being supplied to both the solenoid and the VPI circuits
 - Wire wiggle test performed
 - Valve function was nominal during troubleshooting

- No troubleshooting internal to OMS pod was performed due to lack of access with pod installed
- Documented as a UA/Deferred PR
 - Most probable cause is an intermittent wiring problem in the RP03 VPI circuitry
 - Additional troubleshooting planned (deferred PR) at upcoming OMDP
