Atlantis STS-106

Space Shuttle Program

SSME Flight Readiness Review

August 29, 2000

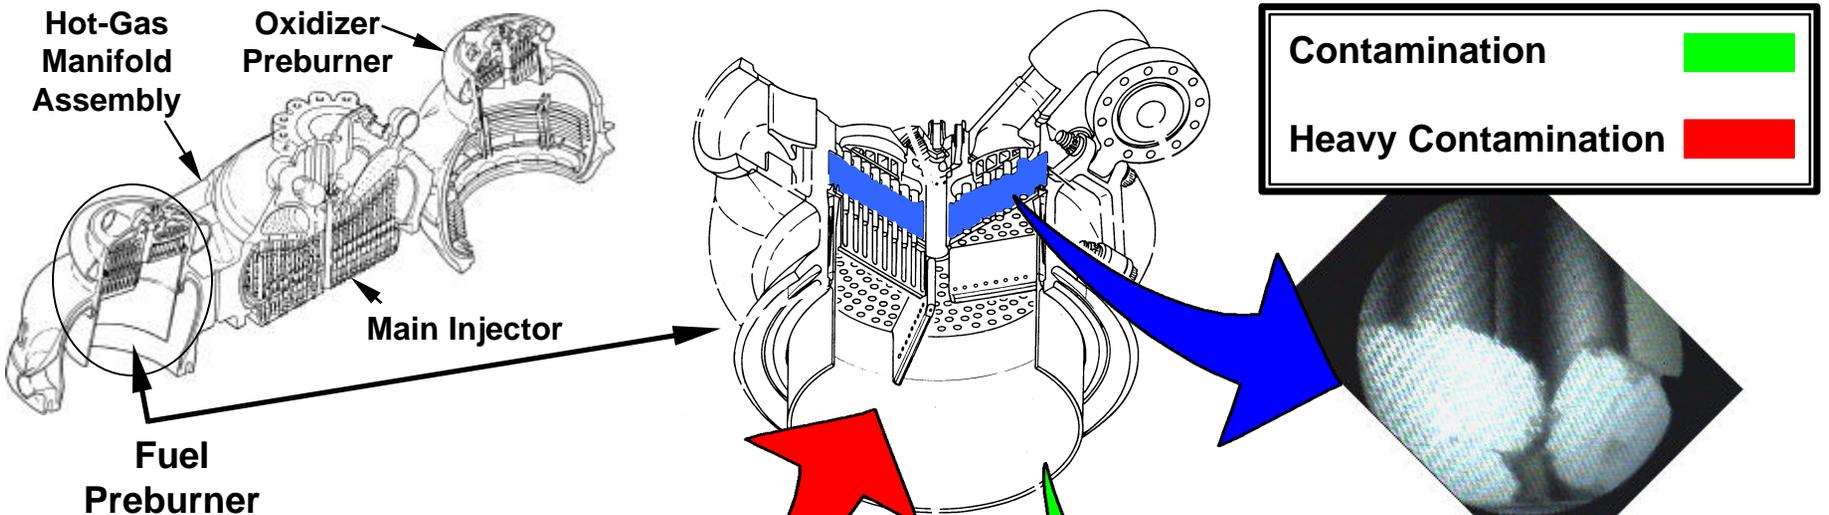
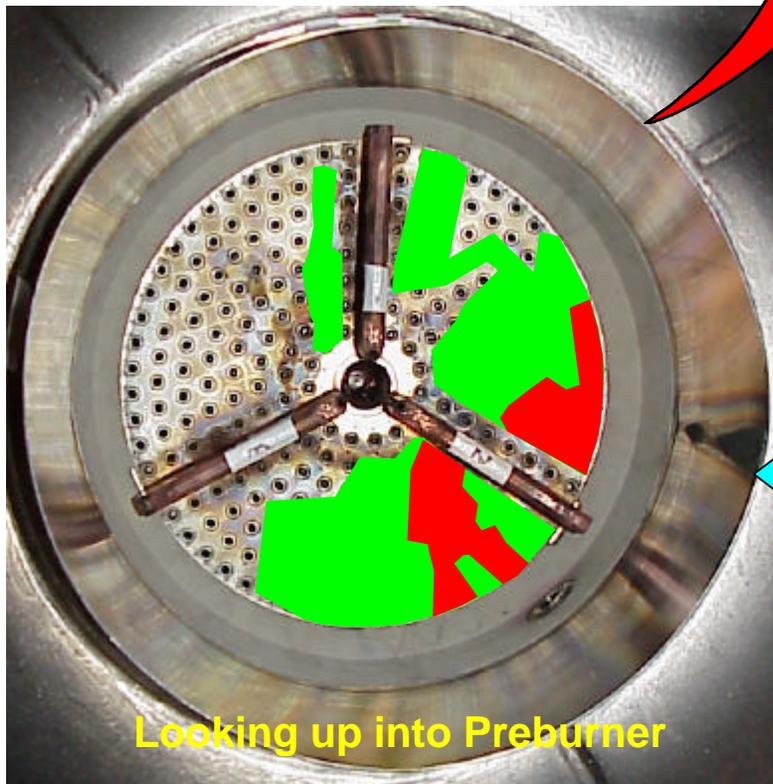
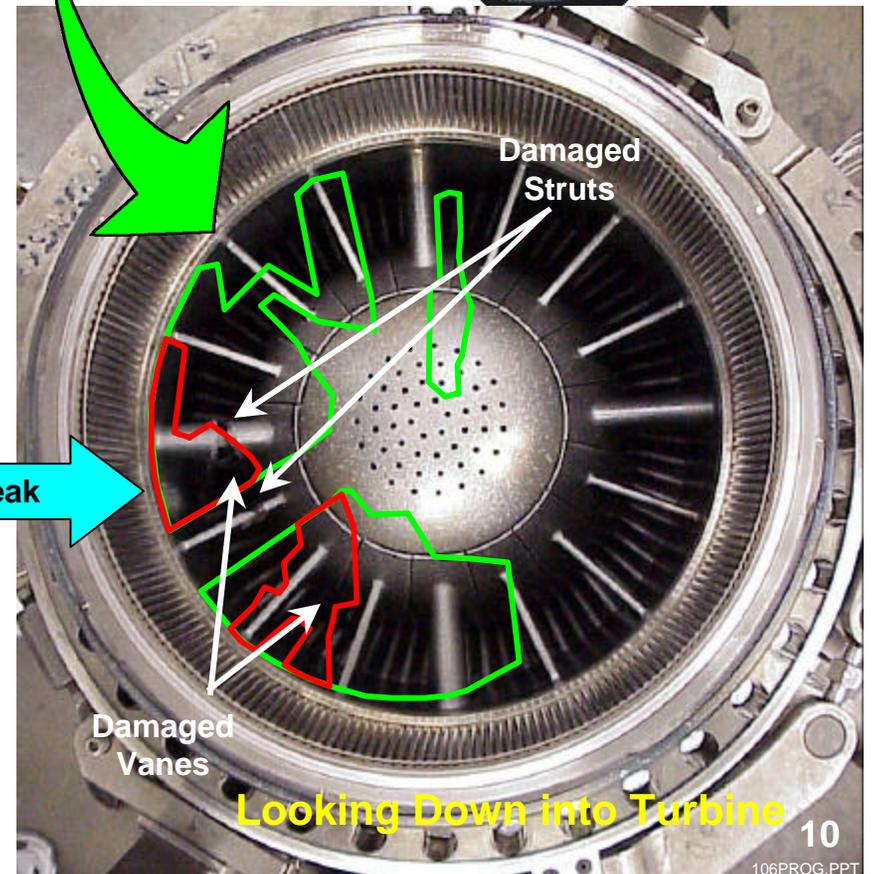
Engine 0523 - Contamination

- MSFC Investigation Team formed to determine cause of shutdown and damage
- Post test inspections found numerous pieces of LOX tape in fuel preburner fuel manifold and blockage of fuel annulus of multiple elements
 - Resulted in LOX rich hot streak in excess of 2700 degrees R
- Root-cause identified as contamination introduced during assembly and/or pretest processing
- Investigation team recommendations being evaluated and corrective actions are being implemented
 - Borescope inspection of all joints prior to assembly has been initiated at all sites
 - Borescope inspection of all disturbed joints required during engine processing

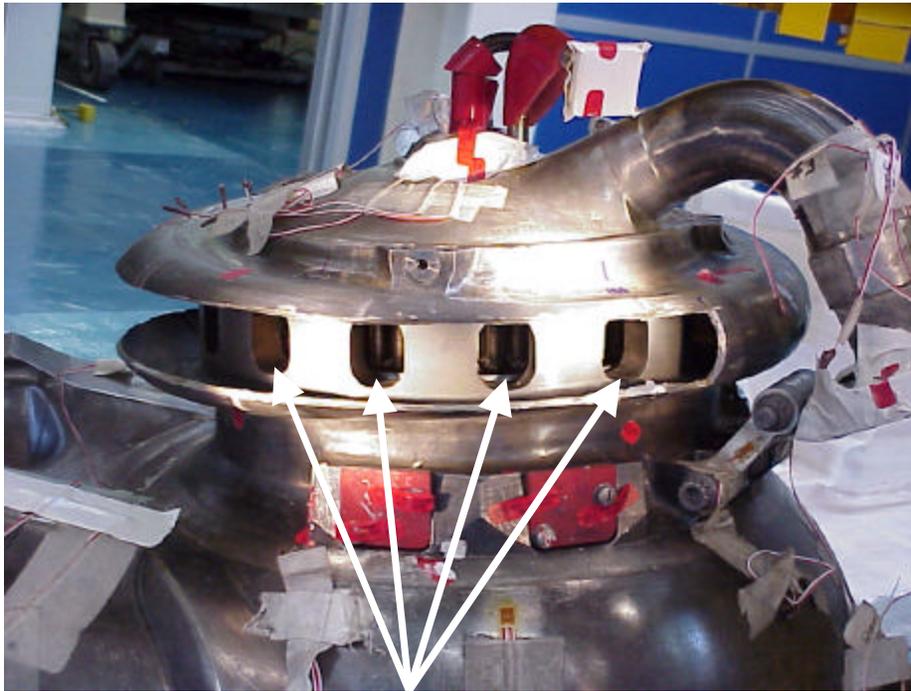
Fuel Preburner Manifold

Tape Contamination Observed Through FPB Transfer Windows

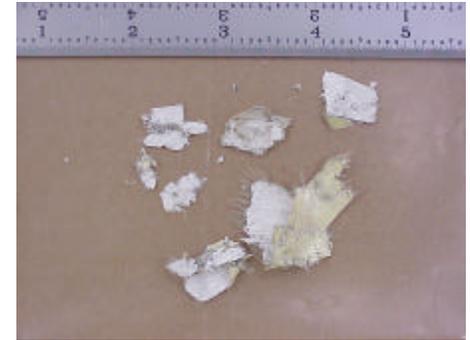
Tape Contamination

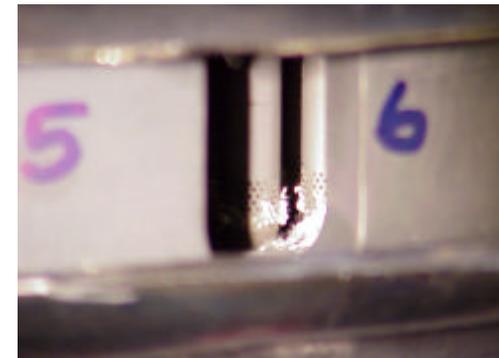
Oxidizer Preburner Manifold

Lesser Amounts of Tape Contamination

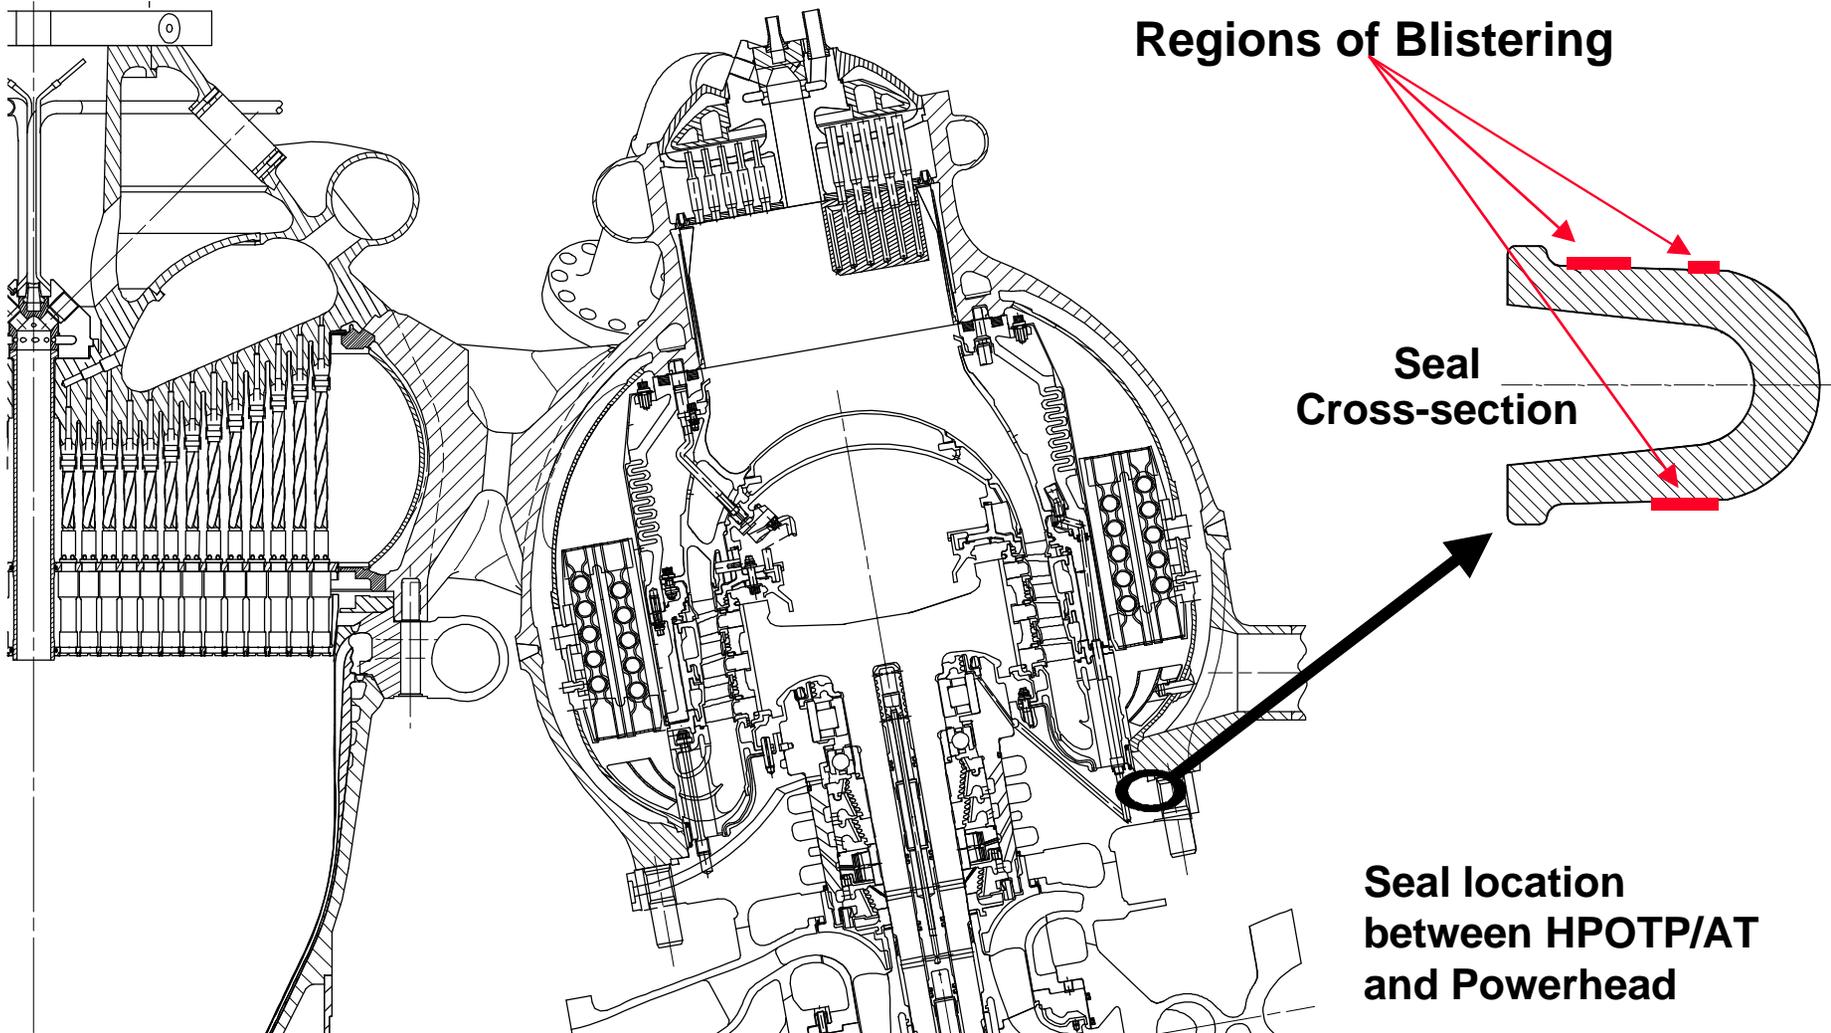
SSME Joint G3 Blistered Seal

- Blisters noted on silver plating of two “increased compression” G3 seals after removal from engine

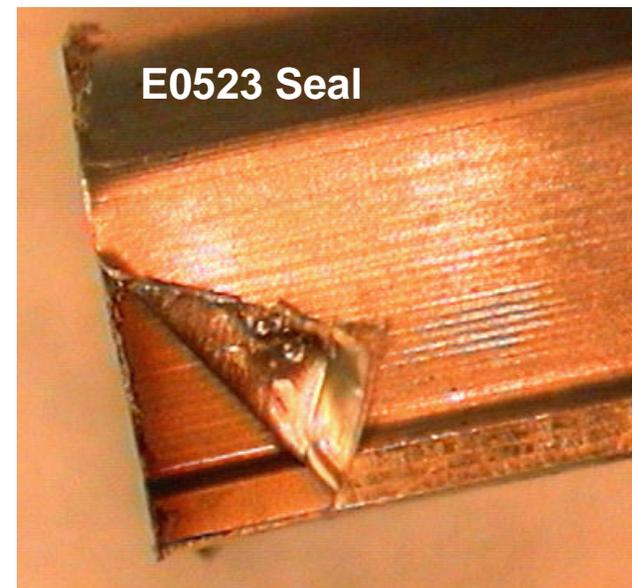
- Blistered seals purchased on 2 different orders
 - One from Hydrodyne (E0526) and one from Langley (E0523)
 - Both plated by Metal Surfaces Inc. approximately 1 year apart
 - Post plating adhesion bake test was verified by the supplier
- Sealing surface inspection completed
 - No indications of leak paths
 - No evidence of hot gas leakage past seal
- Microscopic examination of the seal plating performed
 - Lack of bond between plating layers

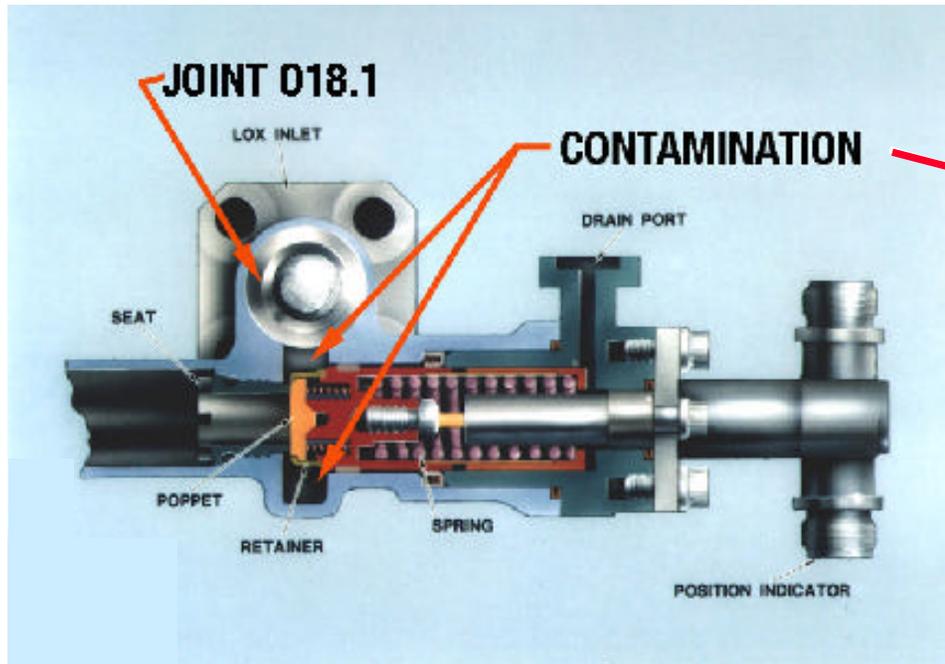
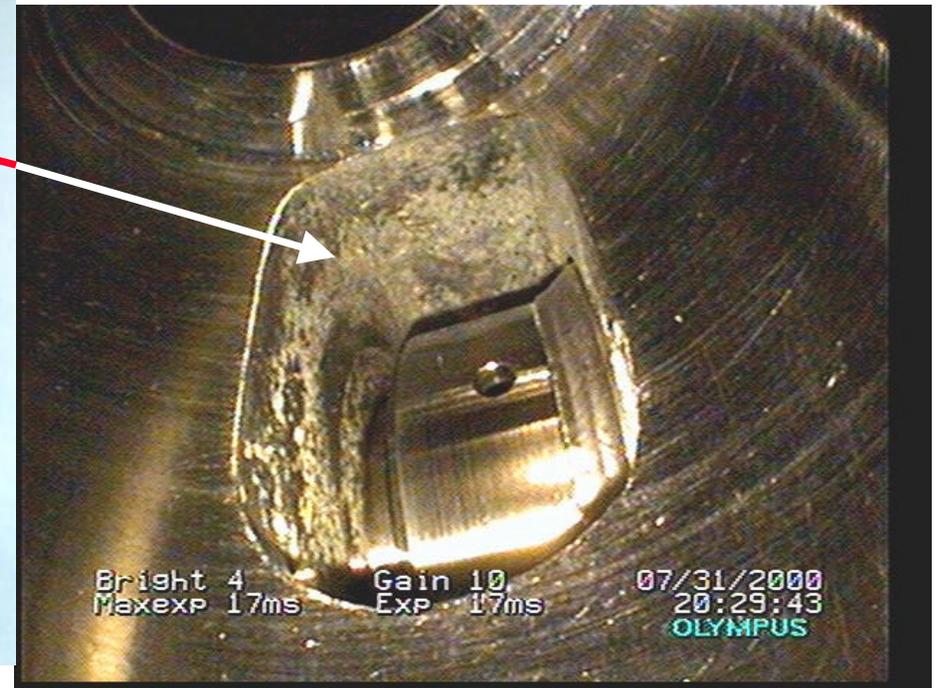
Anti Flood Valve Contamination

- Contamination found within Anti Flood Valves (AFV)

- Post flight inspection of AFV on Engine 2054 identified heavy contamination in poppet cavity
- Engine 2054 AFV and two spare AFVs returned to Canoga for inspection, disassembly, and analysis
- Contamination confined to poppet cavity in housing
 - Physically characterized as hard, well adhered scale
 - Contaminant constituents determined to be silicon, minor calcium and oxygen
 - Composition similar to silicated alkaline based cleaners

- All AFVs on STS-106 inspected and verified free of contamination
- Contamination concern limited to AFVs processed by Globe Dynamics
 - No Globe Dynamics valves on STS-106
- All Globe Dynamics fabricated housings being removed from flight service
