**STS-110**  
**FLIGHT READINESS REVIEW**

**March 26, 2002**

**Ground Operations**

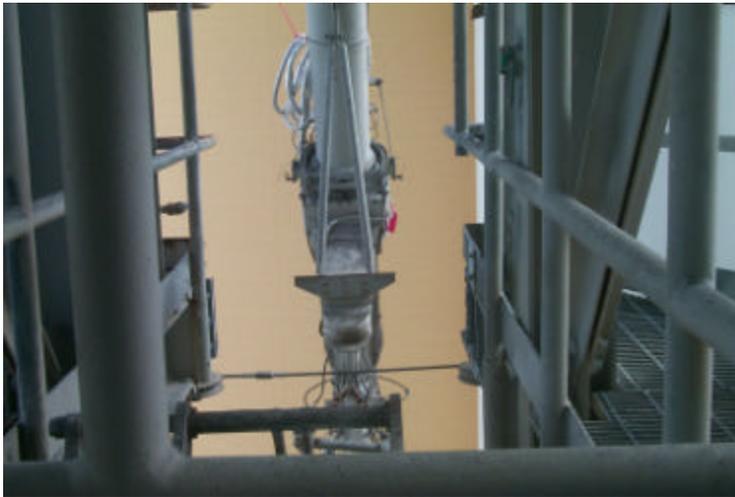
**Vent Arm Prior to Lift and Mate**

- Observation
  - During STS-108 (Pad B), the Hydrogen Vent Arm contacted the Fixed Support Service Structure (FSS) just prior to engaging the primary latching system, causing hardware damage to the vent arm and FSS
    - The vent arm was captured by the secondary capture feature as designed
    - Lifting lug became a debris item
- Concern
  - Potential debris impact with vehicle
  - Damage to Ground Support Equipment

- Actions Taken / Fault Tree Analysis
  - 86 Items were reviewed and closed out
    - North Shock Strut higher loading was determined to be the most probable cause (Uneven with South Shock Strut)
    - Flex Hose Stiffness was tested and determined not to be a factor

- Flight Rationale
  - Provided  $\frac{3}{4}$ " additional clearance on south side of deceleration cable structure beyond STS-108 contact point
  - Removed vent line lifting bracket, eliminating debris source during STS-108 anomaly
  - Pivot arm shocks have been load tested for nominal operation
  - All damaged hardware has been repaired and returned to print condition
