**STS-112 (BI115)  
FLIGHT READINESS REVIEW**

**Solid Rocket Booster**

# TECHNICAL ISSUE - BSM FOREIGN OBJECT DEBRIS

# TECHNICAL ISSUE - APU FUEL PUMP INLET PORT CRACK

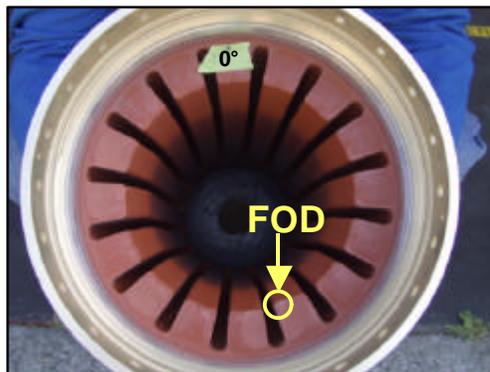
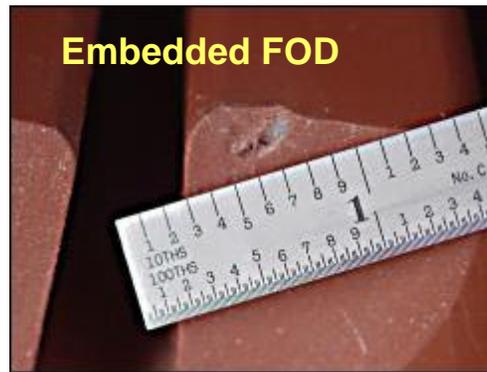
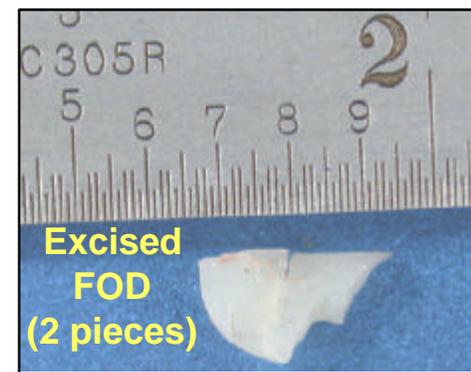
RTV (GE Silicon #1) Sealant in Lot ABT BSM Propellant

- FOD identified as RTV GE Silicone #1
  - Used to repair leaking Ammonium Perchlorate (AP) transport cart butterfly valve
- All BSM lots potentially affected since 1990

- Replaced existing cart valve seals and eliminated use of RTV
  - Implemented use of valve cover during transportation of cart
- Walk-down and process audit of all BSM manufacturing areas conducted
- Work instructions updated with inspections and cautions to preclude contamination
  - USA/MSFC Phase II Team approved
- Redesign of valve completed to preclude leakage
  - Implementation planned for future lots

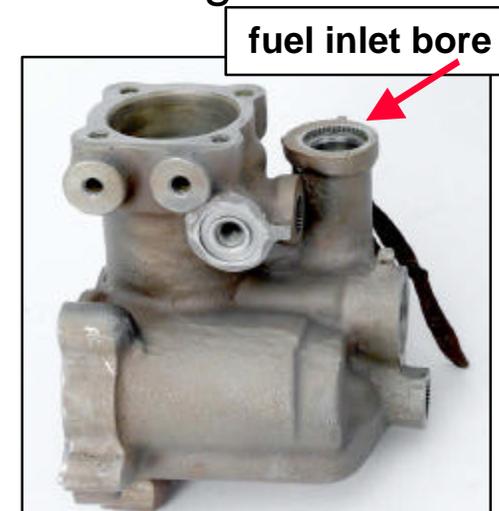
Fuel Pump Housing

- Radial crack in fuel pump inlet port boss found during Rosan fitting installation at Hamilton Sundstrand
  - Localized corrosion pitting present

- Fuel pump housing crack can allow external leakage of hydrazine

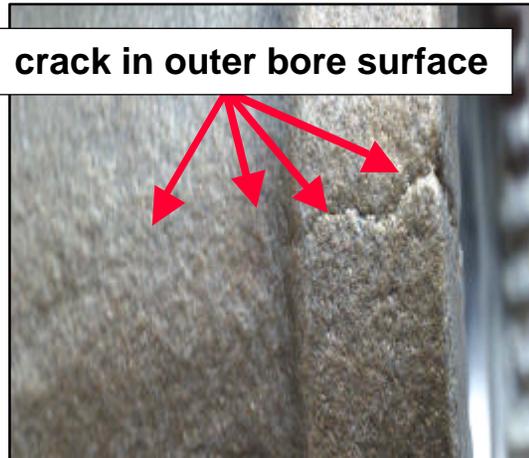
Outer Bore Surface

- Visual inspection showed corrosion pitting coincident with crack on port flange
  - Minimal polysulfide shadow present
- Chemical analysis verified material C355 aluminum per print
- Material evaluation reverified casting integrity
- Evaluations determined fuel pump housing corrosion unique event
  - 104 housings inspected at vendor including 48 unpainted housings
  - No other indications of corrosion
  - PR historical search indicated no other occurrences

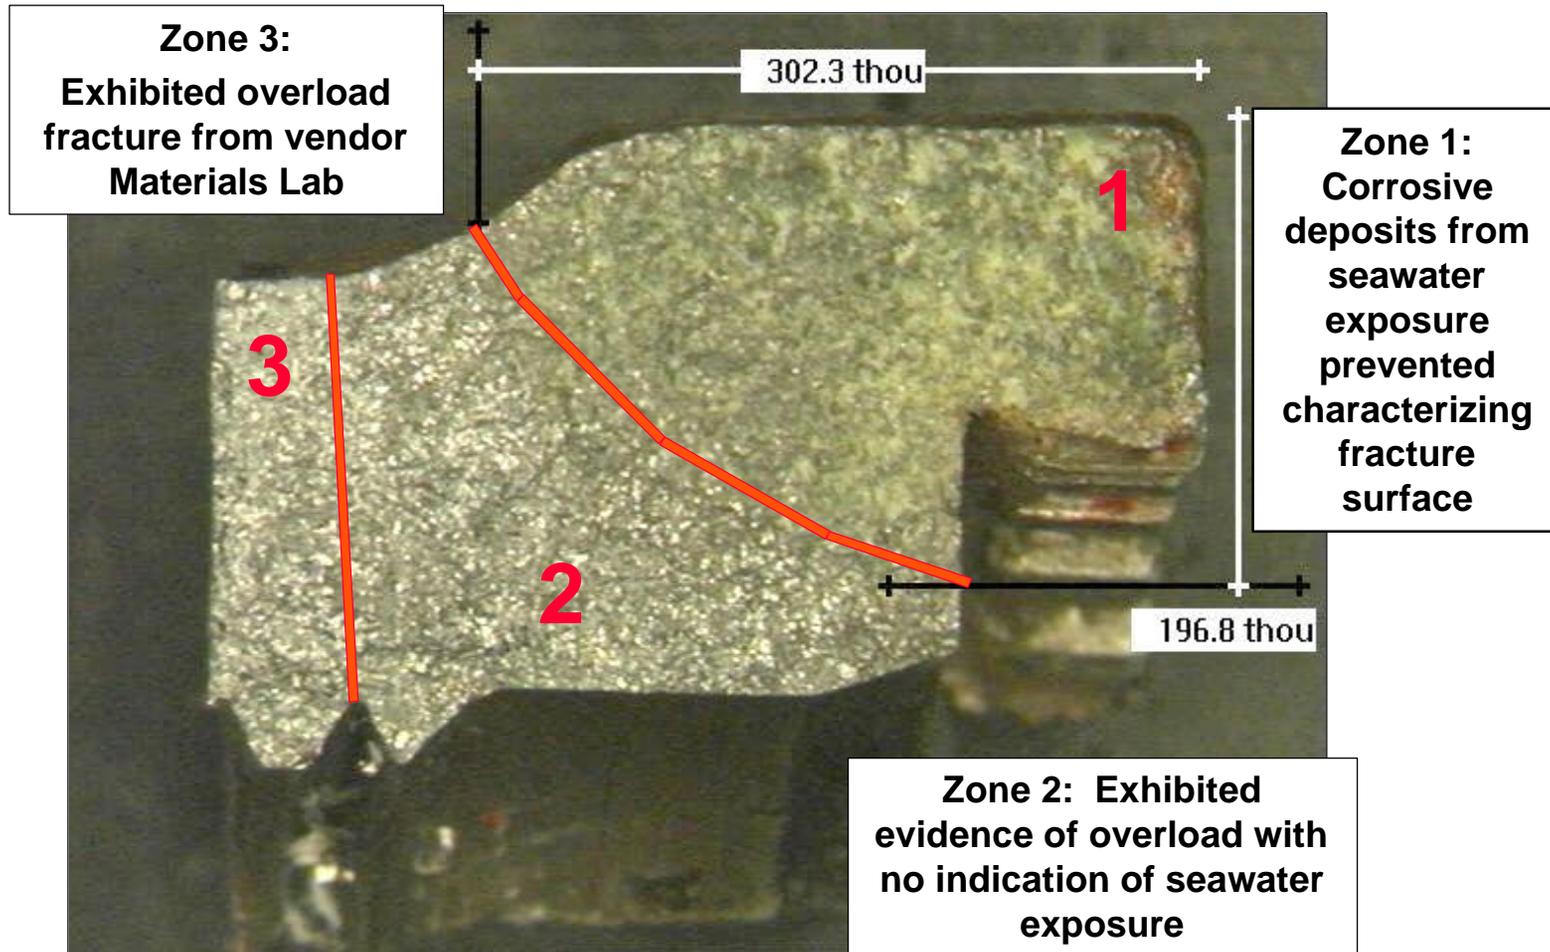
Fuel Pump Housing Fracture Surface

- Fault tree utilized to identify and eliminate potential causes
  - Most probable cause attributed to unique combination of high joint stress due to applied loads and local stress concentration resulting from corrosion pitting
    - Initial high loading event occurs with Rosan fitting installation
    - Water impact can induce additional joint loading
    - Corrosion most likely caused by insufficient application of polysulfide coating
    - Stress concentration can drive loading past material ultimate capability
- Testing performed to characterize material properties and refine analytical models
  - Material properties within specification limits
    - Yield strength, ultimate strength and elongation
  - Torque tension testing revealed yield with worst case design conditions

- Flight induced loading insignificant relative to installation loads
  - Negligible flight crack growth
- External leakage requires crack growth beyond secondary o-ring seal
- Boss failure most likely to occur due to overload not fatigue crack growth

- Vendor processing documentation modified to enhance inspection and assembly operations
