STS-111 Flight Readiness Review

**Space Station and Payload Processing
ISS-14-UF-2/STS-111**

**Multi-Purpose Logistics Module “Leonardo”
Mobile Base System (MBS)**

**Glenn Chin/UB-M
NASA/KSC UF-2 Mission Manager
May 16, 2002**

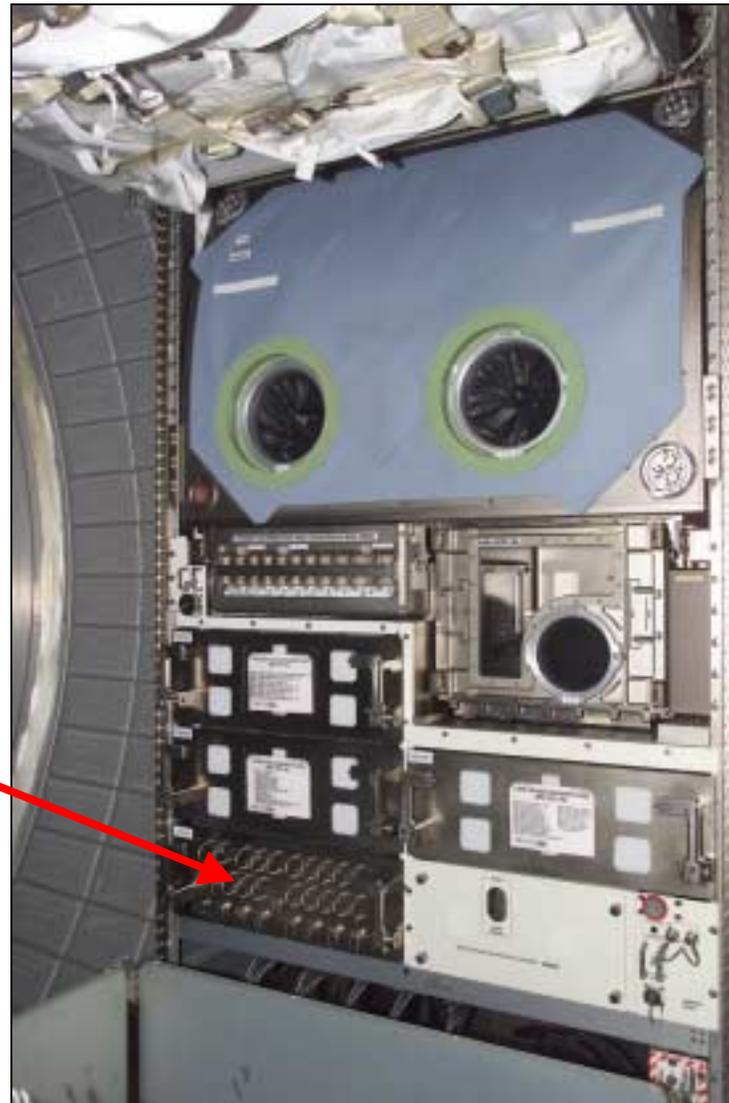
Microgravity Science Glovebox (MSG) Rack Installed in MPLM

The Microgravity Science Glovebox (MSG) Rack is shown here as installed for flight on UF-2 (STS-111). The rack is installed in the MPLM bay 4 ceiling position. The MSG Video Drawer is installed in the lower left position of the rack.

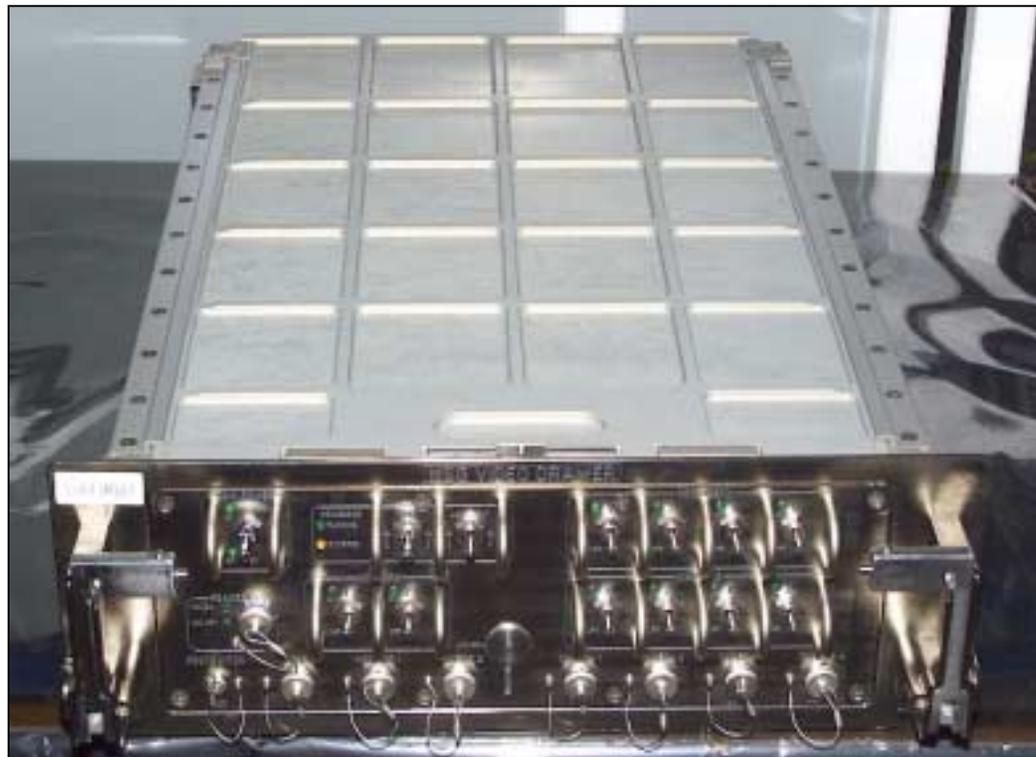
Microgravity Science Glovebox (MSG) Video Drawer

The MSG Video Drawer is a modified International Subrack Interface Standard (ISIS) drawer. The drawer houses video recording equipment used by crew members on orbit. Access to the recording equipment is gained by partially deploying the drawer from the rack and sliding the top lid of the drawer toward the back of the rack.

Power to the drawer is maintained by a telescoping umbilical that remains connected to the rack when the drawer is deployed and stowed.

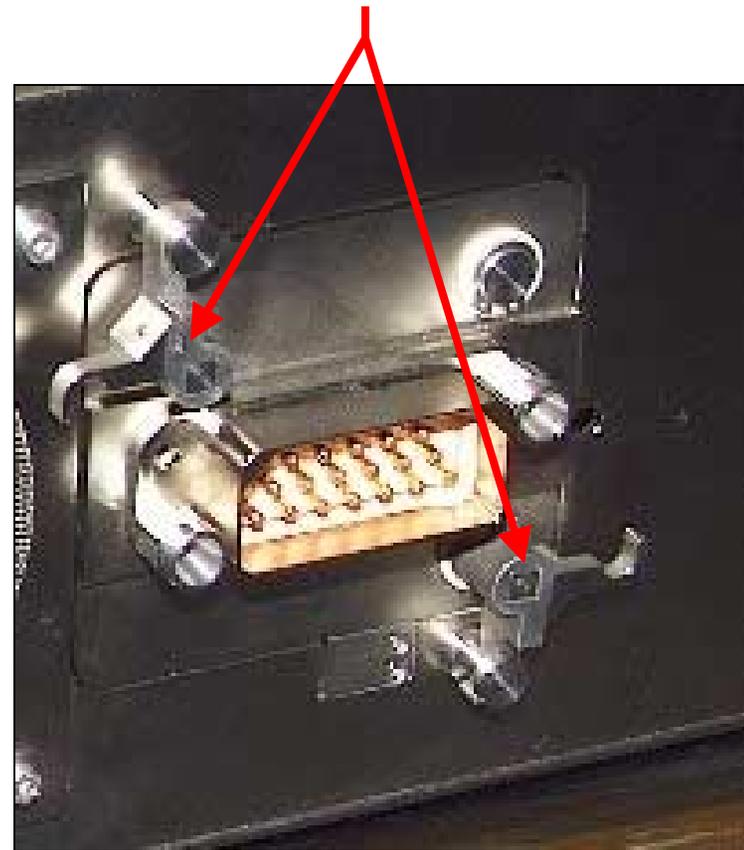
Retention Hook Assemblies

Umbilical Connector Detail

Shown here is the umbilical connector with the retention hooks in the launch position. In this position, the retention hooks retain the telescoping umbilical inside the Video Drawer. On orbit, the retention hooks will be rotated to grapple the connector bar on the rack side of the interface. In that configuration, the retention hooks maintain the electrical connection when the drawer is deployed and stowed.
