# **Discovery STS-103**

## **Space Shuttle Program**

### **SSME Flight Readiness Review**

*19 November 1999*

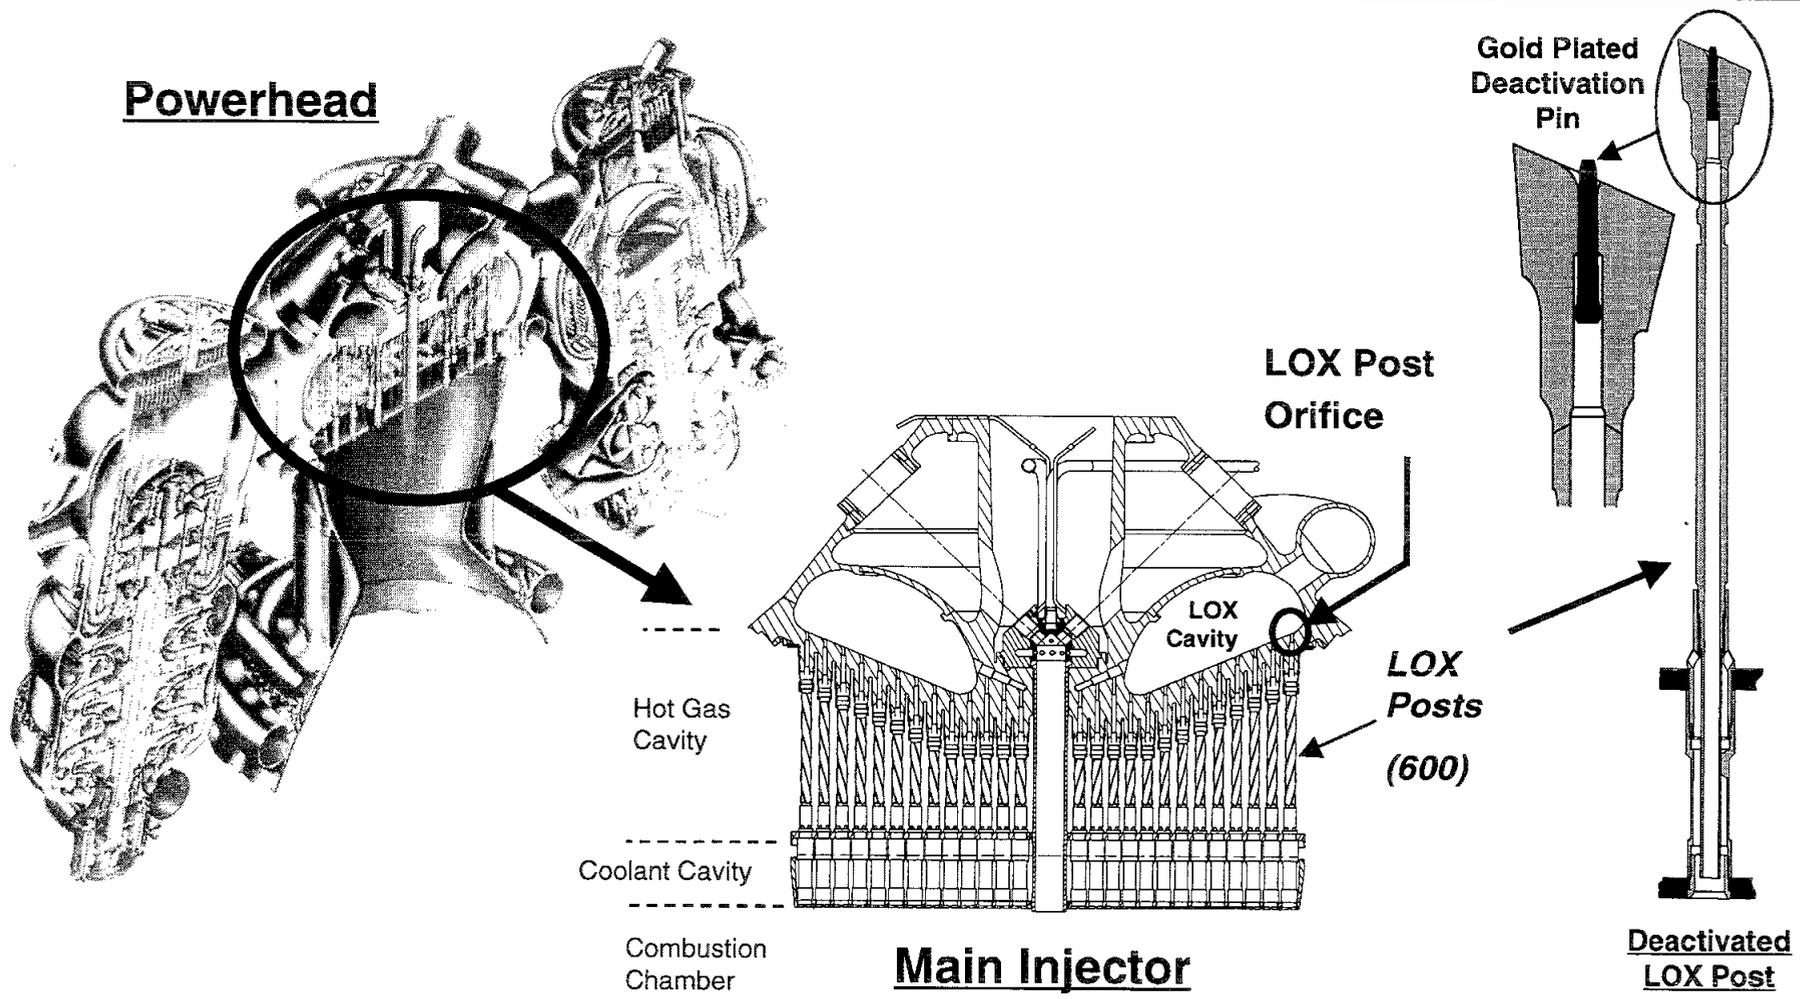
## *Powerhead, Main Injector and LOX Post Details*

- Post flight inspection noted loss of main injector LOX post deactivation pin and impact damage on MCC wall near throat
  - Minor impact damage (.0015" deep) on MCC directly below missing pin
    - 2.5" forward of the throat center line
- Two E2019 LOX posts were deactivated prior to STS-93
  - Standard procedure upon LOX posts reaching calculated life limit (reference DAR 2049R1)
  - Deactivated posts were Row 13 Post 3 and Row 13 Post 32
    - Post 32 pin found missing after flight
  - Deactivation pins are gold plated Inconel 718
- Materials analysis confirmed gold found in nozzle tube dents / ruptures matched identically gold plating on deactivation pins

- Pin expelled during engine start as pressure builds in LOX dome (~5 sec)
- Pin strikes MCC hot wall and entrains in hot gas flow stream at throat
- Pin traverses across flow streams and strikes the nozzle tubes ~28 inches forward of aft manifold
- Puncturing of the wall results in fuel leakage, increased LOX usage, and early depletion of the LOX supply

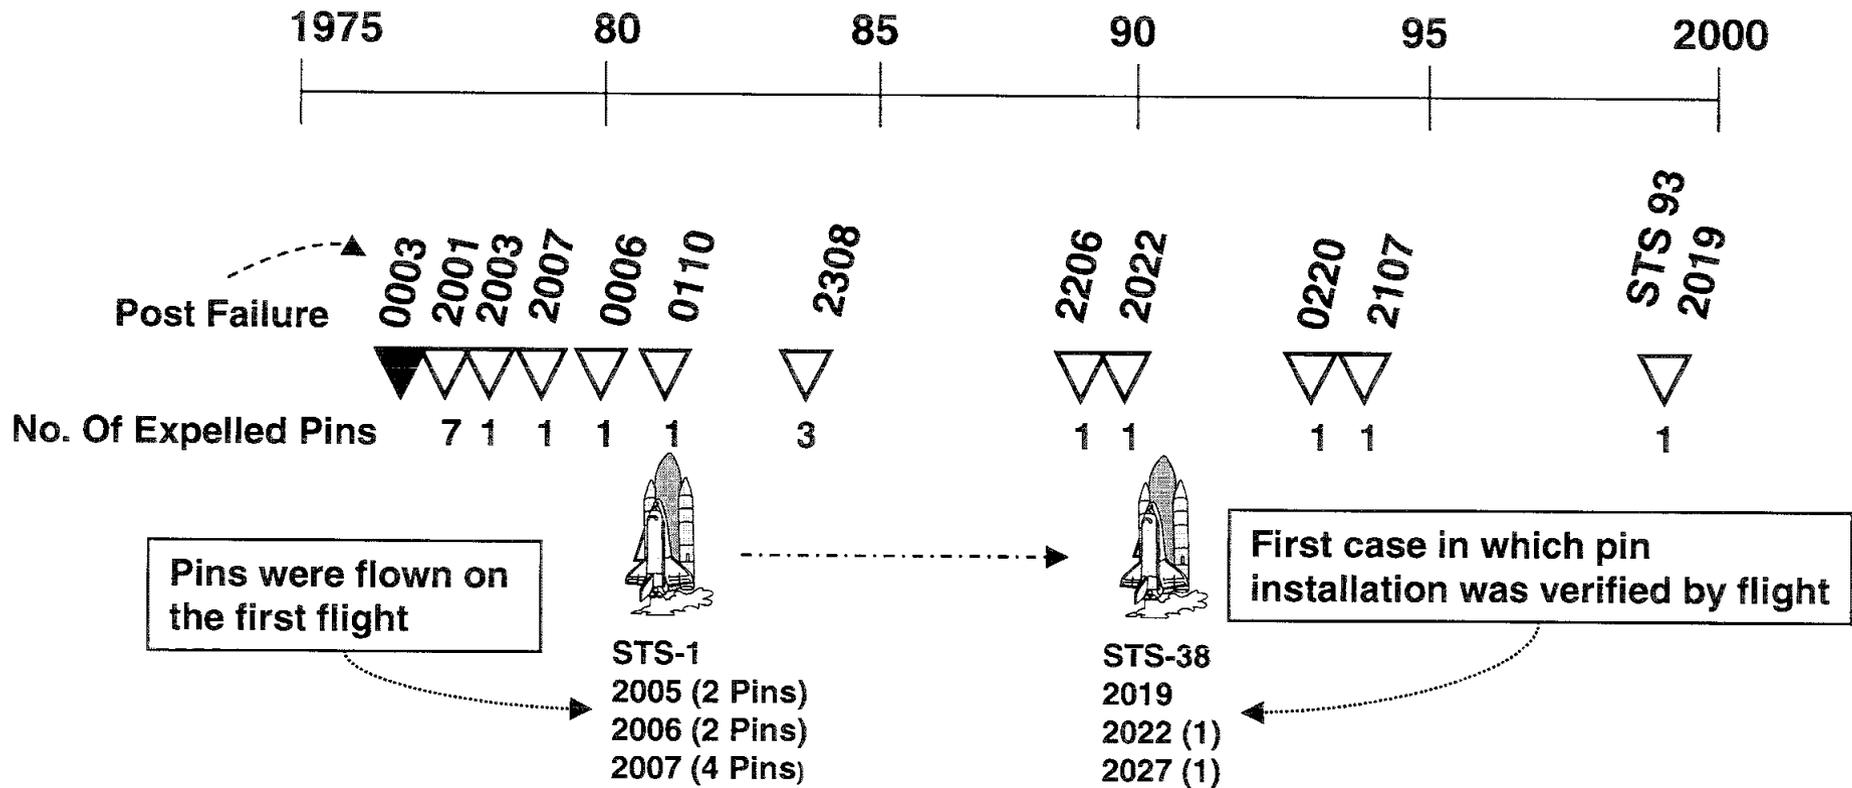
## Lox Post Pinning Timeline

**79 of 95 flights have included engines with pinned posts**

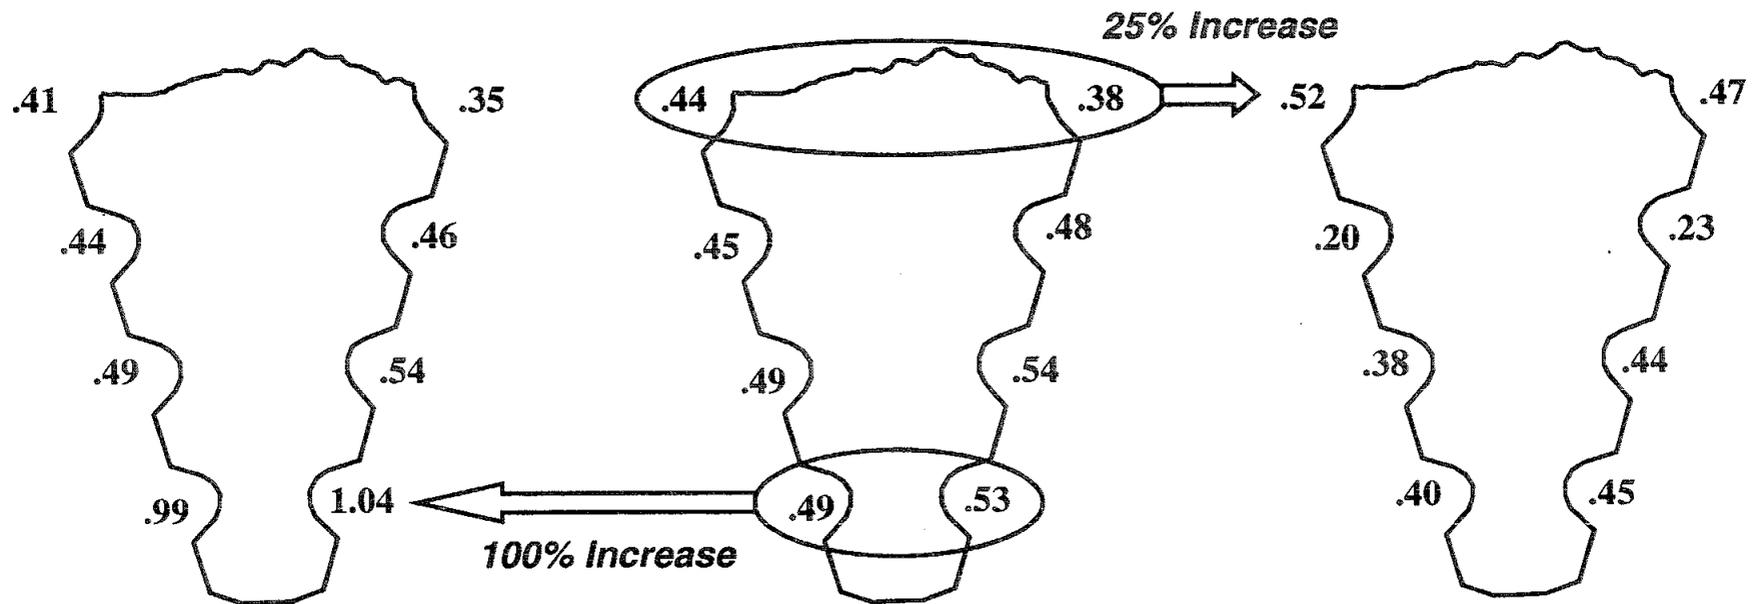
## Lobe to Lobe Dimensional Tolerance Sensitivity

*Biased to Lower Lobe Contact*

Nominal Firtree Loading  
All Lobes Contacted Equally
