TWR-75738
ECS SS10969

Reusable Solid Rocket Motor **STS-104 Flight Readiness Review/CoFR**

Motor Set RSRM-80

28 June 2001

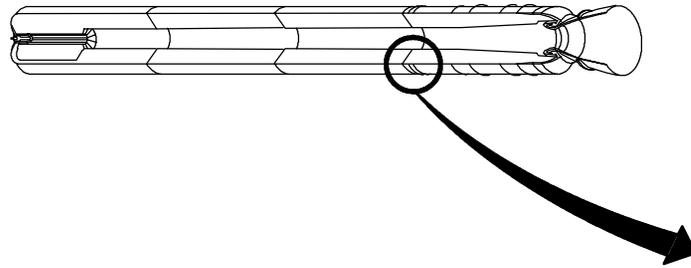
STS-105 (RSRM-81) LH Aft Condition

- A pattern identification label was found embedded in the clevis insulation of the STS-105 LH aft segment during processing at KSC
 - The label-caused void was cut open, most of the label removed, the rubber bonded back in place, and the repair blended to the surrounding contour
 - STS-105 LH aft segment repair has been fully evaluated and meets all requirements

- Cause of the out-of-place label is understood
 - Missing or misaligned polyethylene film cover resulted in label adhering to the back of a green rubber ply in the pre-cut ply kit
 - Cause determined to be a rare and isolated event
- A joint Thiokol and MSFC team conducted a comprehensive evaluation of the insulation layup process and design to understand the probability and criticality of labels in the insulation
