**STS-105
PROGRAM
FLIGHT READINESS REVIEW**

AUGUST 1, 2001

Orbiter

STS-102 INFLIGHT ANOMALIES

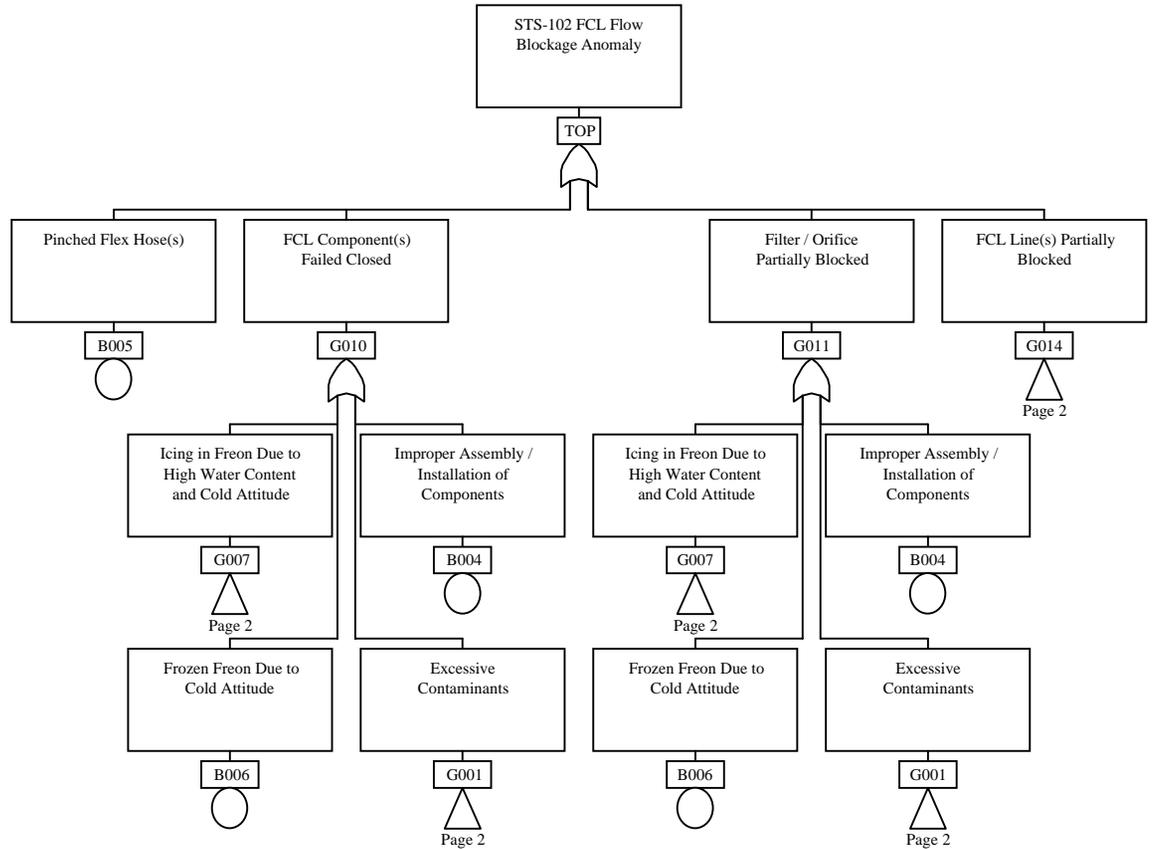
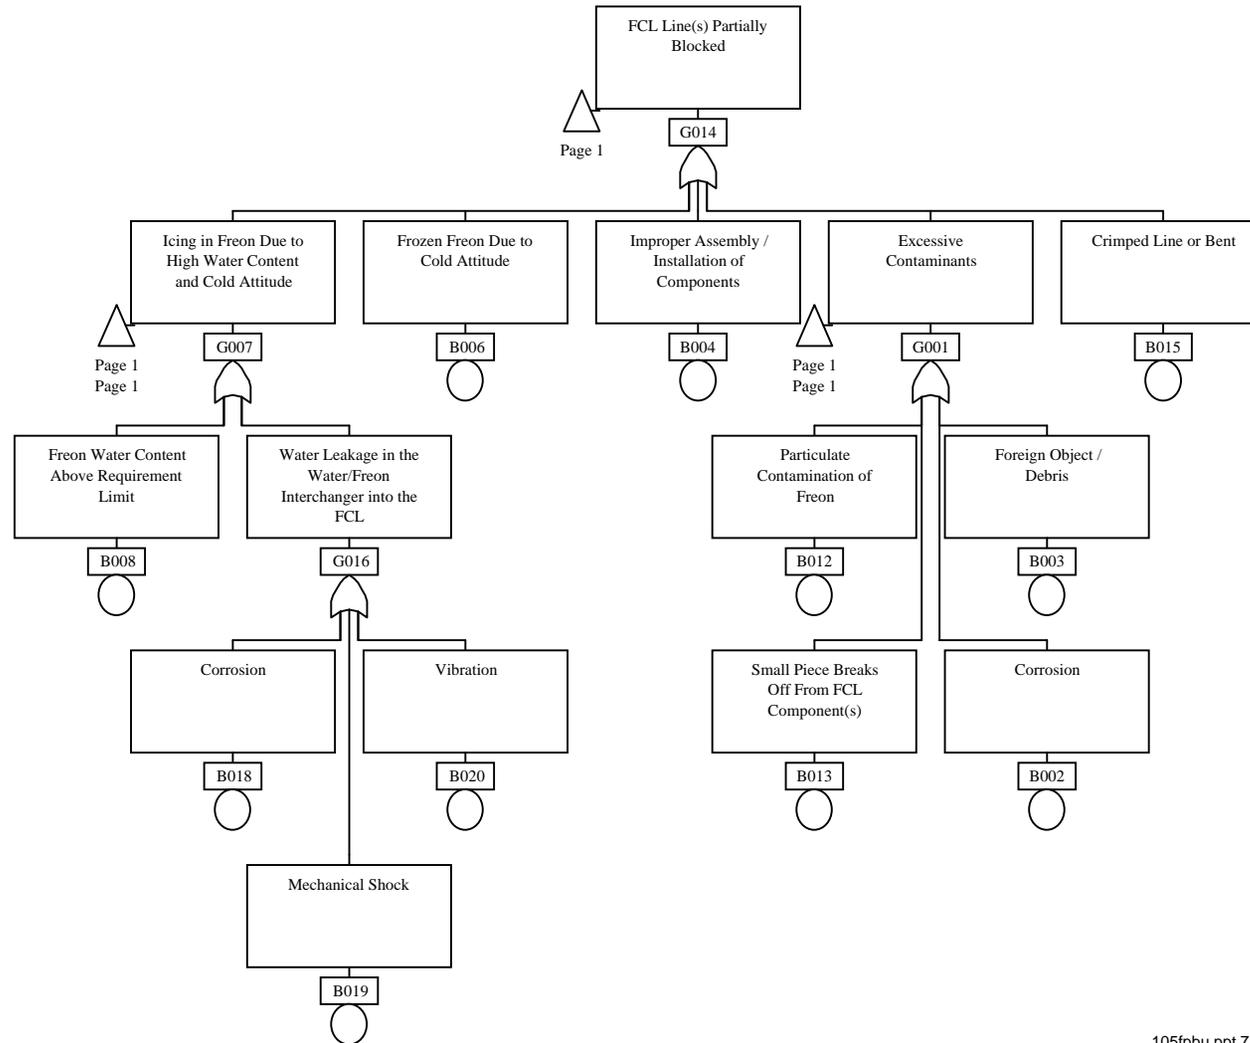
STS-102 FCL FLOW BLOCKAGE ANOMALY

- During STS-102 Docking period, a FES water dump was performed with RFCAs in “High” setting
- Radiator Freon temp dropped from -18°F to as low as -82°F and flow decreased
- Cause of icing attributed to radiator being too cold, although current flight rule allows -85°F min Freon temp
 - Similar problem was observed during STS-28 and STS-35

- Freon post-flight sample showed water content of 44 ppm and 50 ppm in FCL 1 and 2 vs. 15 ppm max OMRSD allowable limit
- Freon sample confirmed that radiator freezing was due to high moisture content
- Both FCLs have been re-serviced with new Freon
 - FCL 1 with 6 ppm moisture is within 15 ppm max limit
 - FCL 2 with 23 ppm requires a waiver to fly
 - -82F Water-in-Freon solubility temperature
 - Minimum predicted for STS-105 is -20F per pre-flight analysis based on nominal planned attitude
 - -65F panel temperature expected during radiator cold soak per previous flight data
- Investigation to determine the cause of moisture content increase is ongoing

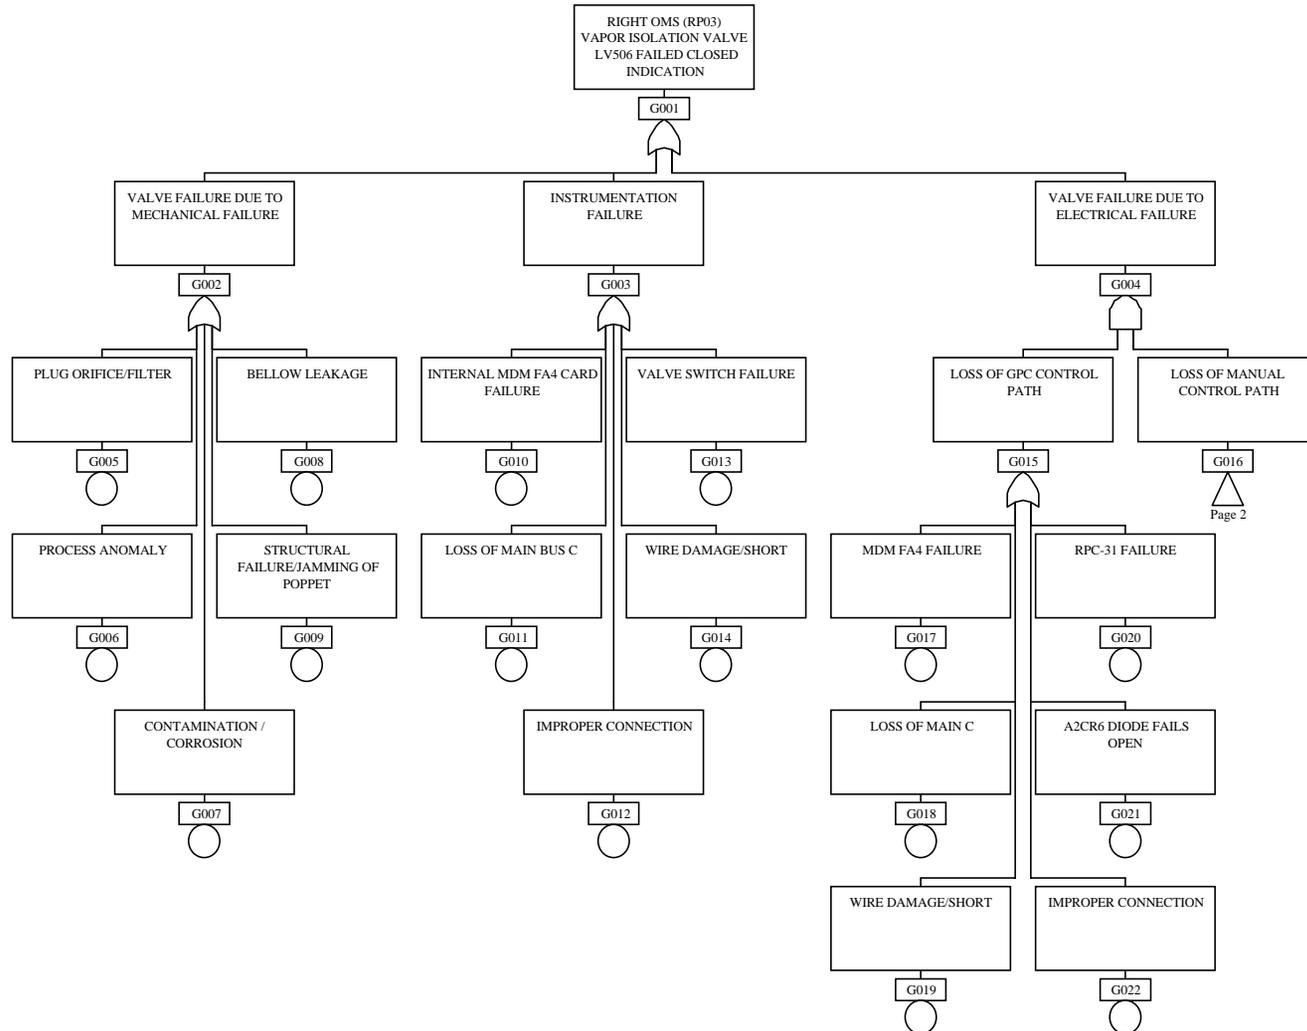
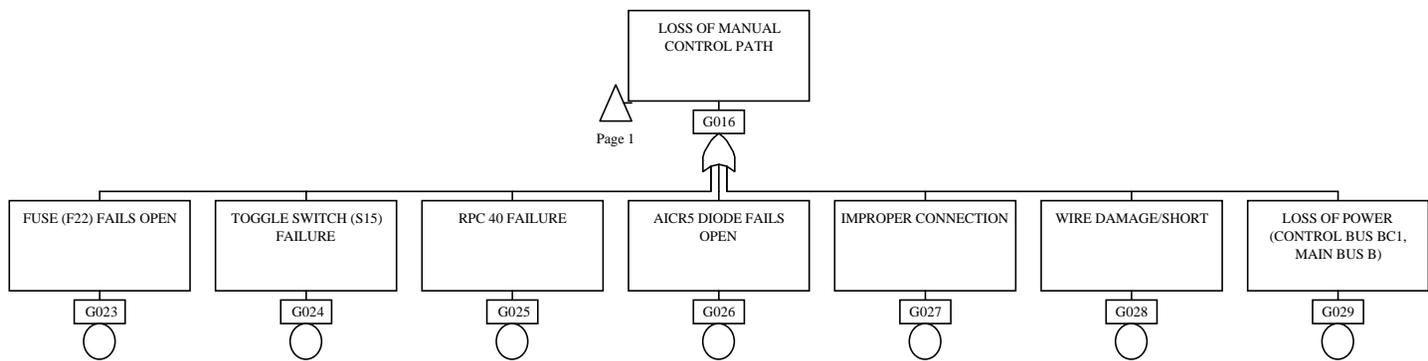
OMS VAPOR ISOLATION VALVE FAILED CLOSED INDICATION	Presenter:
	Organization/Date: Orbiter/08-01-01

- During last two (of 8) right OMS (RP03) engine burns, vapor isolation valve #2 (LV506, S/N 25) failed to indicate open

- Vapor iso valves 1 and 2 were commanded open via cockpit switch prior to each OMS engine burn
 - Valve 1 indicated open and valve 2 did not indicate open
- Valve function cannot be determined in-flight without VPI
 - A single cockpit switch throw controls both valves
 - Two switches available for this function
 - No system operation impact because valves 1 and 2 are in parallel, with valve 1 providing a redundant flow path
 - Tank pressures verified at least one flow path was open

- Possible causes of failure evaluated
 - Contamination/corrosion in the valve switch
 - Wiring problem
 - MDM failure (FA4)
 - Vapor iso valve 2 VPI signal goes through MDM FA4, card D
- Troubleshooting conducted revealed no cause for the failure
 - A BITE test 4 was performed - no anomalies with MDM FA4 were found
 - Orbiter wiring connectors were checked and no discrepancies were evident
 - Valve cycling performed with break out boxes installed revealed power being supplied to both the solenoid and the VPI circuits
 - Wire wiggle test performed
 - Valve function was nominal during troubleshooting

- No troubleshooting internal to OMS pod was performed due to lack of access with pod installed
- Documented as a UA/Deferred PR
 - Most probable cause is an intermittent wiring problem in the RP03 VPI circuitry
 - Additional troubleshooting planned (deferred PR) at upcoming OMDP

GATE	DESCRIPTION	ACTIONEE	RESOLVED (Y/N)	COMMENTS/RATIONALE
G005	PLUG ORIFICE/FILTER	B. Werner	Y	This has no effect on the VPI.
G006	PROCESS ANOMALY	B. Werner	Y	If the failure were due to a process anomaly, it probably would have been present when the valve was installed.
G007	CONTAMINATION / CORROSION	B. Werner	N	Contamination or corrosion could possibly affect the VPI limit switch.
G008	BELLOW LEAKAGE	B. Werner	Y	This has no effect on the VPI.
G009	STRUCTURAL FAILURE/JAMMING OF POPPET	B. Werner	Y	This has no effect on the VPI.
G010	INTERNAL MDM FA4 CARD FAILURE	Instrumentation (Fryxell, William T)	Y	BITE test verified correct operation of the MDM.
G011	LOSS OF MAIN BUS C	D. Sovereign	Y	Loss of main C would also lose VPI from Helium Isolation valve B, which works correctly.
G012	IMPROPER CONNECTION	D. Sovereign	Y	An improper connection would not be intermittent.
G013	VALVE SWITCH FAILURE	B. Werner	N	This is a possible cause, however valve numbers 17 and 25 show opposite failures.

G014	WIRE DAMAGE/SHORT	D. Sovereign	N	If the wire were damaged or shorted, valve numbers 17 and 25 would probably not have shown opposite failures.
G017	MDM FA4 FAILURE	Instrumentation (Fryxell, William T)	Y	BITE test verified correct operation of the MDM.
G018	LOSS OF MAIN C	D. Sovereign	Y	Loss of Main C would also lose indication from Helium Isolation valve B, which works correctly.
G019	WIRE DAMAGE/SHORT	D. Sovereign	N	If the wire were damaged or shorted, valve numbers 17 and 25 would probably not have shown opposite failures.
G020	RPC-31 FAILURE	D. Sovereign	Y	RPC-31 supplies current to the valve under GPC control, and the valve operates correctly.
G021	A2CR6 DIODE FAILS OPEN	D. Sovereign	Y	A2CR6 is an isolation diode for the valve under GPC control, and the valve operates correctly.
G022	IMPROPER CONNECTION	D. Sovereign	Y	An improper connection would not be intermittent.
G023	FUSE (F22) FAILS OPEN	D. Sovereign	Y	F22 also supplies current to the command circuit of Helium Isolation valve B, which works correctly.

G024	TOGGLE SWITCH (S15) FAILURE	D. Sovereign	Y	S15 also commands Helium Isolation valve B, which works correctly.
G025	RPC 40 FAILURE	D. Sovereign	Y	RPC-40 supplies current to the valve under manual control, and the valve works correctly.
G026	A1CR5 DIODE FAILS OPEN	D. Sovereign	Y	A1CR5 is an isolation diode in the manual command circuit for the valve, and the valve operates correctly.
G027	IMPROPER CONNECTION	D. Sovereign	Y	An improper connection would not be intermittent.
G028	WIRE DAMAGE/SHORT	D. Sovereign	N	If the wire were damaged or shorted, valve numbers 17 and 25 would probably not have shown opposite failures.
G029	LOSS OF POWER (CONTROL BUS BC1, MAIN BUS B)	D. Sovereign	Y	Control Bus BC1 also supplies command current to Helium Isolation valve B, which works correctly.
