**STS-112 (BI115)  
FLIGHT READINESS REVIEW**

**Solid Rocket Booster**

# TECHNICAL ISSUE - BSM FOREIGN OBJECT DEBRIS

# TECHNICAL ISSUE - APU FUEL PUMP INLET PORT CRACK

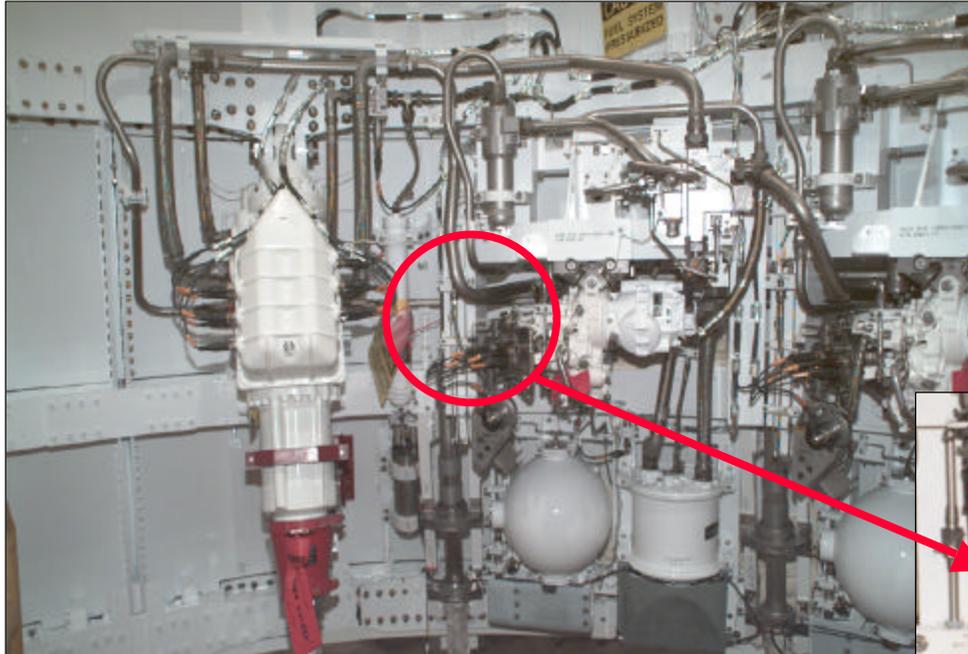
APU fuel pump inlet

- Radial crack in fuel pump inlet port boss found during Rosan fitting installation at Hamilton Sundstrand
  - Localized corrosion pitting present

- Fuel pump housing crack can allow external leakage of hydrazine

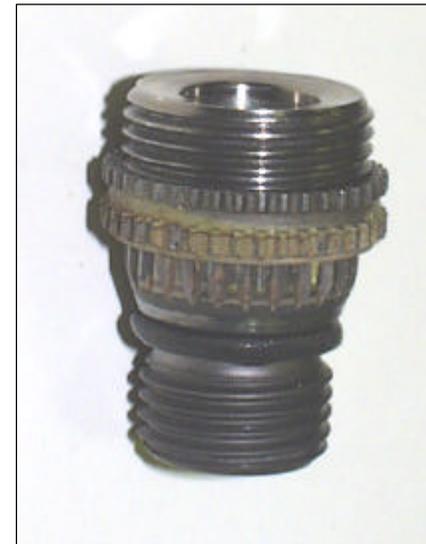
Rosan Fitting

- Fuel pump refurbished at Hamilton Sundstrand following every flight
- Subject housing manufactured in 1986 and flew on STS-86 (1997) and STS-102 (2001) as part of APU S/N 156
  - Rosan fitting not removed following STS-86 flight
  - Defect found during STS-102 refurbishment Rosan installation
    - Rosan fitting removed to implement Chem film corrosion protection and Krytox grease replacement of Apiezon grease
