STS-102
FLIGHT READINESS REVIEW

February 27, 2001

Ground Operations

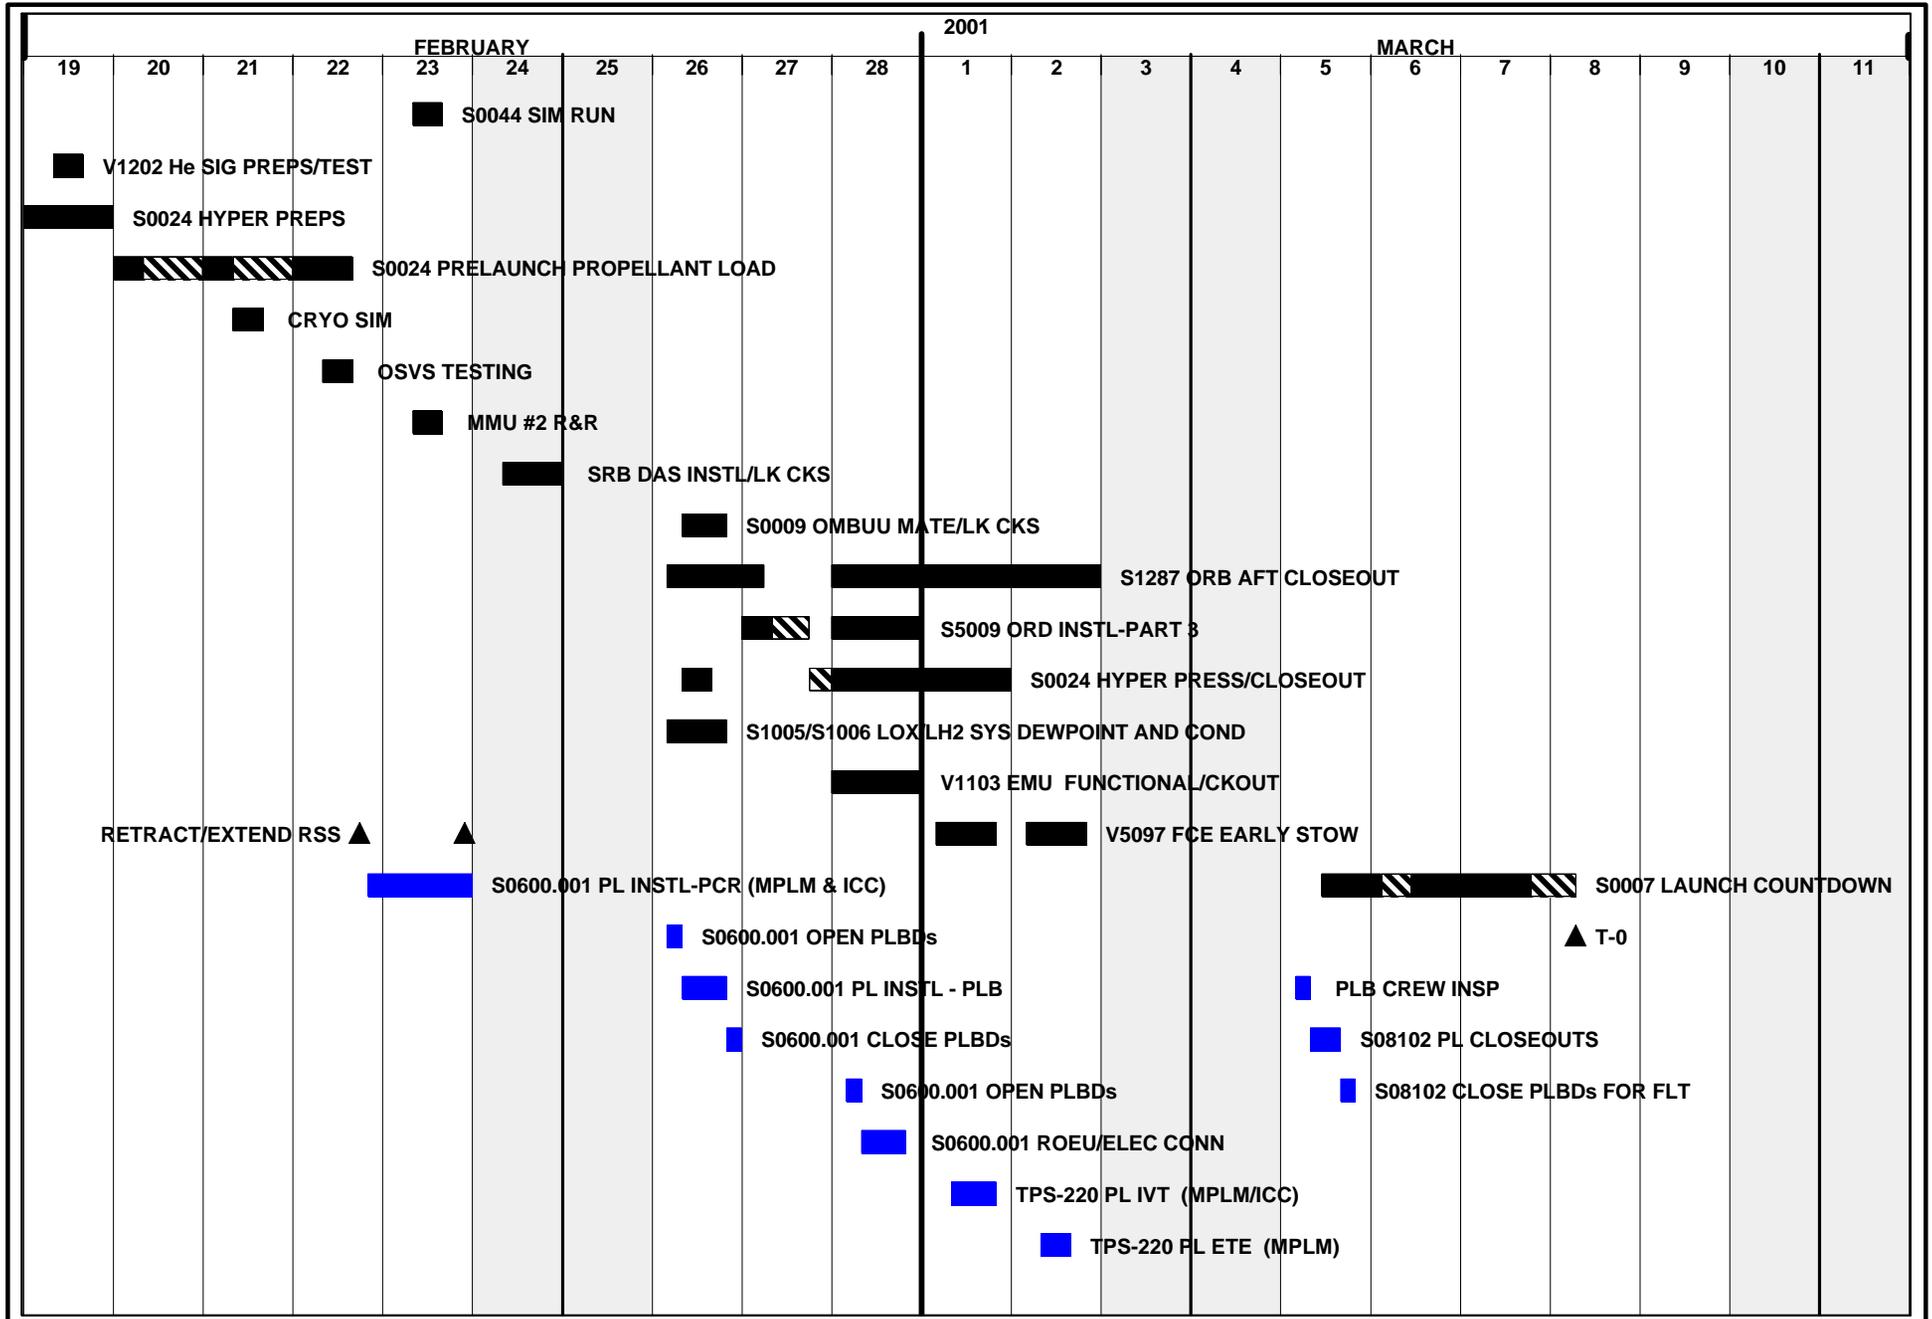
STS-102 / OV-103 Operations Summary

OPR: USA - D. Thompson, INTEG(1-2567)
NASA - E. Mango, PH (1-9221)

21FEB01 07:45

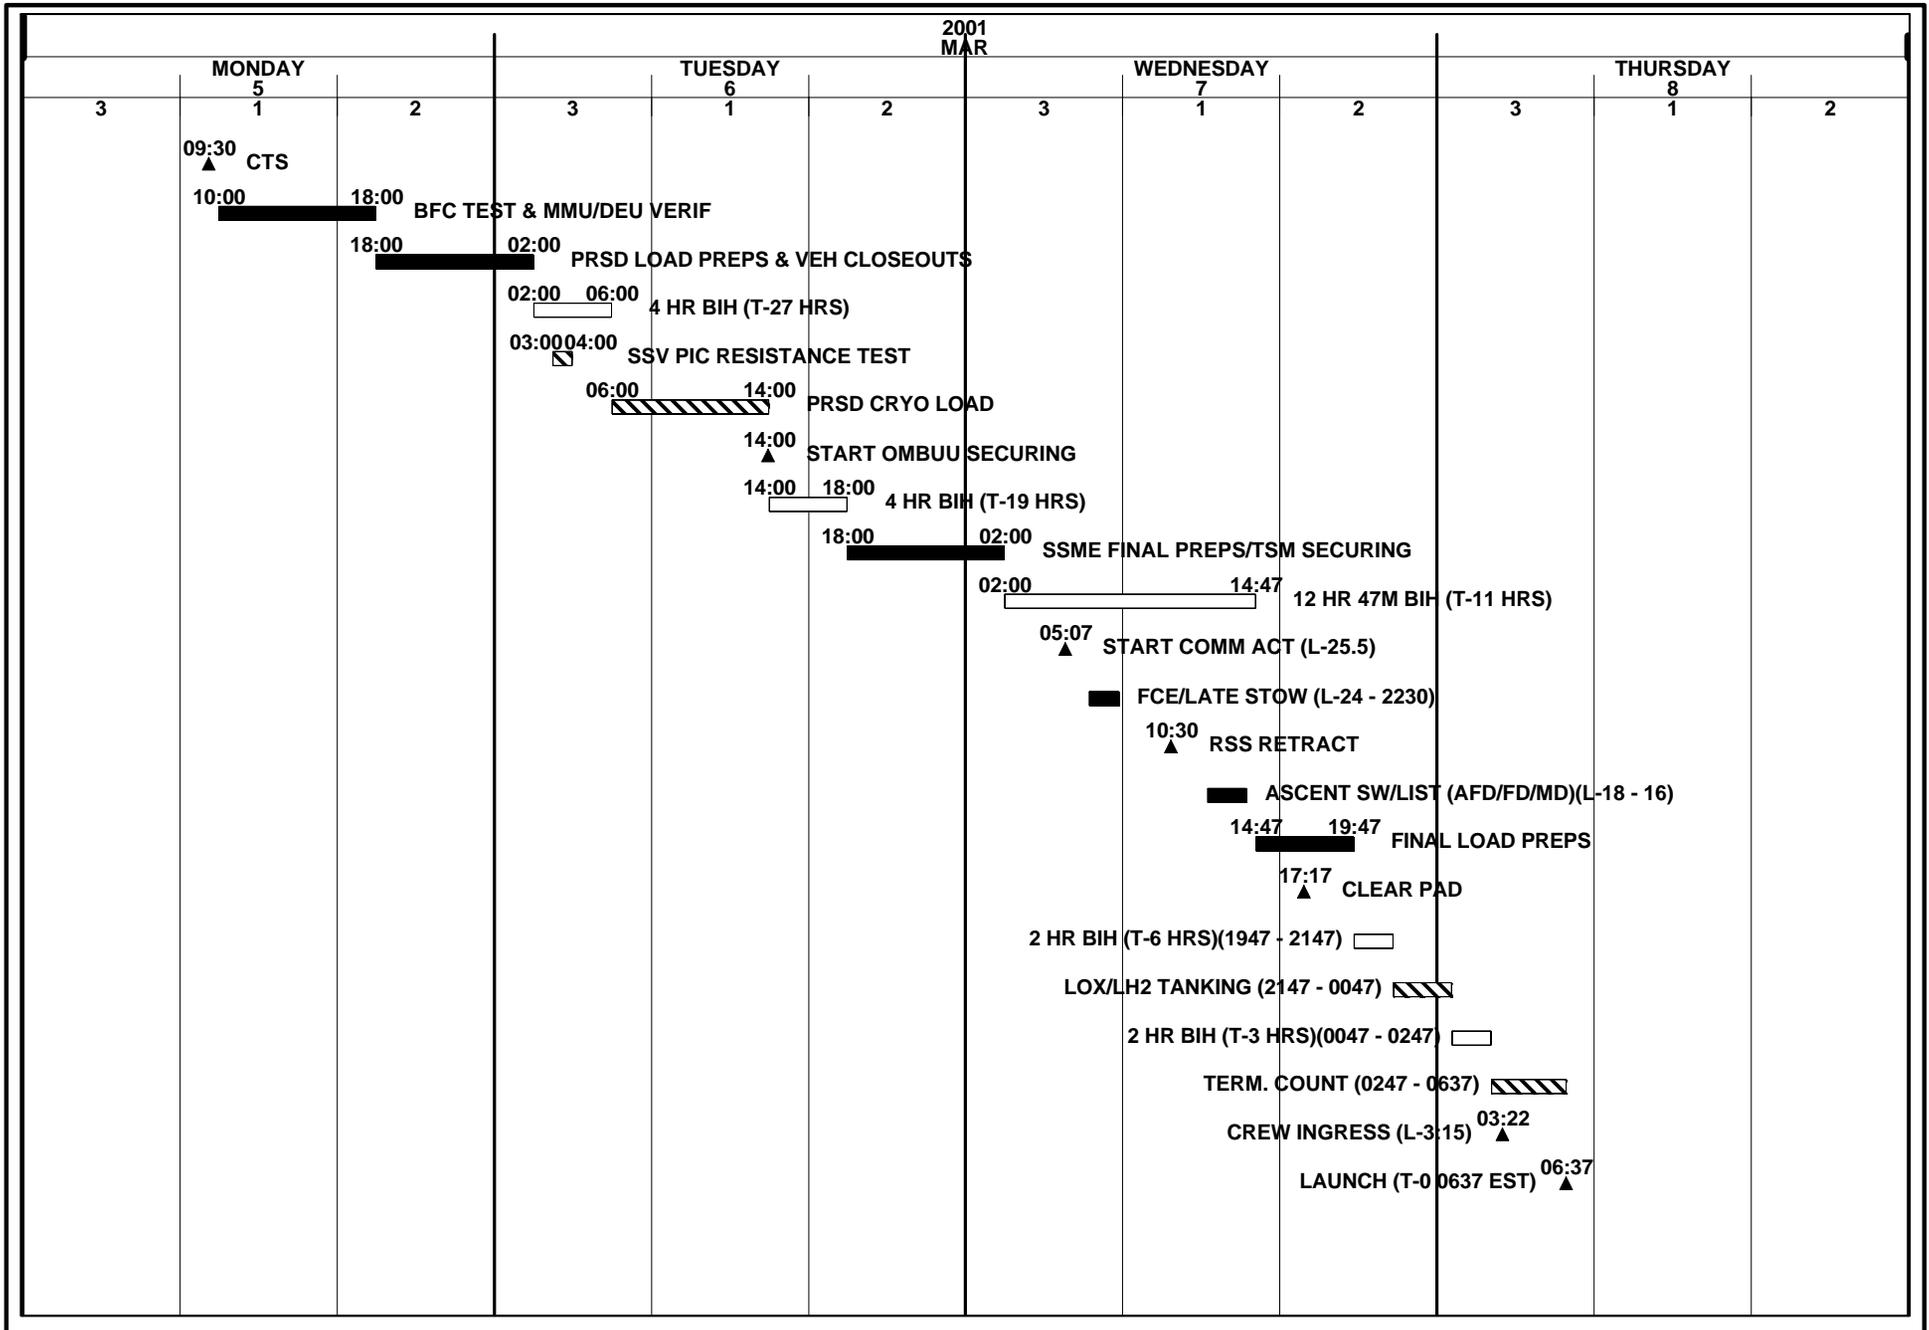
Launch Countdown Summary

STS-102 / OV-103

OPF: J. Spaulding (1-9306)

23FEB01 15:07
